Trails Dashboard

Pavement Condition Index

July 17, 2024

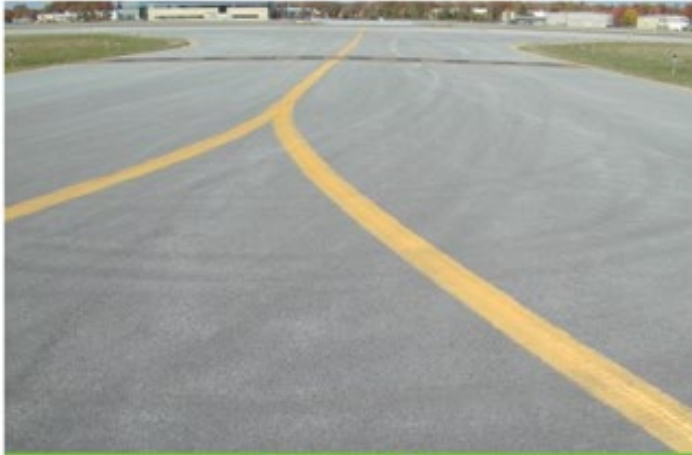
PCI: 100

REPRESENTATIVE PAVEMENT SURFACE*

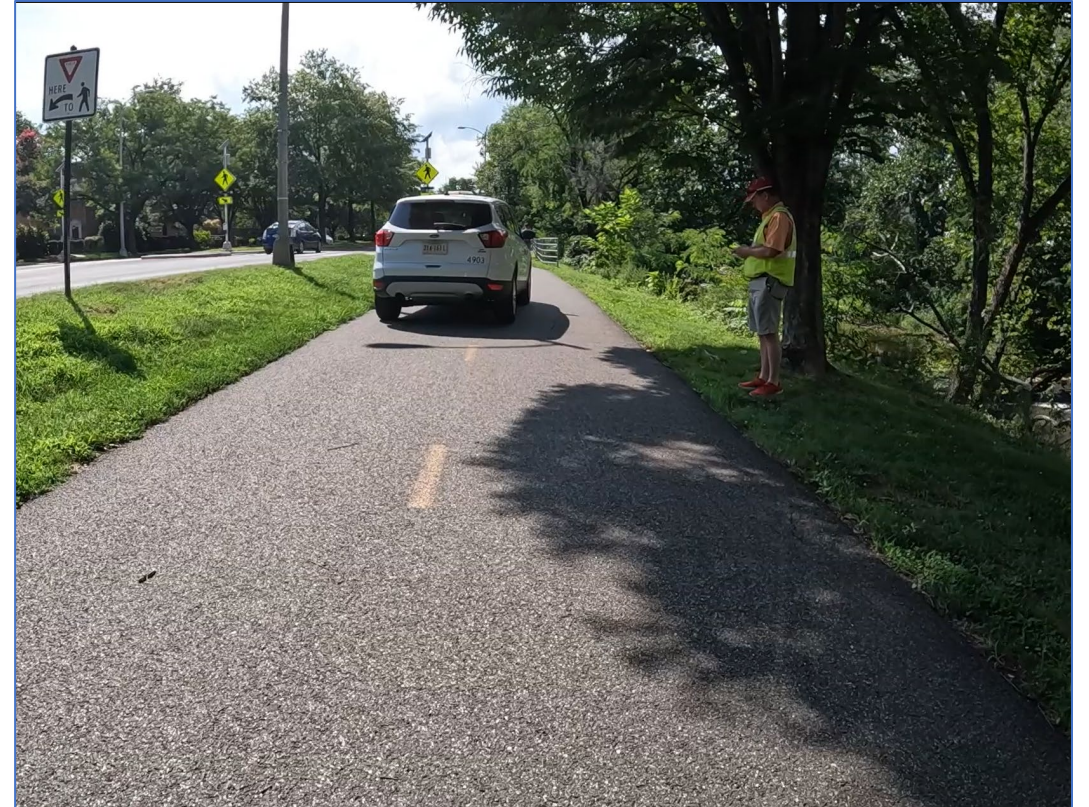
- Digital modeling of 24 miles of trail surfaces (2018)
 - Lasers to detect imperfections
- Visual tracking on-foot, then by vehicle (2022)
- No pavement testing, exploratory probing, dismantling, or subsurface studies were performed

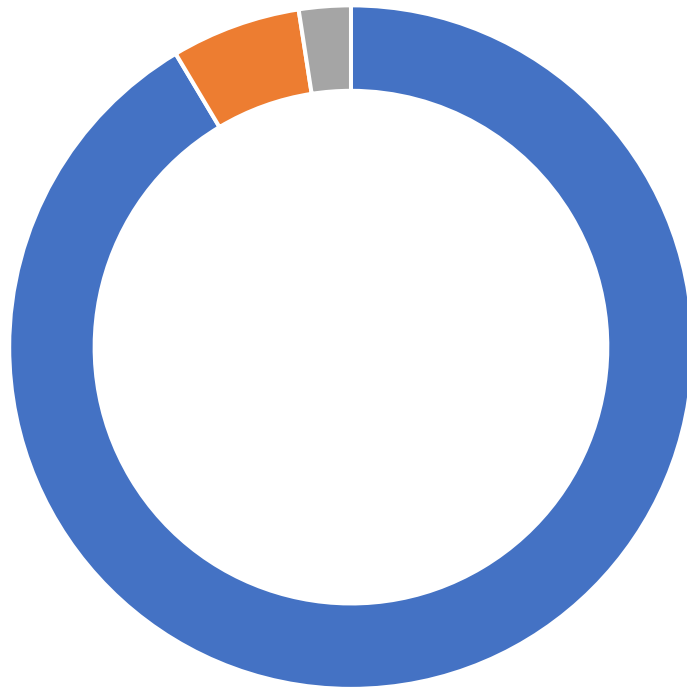
2022 Trail Surface Results

■ Asphalt ■ Concrete ■ Pavers

- 24.4 mi. studied
 - 22.4 mi. asphalt (Avg score 77)
 - 1.5 mi. concrete (Avg score 87)
 - 0.6 mi. pavers (Avg score 98)

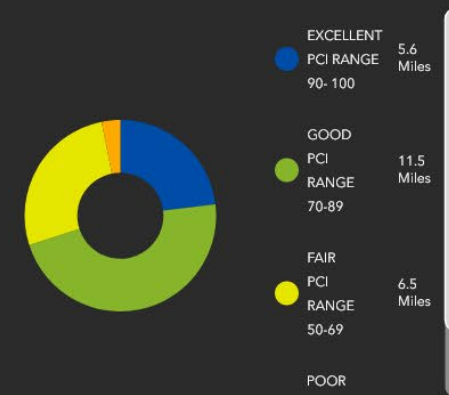
Condition
