Transit at the Table – It Works!

Baltimore Region MDOT MTA/LOTS Transfer Points Study

Sept. 24, 2019

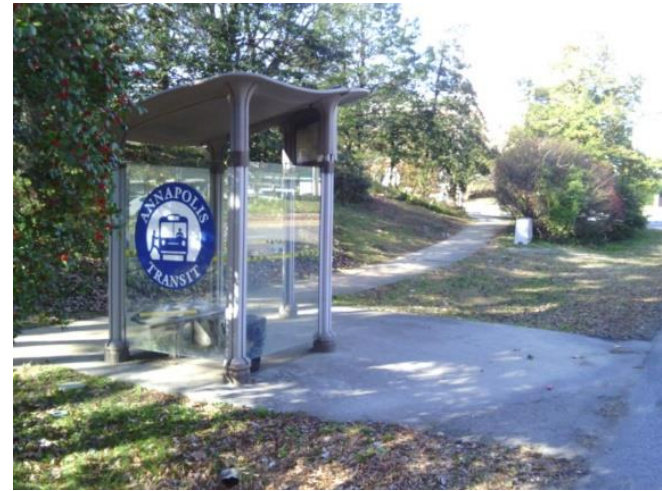
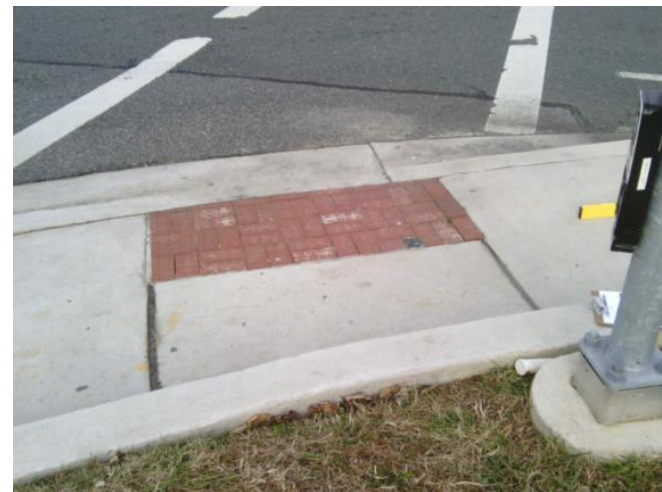
- 97 total locations were surveyed
- Compliance was determined for hundreds of features, including:
 - 221 bus stops
 - 204 curb ramps
 - 101 intersections
 - 13 sidewalk barriers
 - 2 wayfinding signs

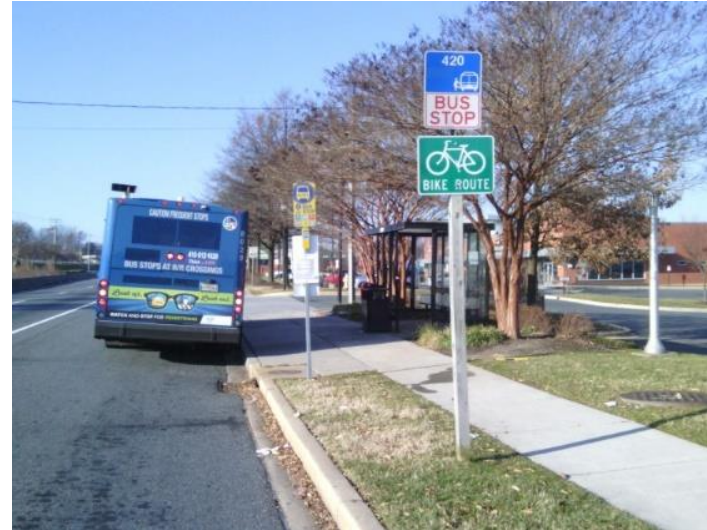
Harford Transit LINK Service Area Bus Stops - Reasons for Non-Compliance

20 were ADA Non-Compliant

- Sign protrusions
- Landing pads

Reason	Number	% of Non-Compliant	% of All Stops
Sign less than 80"	13	65.0%	38.2%
No Landing Pad	7	35.0%	20.6%
Sidewalk as Landing Pad	3	15.0%	8.8%
Landing Pad less than 5'x8'	1	5.0%	2.9%
Catch Basin Obstruction	1	5.0%	2.9%

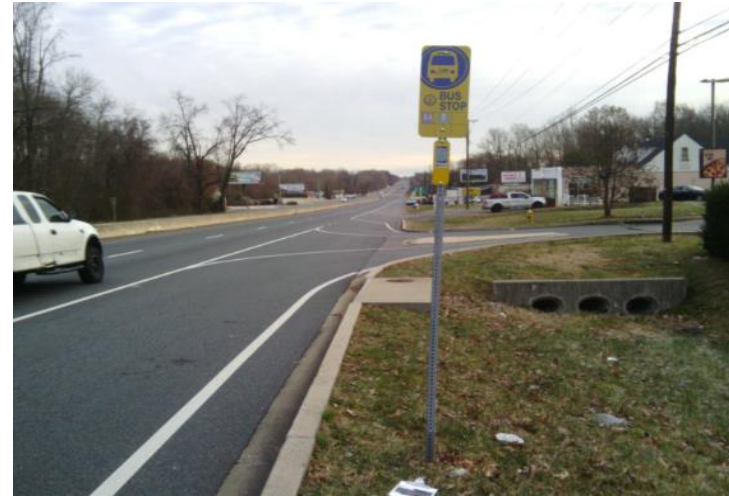
Harford Transit LINK Pathways Summary		
Compliance Category	Miles	Percent
Compliant	1.6	63.7%
Non-Compliant, Functional	0.2	7.4%
Non-Compliant, Non-Functional	0.7	28.9%
Total	2.5

- 1.6 miles Compliant
- 0.2 Non-Compliant, Functional
- 0.7 Non-Compliant, Non-Functional.

Primary issue: missing sidewalks

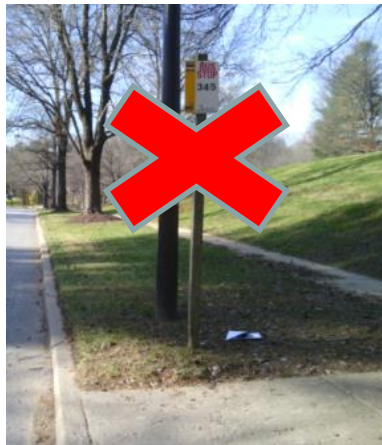
Existing Conditions: Invisible Stops

- These are stops where the exact location is impossible to determine due to lack of signage
- Many invisible stops are catalogued in GIS and listed on route schedules, but there is no physical evidence of them at an actual location

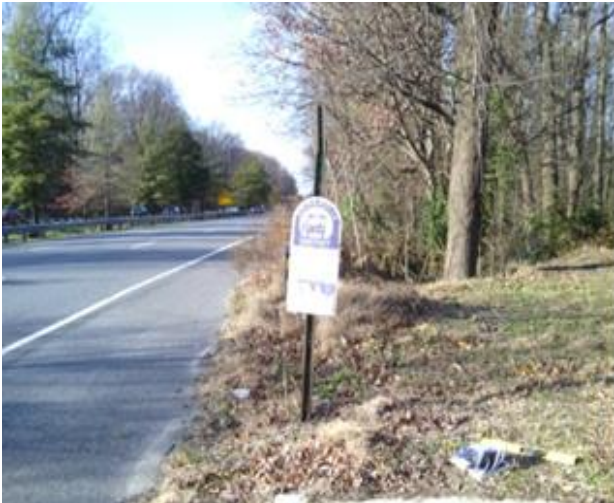
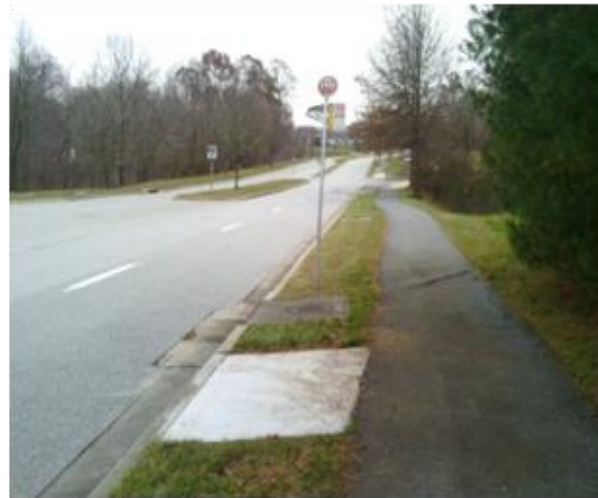
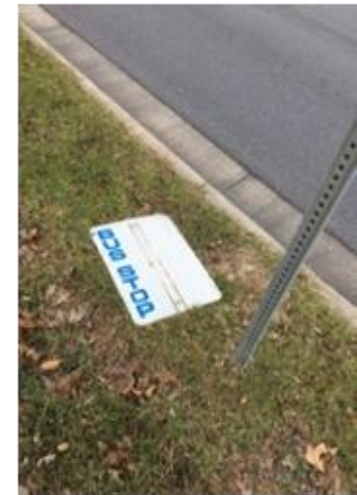
Existing Conditions: Damaged Signage

- Several signs were damaged to the extent that they were illegible or invisible to riders
- Damaged signs can cause confusion for potential riders and lead to a loss of confidence in service reliability

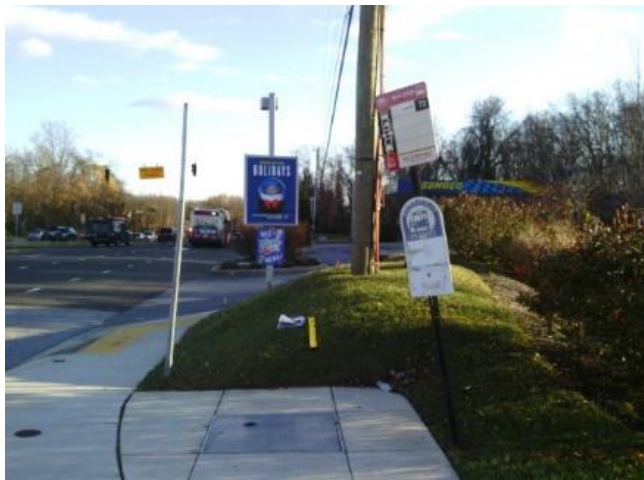
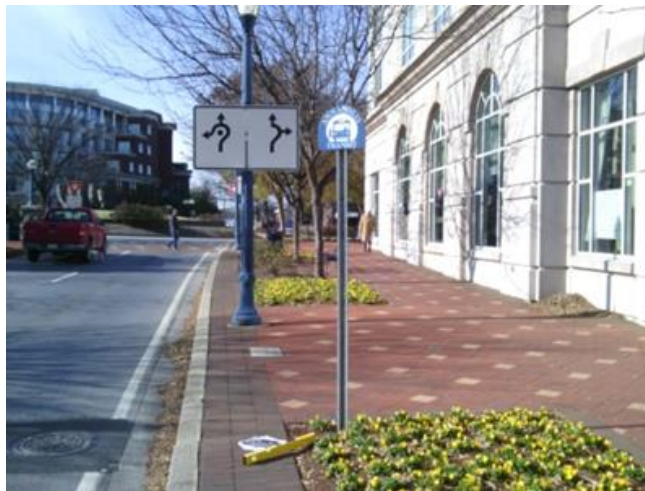
Existing Conditions: Inconsistent Design

- Many transit providers had inconsistent branding on their signage
 - MDOT MTA had four different design styles, one of which did not have the provider's name on it
 - Annapolis Transit also had varying sign designs

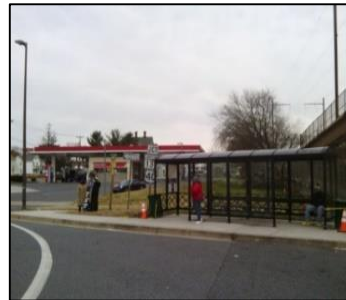
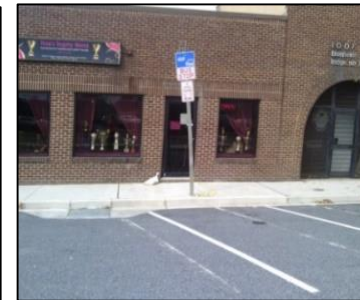
Bus Bays at the Aberdeen MARC Station (left); MTA Commuter Bus Stop Across from the Aberdeen MARC Station (right)

Aberdeen MARC Station		
Harford County		
Required Improvements		
N/A	0	\$0.00
Enhanced Improvements		
Wayfinding Signage	1	\$200.00
Stop 1	Primary Owner:	MTA Commuter Bus
New Compliant Landing Pad	1	\$4,000.00
New Sign	1	\$200.00
New Information Case	1	\$500.00
Stop 2	Primary Owner:	Harford Transit Link
New Information Case	1	\$500.00
Digital Display	1	\$1,000.00
New Sign	1	\$200.00
	Location Cost:	\$200.00
	Stop 1 Cost:	\$4,700.00
	Stop 2 Cost:	\$1,700.00
	Total Cost	\$6,600.00
