RTA of Central Maryland Stop Improvement Profiles

RTA of Central Maryland & MDOT-MTA Potential Transfer Stops

BMC Transfer Study Location Profiles

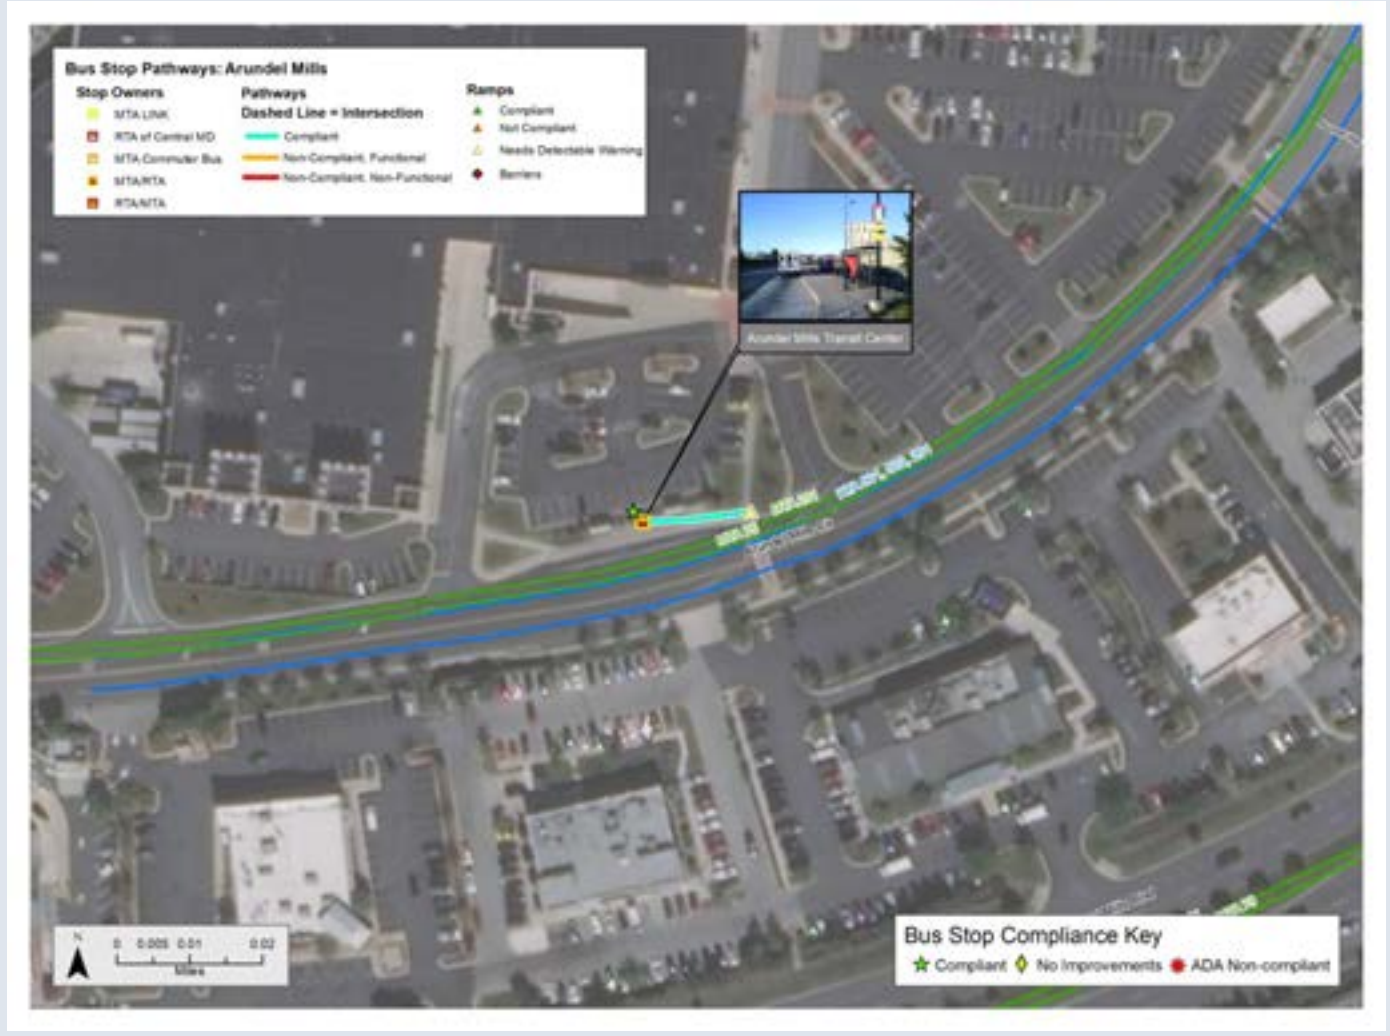
Landing Pads Needed:	0	Curb Ramps to Install:	1
Sidewalk (ft) to be installed/repaired:	0	Detectable Warnings Needed:	0
Signs with Non-Compliant Height:	0	Consolidate Signage?	No
New Signs Needed:	No	Pedestrian Control:	No
Compliant Amenities:	Yes	Traffic Control:	No

Arundel Mills		
Anne Arundel County		
Required Improvements		
New sidewalk to be installed	0	\$0.00
New curb ramps	1	\$3,500.00
Detectable warning	0	\$0.00
Enhanced Improvements		
Pedestrian Control	1	\$695.00
Crosswalk	0	\$0.00
Stop 1: Arundel Mills Bus Bay	Primary Owner: MTA LINK	
New Compliant Landing Pad	0	\$0.00
New Sign	0	\$0.00
New Information Case	1	\$500.00
Digital Display	1	\$1,000.00
New Shelter	1	\$15,000.00
	Location Cost:	\$4,195.00
	Stop 1 Cost:	\$16,500.00
	Total Cost	\$20,695.00

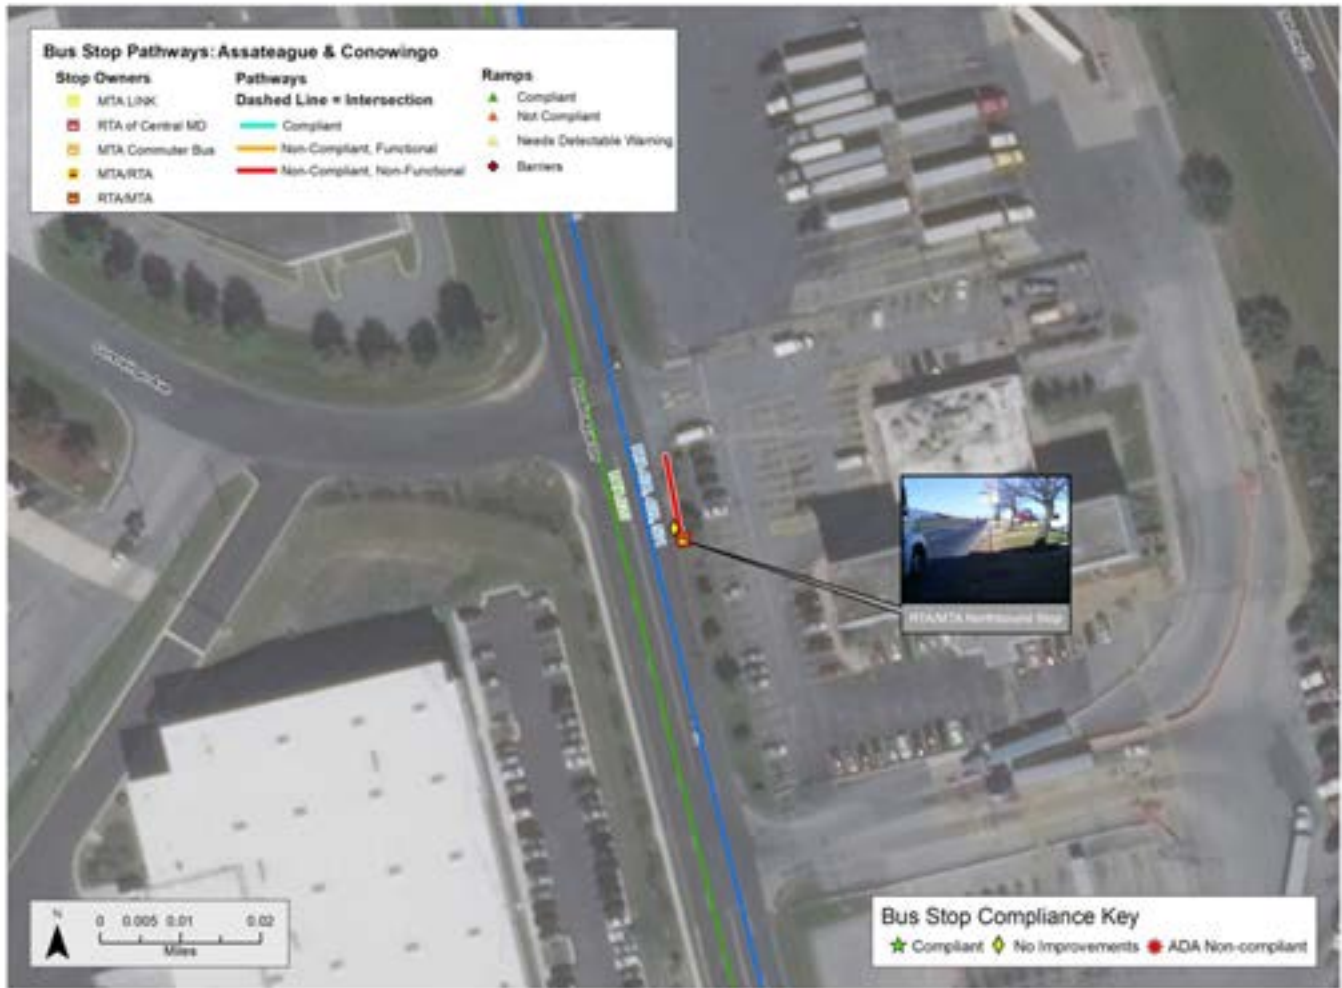
Landing Pads Needed:	1	Curb Ramps to Install:	1
Sidewalk (ft) to be installed/repaired:	55	Detectable Warnings Needed:	1
Signs with Non-Compliant Height:	0	Consolidate Signage?	No
New Signs Needed:	No	Pedestrian Control:	No
Compliant Amenities:	NA	Traffic Control:	No

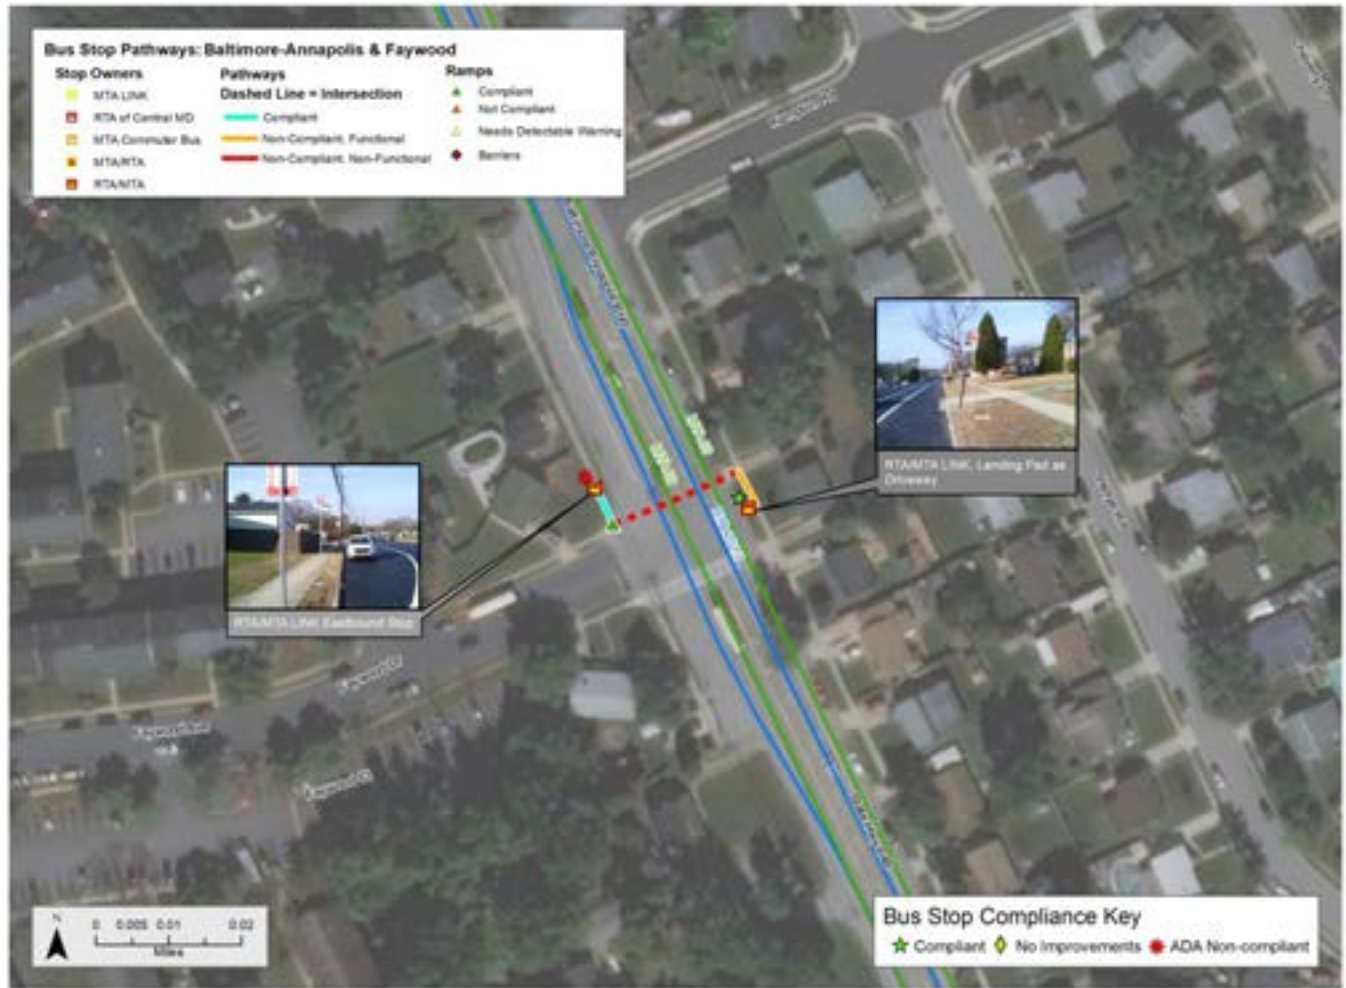
Landing Pads Needed:	1	Curb Ramps to Install:	1
Sidewalk (ft) to be installed/repaired:	35	Detectable Warnings Needed:	1
Signs with Non-Compliant Height:	0	Consolidate Signage?	Yes
New Signs Needed:	No	Pedestrian Control:	No
Compliant Amenities:	No	Traffic Control:	No

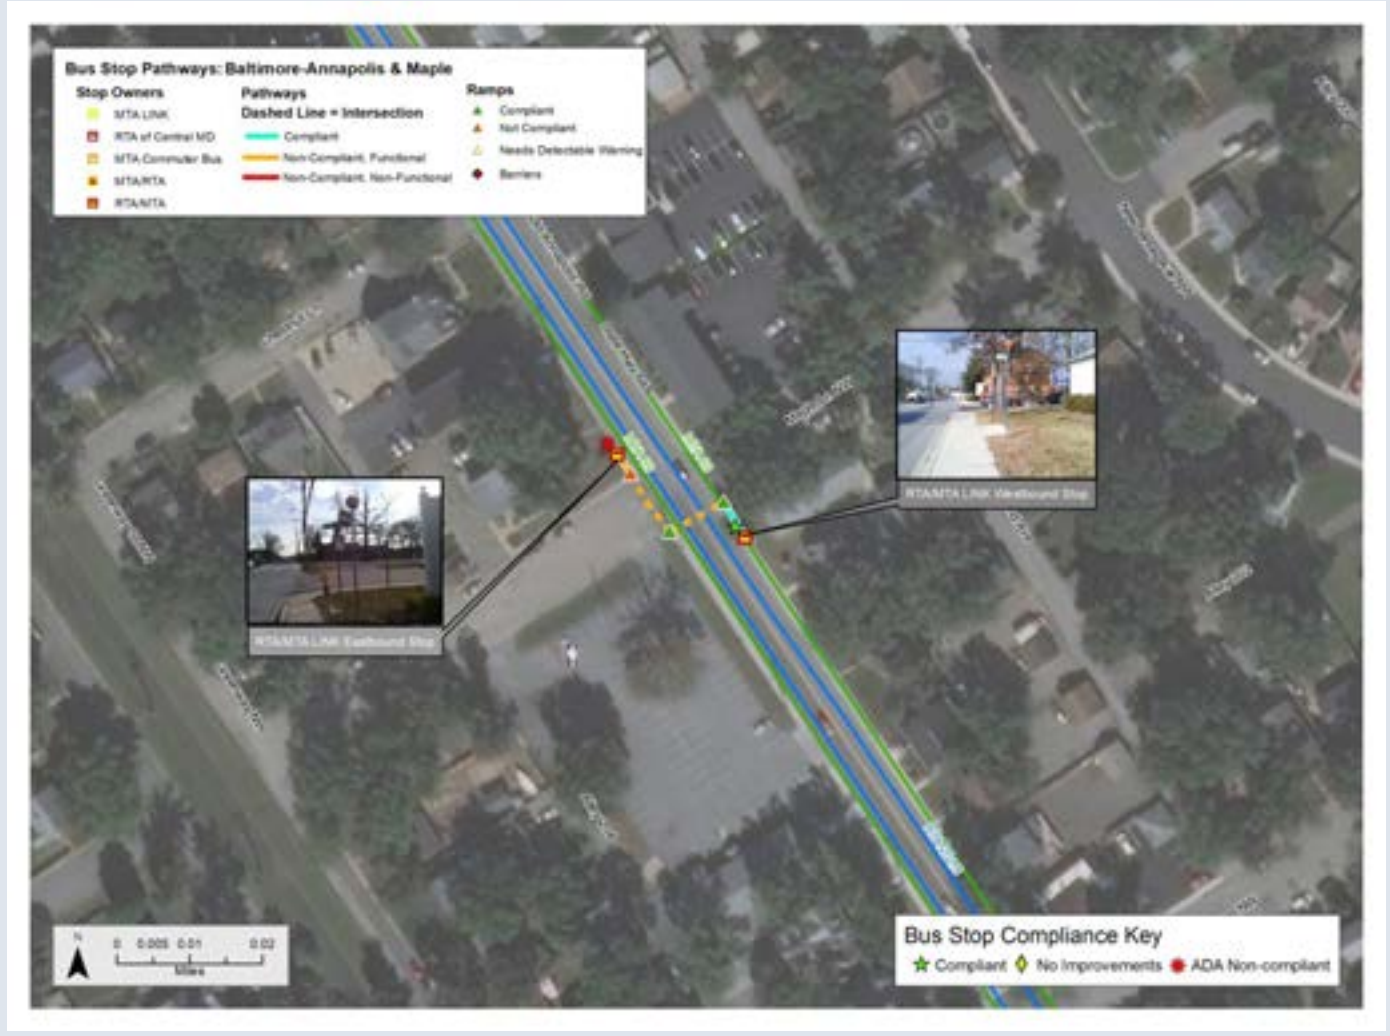
Landing Pads Needed:	1	Curb Ramps to Install:	1
Sidewalk (ft) to be installed/repaired:	19	Detectable Warnings Needed:	1
Signs with Non-Compliant Height:	1	Consolidate Signage?	Yes
New Signs Needed:	No	Pedestrian Control:	No
Compliant Amenities:	NA	Traffic Control:	No

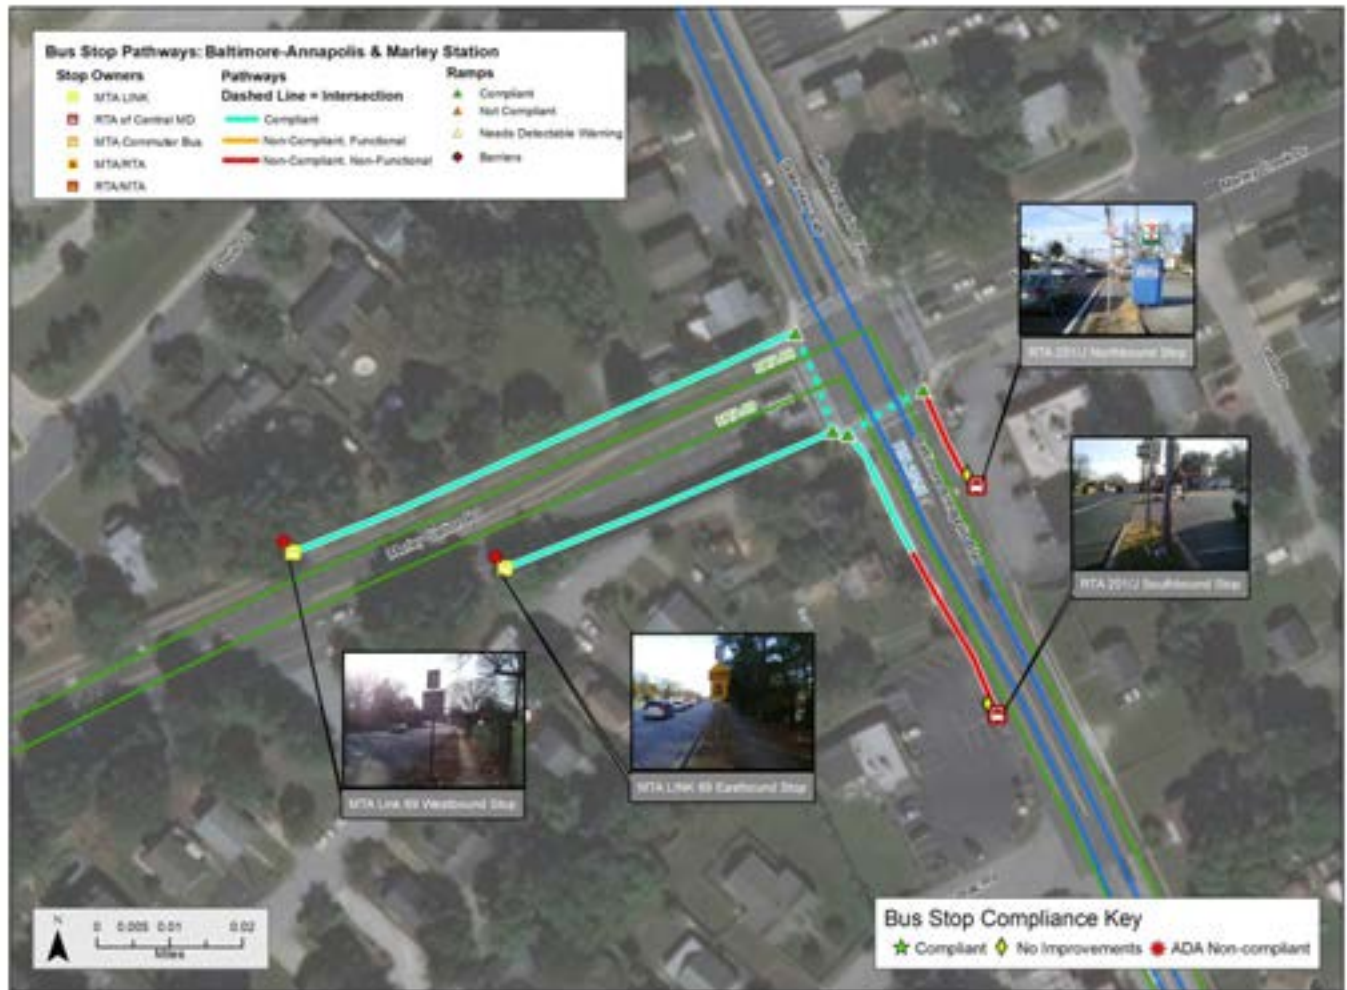
Landing Pads Needed:	4	Curb Ramps to Install:	1
Sidewalk (ft) to be installed/repaired:	215	Detectable Warnings Needed:	1
Signs with Non-Compliant Height:	0	Consolidate Signage?	Yes
New Signs Needed:	No	Pedestrian Control:	Yes
Compliant Amenities:	NA	Traffic Control:	Yes

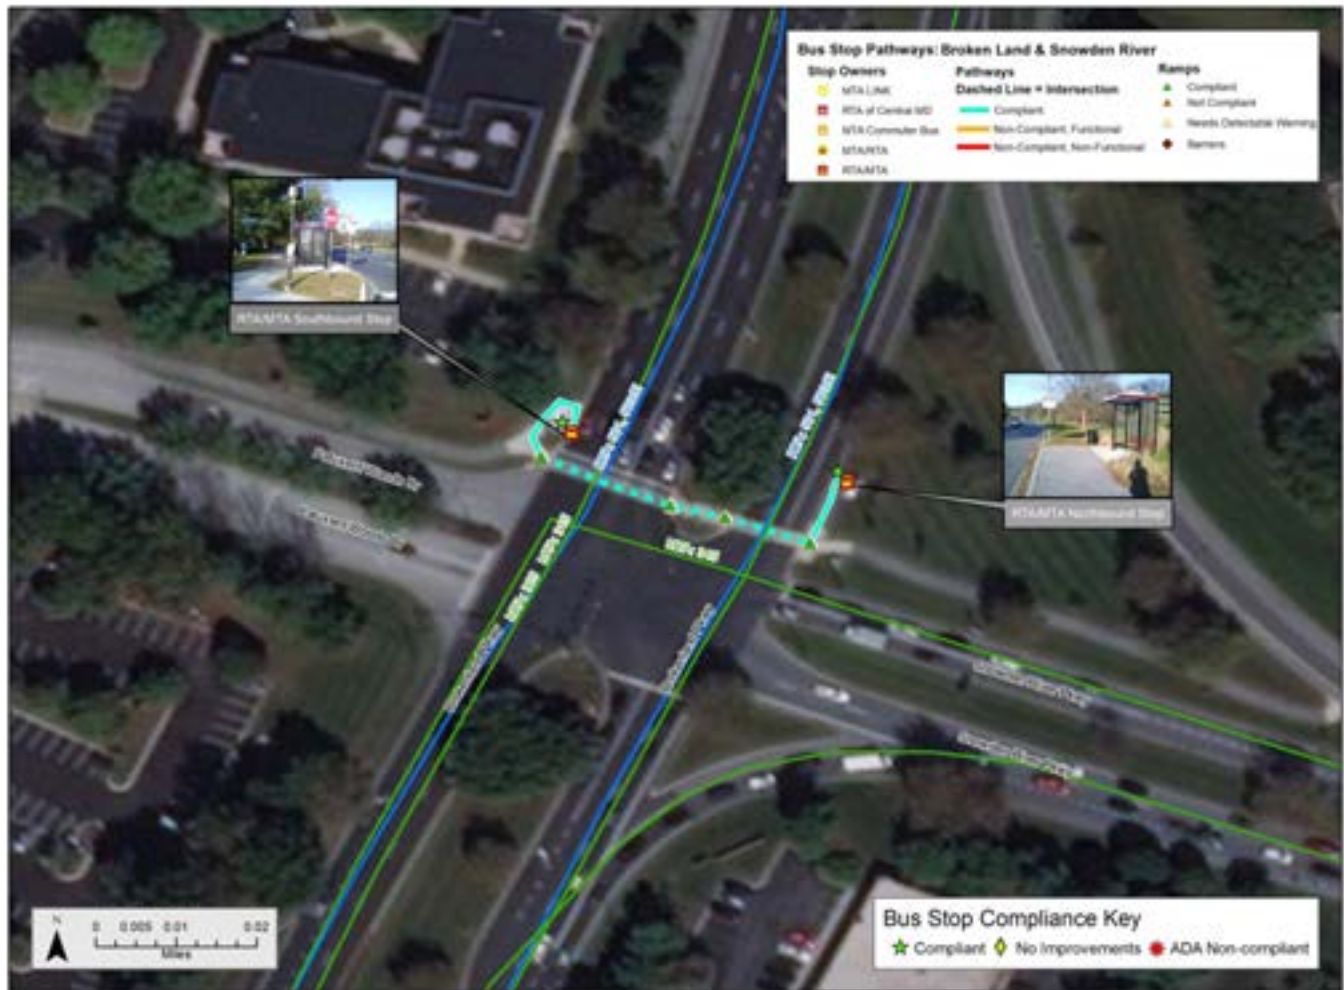
Landing Pads Needed:	0	Curb Ramps to Install:	0
Sidewalk (ft) to be installed/repaired:	0	Detectable Warnings Needed:	0
Signs with Non-Compliant Height:	0	Consolidate Signage?	NA
New Signs Needed:	No	Pedestrian Control:	Yes
Compliant Amenities:	Yes	Traffic Control:	Yes

Broken Land & Snowden River		
Howard County		
Required Improvements		
New sidewalk to be installed	0	\$0.00
New curb ramps	0	\$0.00
Detectable warning	0	\$0.00
Enhanced Improvements		
Pedestrian Control	0	\$0.00
Crosswalk	0	\$0.00
Stop 1: RTA/MTA SB Stop	Primary Owner: RTA of Central MD	
New Compliant Landing Pad	0	\$0.00
New Sign	0	\$0.00
Digital Display	1	\$1,000.00
Stop 2: RTA/MTA NB Stop	Primary Owner: RTA of Central MD	
New Compliant Landing Pad	0	\$0.00
New Sign (Need MTA Sign)	0	\$0.00
Digital Display	1	\$1,000.00
	Location Cost:	\$0.00
	Stop 1 Cost:	\$1,000.00
	Stop 2 Cost:	\$1,000.00
	Total Cost	\$2,000.00

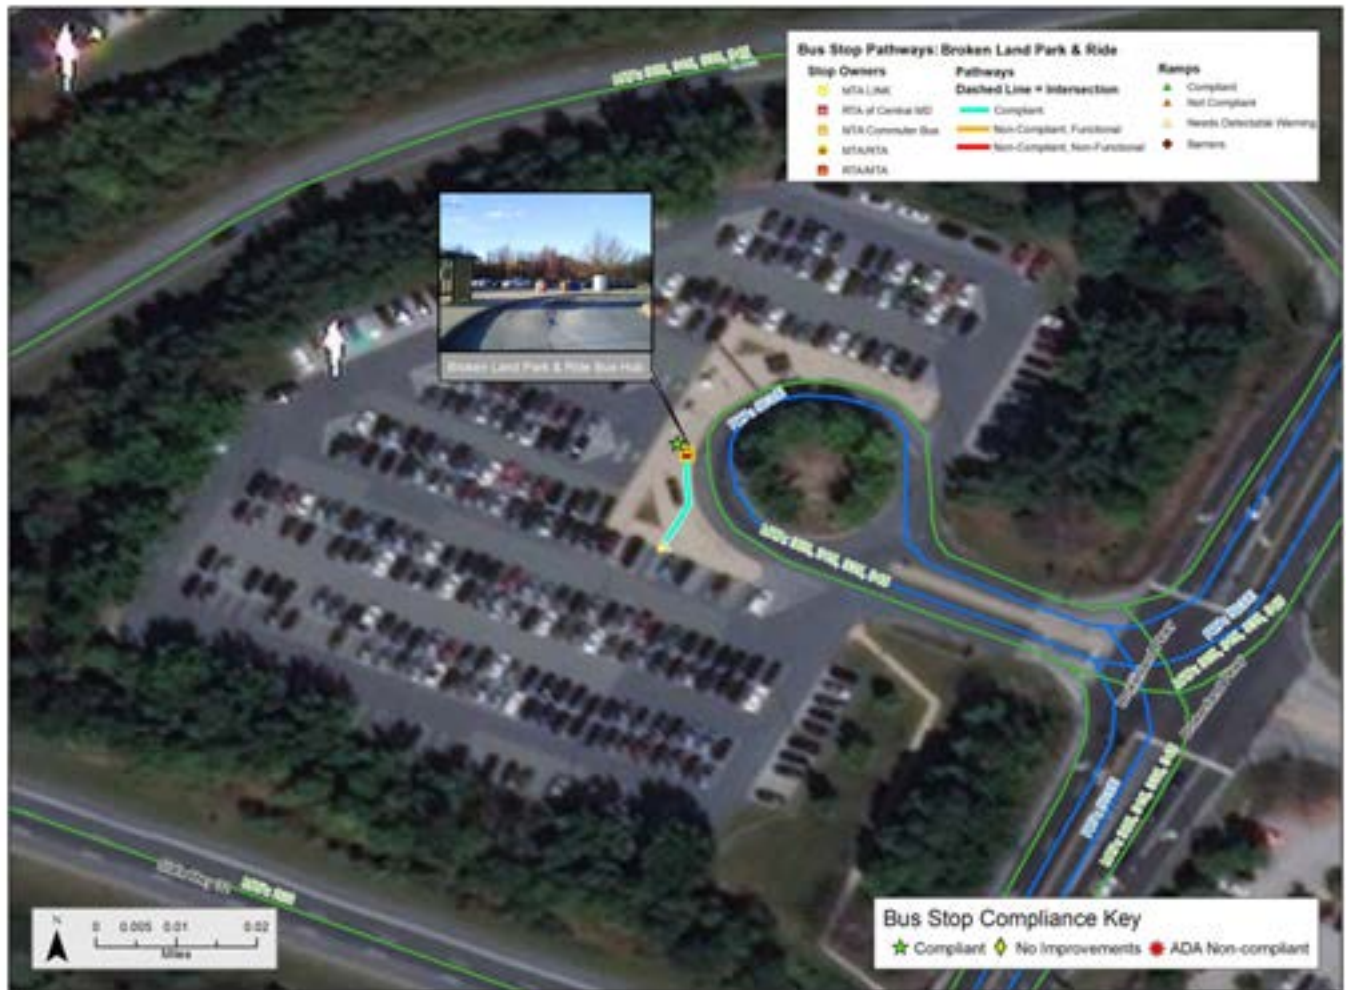
Landing Pads Needed:	0	Curb Ramps to Install:	0
Sidewalk (ft) to be installed/repaired:	0	Detectable Warnings Needed:	1
Signs with Non-Compliant Height:	0	Consolidate Signage?	NA
New Signs Needed:	No	Pedestrian Control:	NA
Compliant Amenities:	Yes	Traffic Control:	NA

Broken Land Park & Ride		
Howard County		
Required Improvements		
New sidewalk to be installed	0	\$0.00
New curb ramps	0	\$0.00
Detectable warning	1	\$75.00
Enhanced Improvements		
Pedestrian Control	0	\$0.00
Crosswalk	0	\$0.00
Stop 1: RTA/MTA P&R Stop	Primary Owner: MTA Commuter Bus	
New Compliant Landing Pad	0	\$0.00
New Sign	0	\$0.00
New Shelter	1	\$15,000.00
Digital Display	1	\$1,000.00
	Location Cost:	\$75.00
	Stop 1 Cost:	\$16,000.00
	Total Cost	\$16,075.00

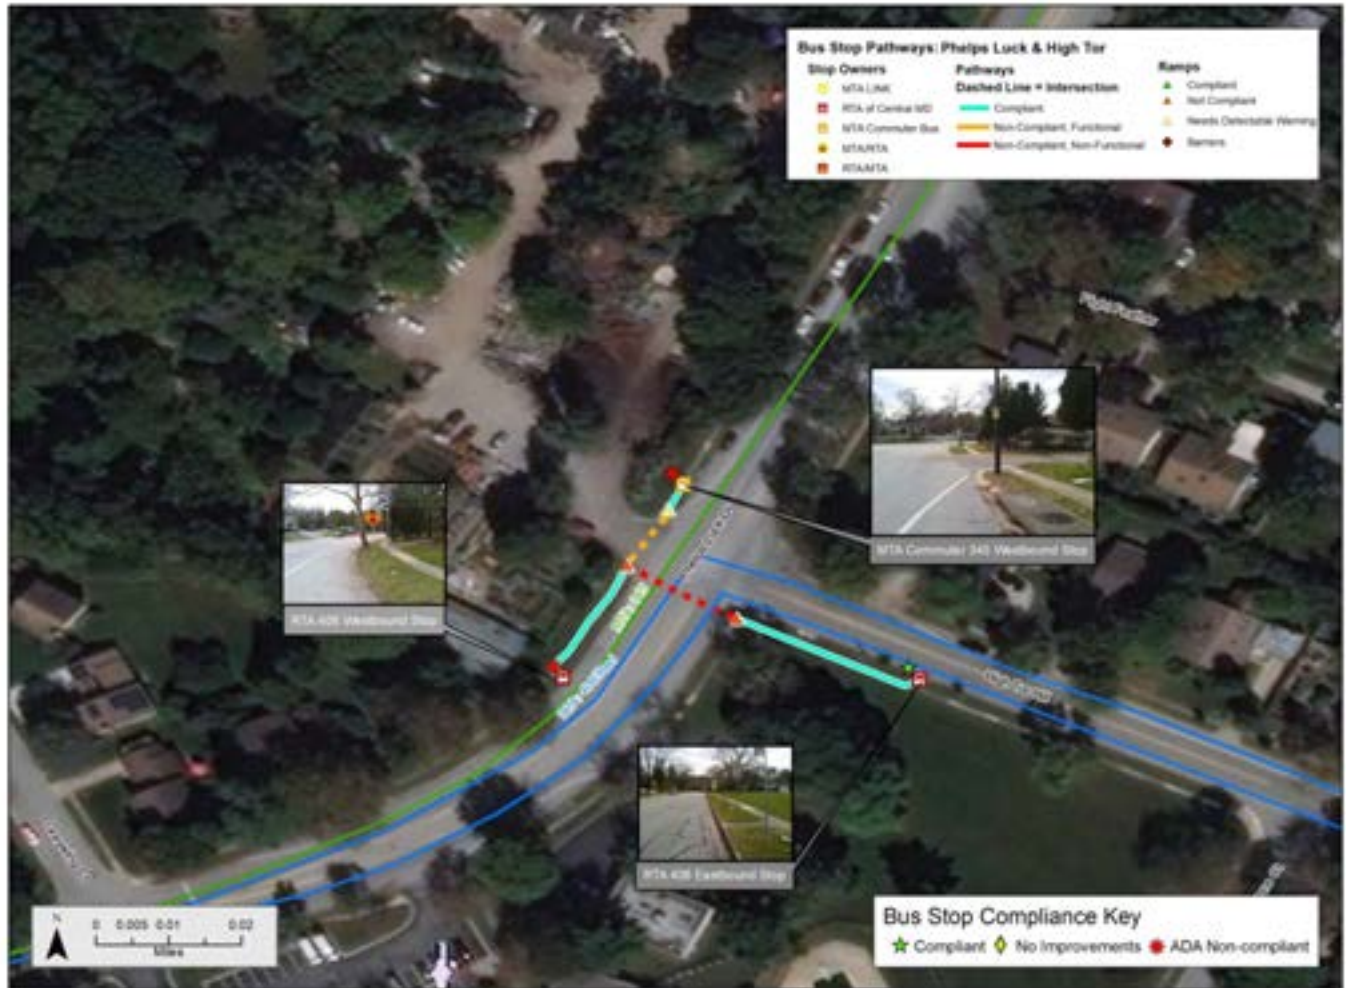
Landing Pads Needed:	2	Curb Ramps to Install:	2
Sidewalk (ft) to be installed/repaired:	0	Detectable Warnings Needed:	3
Signs with Non-Compliant Height:	0	Consolidate Signage?	Yes
New Signs Needed:	No	Pedestrian Control:	No
Compliant Amenities:	NA	Traffic Control:	No

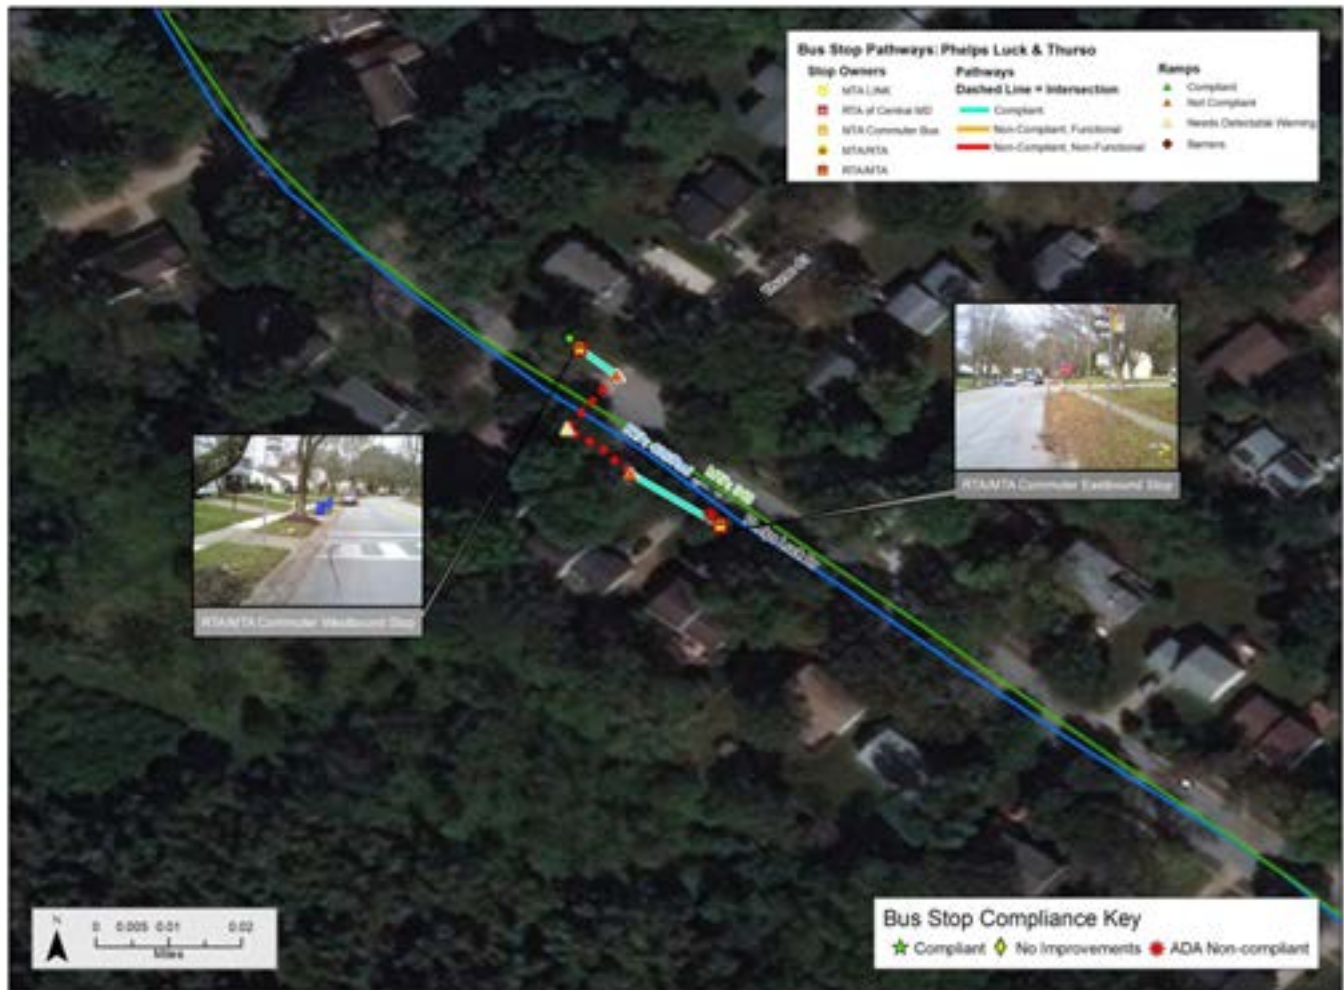
Phelps Luck & Thurso

Landing Pads Needed:	2	Curb Ramps to Install:	2
Sidewalk (ft) to be installed/repaired:	0	Detectable Warnings Needed:	3
Signs with Non-Compliant Height:	0	Consolidate Signage?	No
New Signs Needed:	No	Pedestrian Control:	No
Compliant Amenities:	Yes	Traffic Control:	No

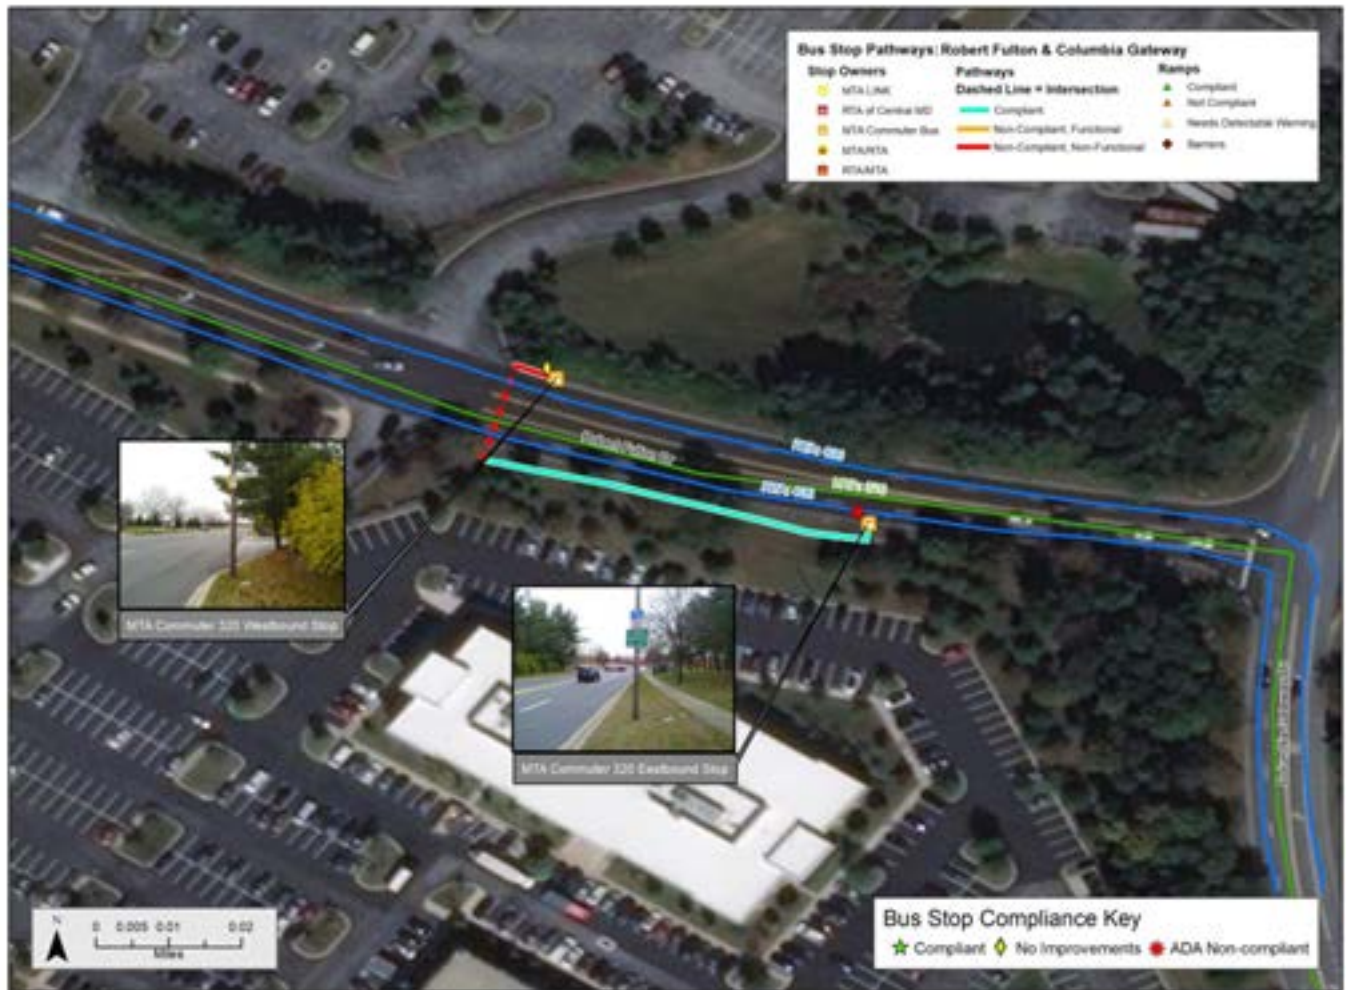
Landing Pads Needed:	2	Curb Ramps to Install:	2
Sidewalk (ft) to be installed/repaired:	27	Detectable Warnings Needed:	2
Signs with Non-Compliant Height:	0	Consolidate Signage?	No
New Signs Needed:	No	Pedestrian Control:	Yes
Compliant Amenities:	Yes	Traffic Control:	Yes

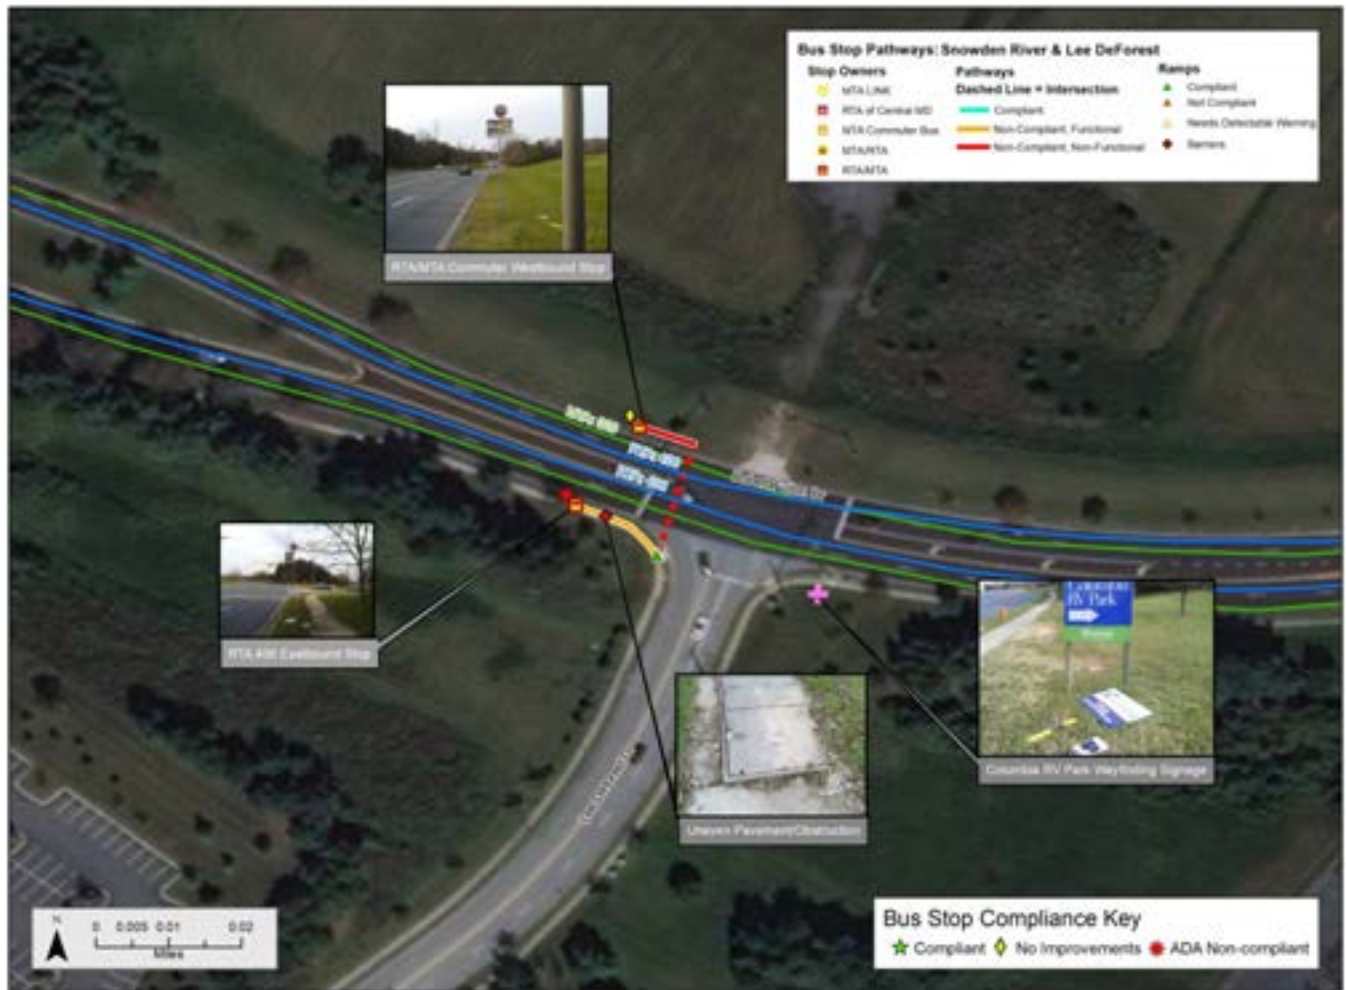
Landing Pads Needed:	2	Curb Ramps to Install:	1
Sidewalk (ft) to be installed/repaired:	91	Detectable Warnings Needed:	1
Signs with Non-Compliant Height:	0	Consolidate Signage?	No
New Signs Needed:	No	Pedestrian Control:	No
Compliant Amenities:	NA	Traffic Control:	No

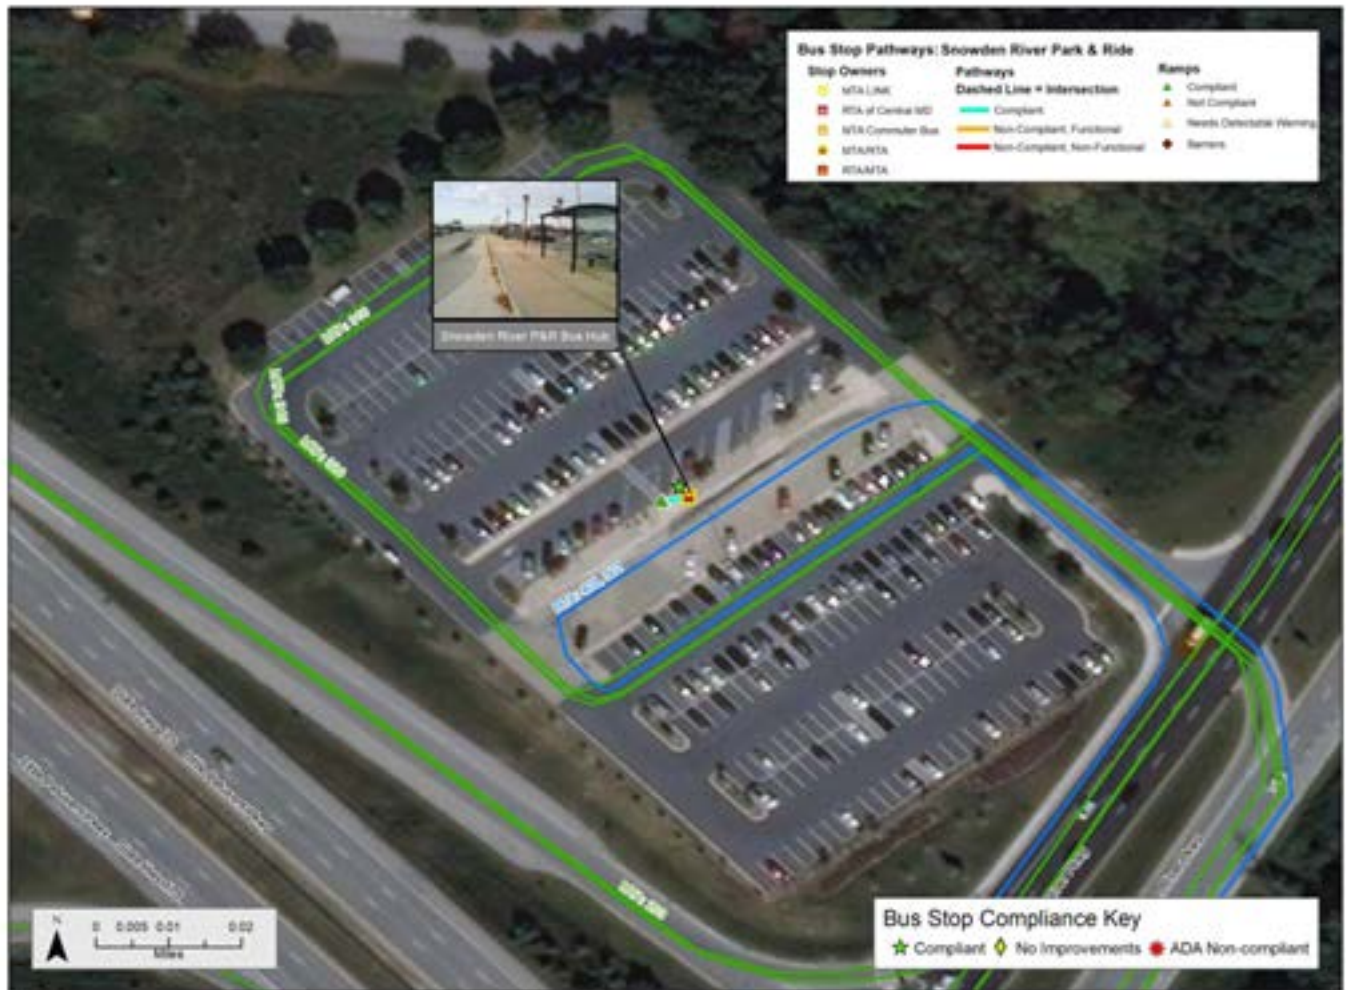
Landing Pads Needed:	0	Curb Ramps to Install:	0
Sidewalk (ft) to be installed/repaired:	0	Detectable Warnings Needed:	0
Signs with Non-Compliant Height:	0	Consolidate Signage?	No
New Signs Needed:	No	Pedestrian Control:	NA
Compliant Amenities:	NA	Traffic Control:	NA

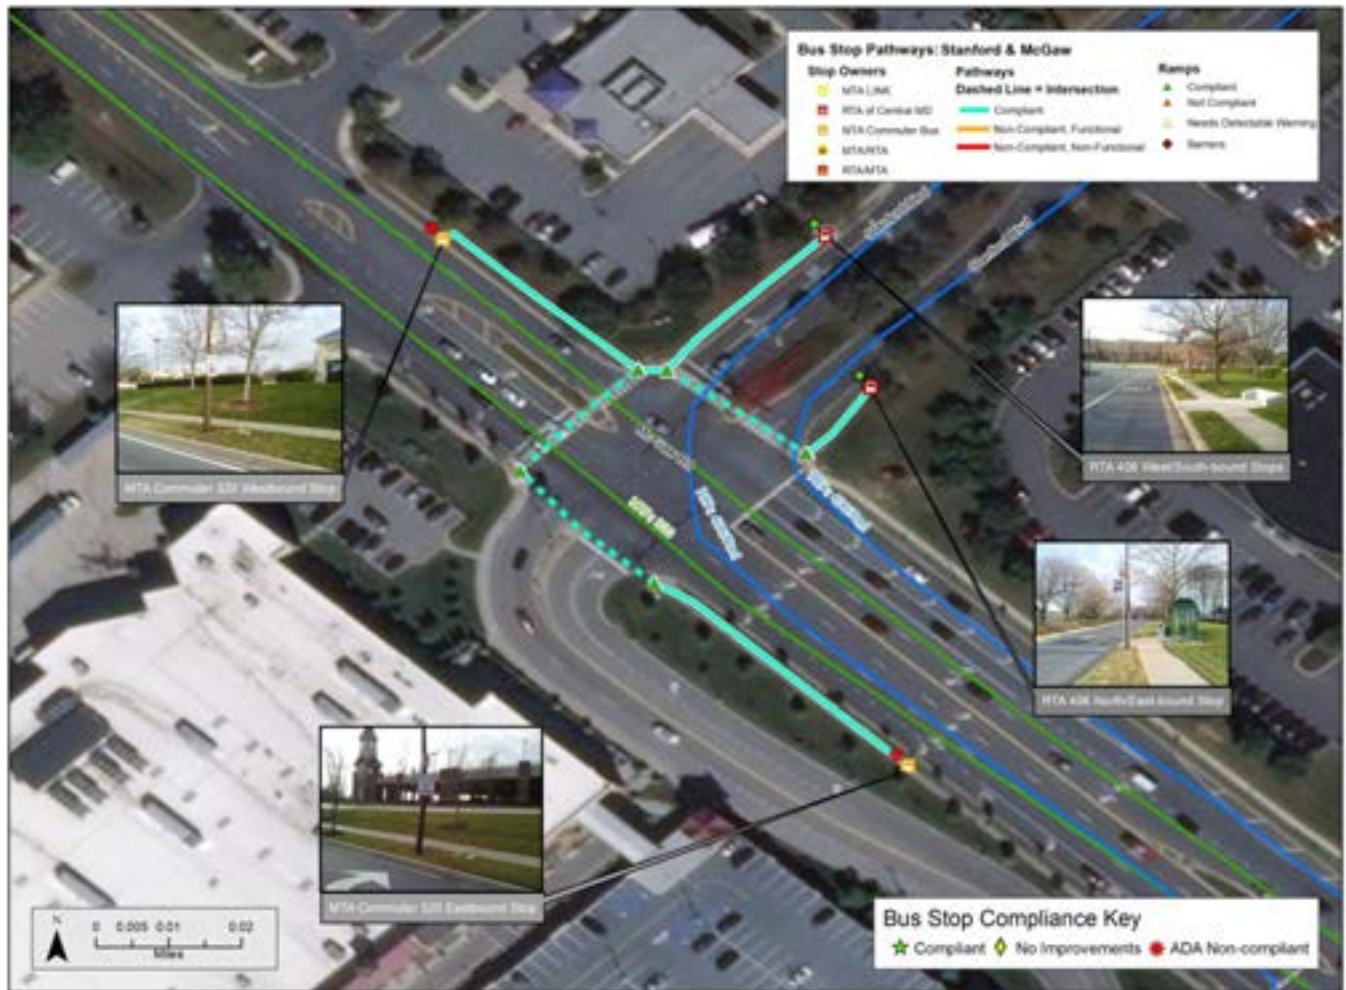
Landing Pads Needed:	2	Curb Ramps to Install:	0
Sidewalk (ft) to be installed/repaired:	0	Detectable Warnings Needed:	0
Signs with Non-Compliant Height:	0	Consolidate Signage?	Yes
New Signs Needed:	No	Pedestrian Control:	Yes
Compliant Amenities:	Yes	Traffic Control:	Yes

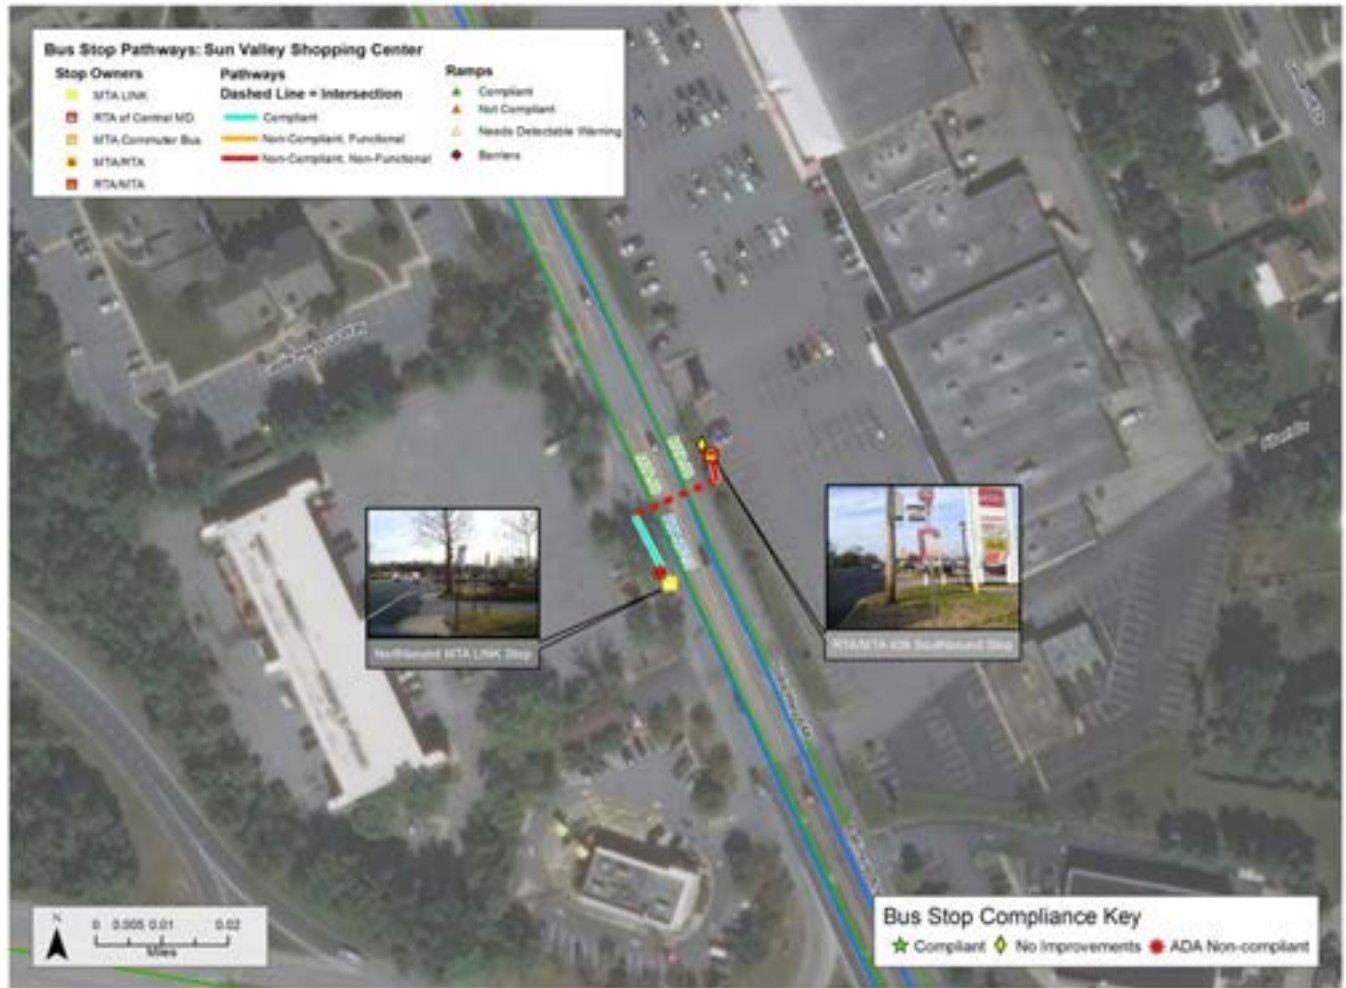
Landing Pads Needed:	1	Curb Ramps to Install:	2
Sidewalk (ft) to be installed/repaired:	79	Detectable Warnings Needed:	2
Signs with Non-Compliant Height:	2	Consolidate Signage?	Yes
New Signs Needed:	No	Pedestrian Control:	No
Compliant Amenities:	NA	Traffic Control:	No

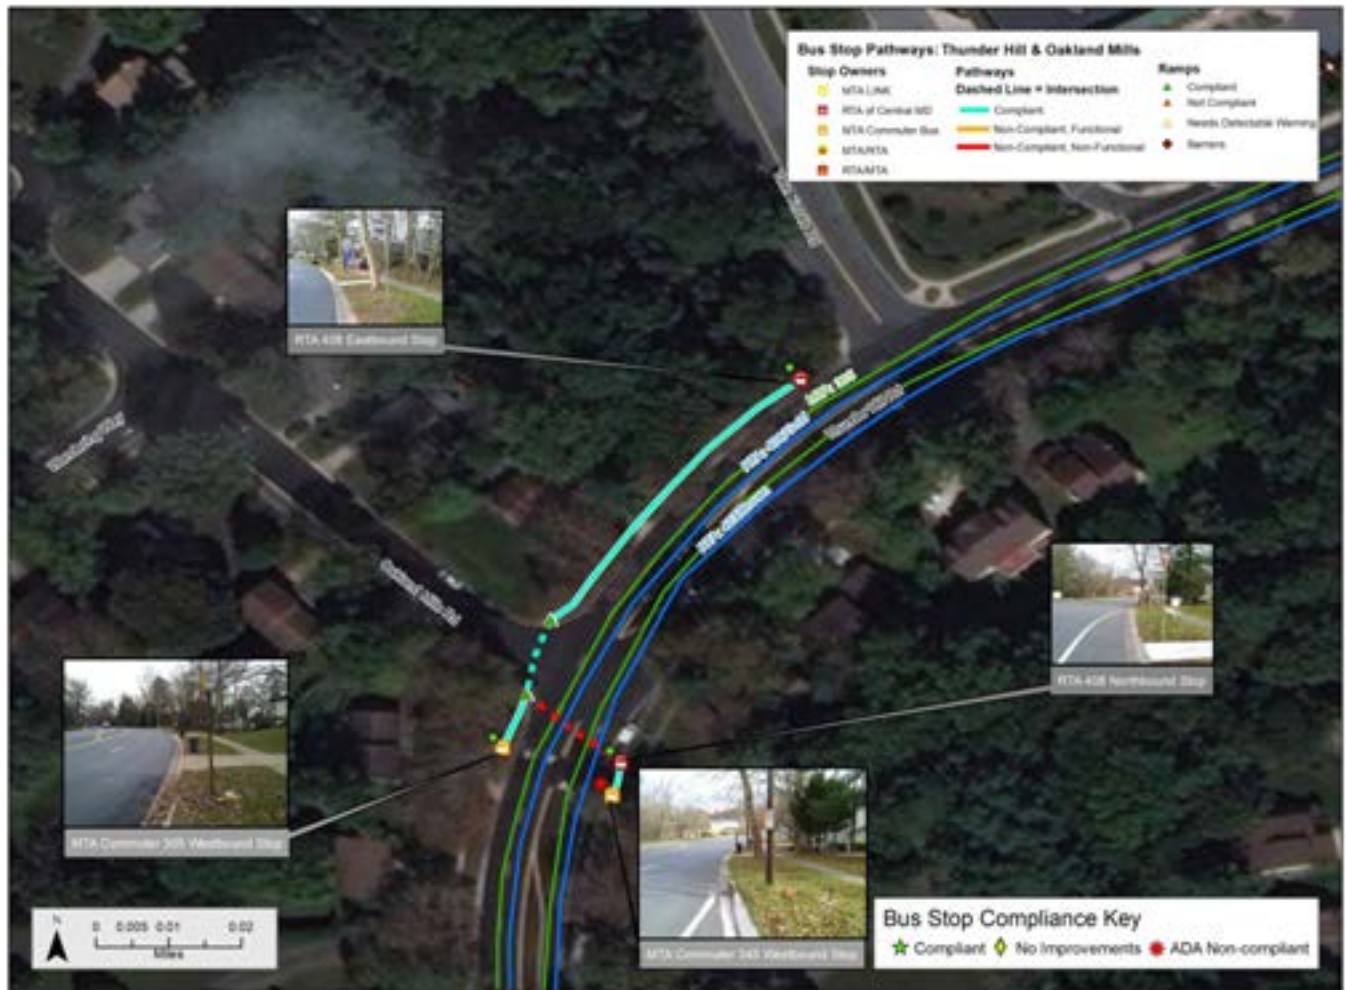
Landing Pads Needed:	1	Curb Ramps to Install:	1
Sidewalk (ft) to be installed/repaired:	0	Detectable Warnings Needed:	1
Signs with Non-Compliant Height:	1	Consolidate Signage?	Yes
New Signs Needed:	No	Pedestrian Control:	No
Compliant Amenities:	NA	Traffic Control:	No

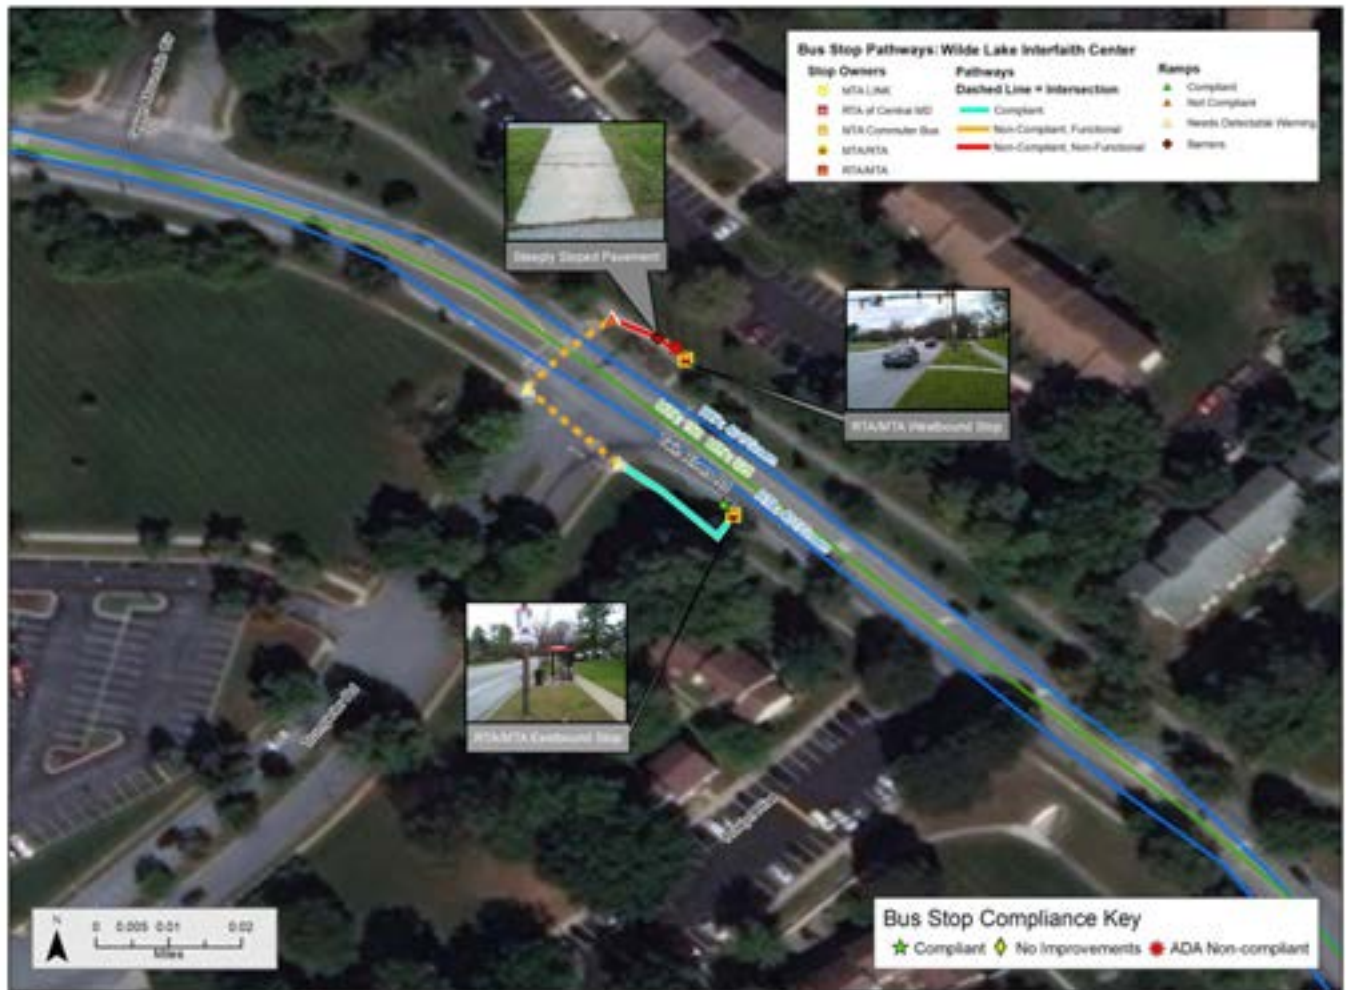
Landing Pads Needed:	1	Curb Ramps to Install:	1
Sidewalk (ft) to be installed/repaired:	50	Detectable Warnings Needed:	3
Signs with Non-Compliant Height:	0	Consolidate Signage?	No
New Signs Needed:	No	Pedestrian Control:	Yes
Compliant Amenities:	Yes	Traffic Control:	Yes
