# Baltimore Metropolitan Council Regional MTA/LOTS Transfer Points Study Final - August 2019

This report serves as the final, comprehensive document for the Regional MDOT MTA/LOTS (Locally Operated Transit Systems) Transfer Study, commissioned by BMC and completed by KFH Group, Inc. This report has re-organized and refined the prior project technical memorandums into the following three chapters. Included within this report are appendices that contain improvement profiles, line-item cost estimates, and LOTS/MDOT MTA transfer tables for each transfer location.

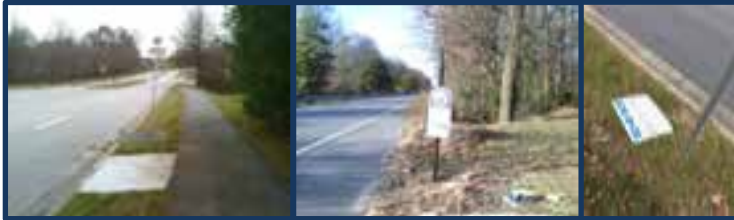
**Figure 2-5: Damaged signage.** From left, Columbia Gateway & John McAdams, 1257 Ritchie, and Robert

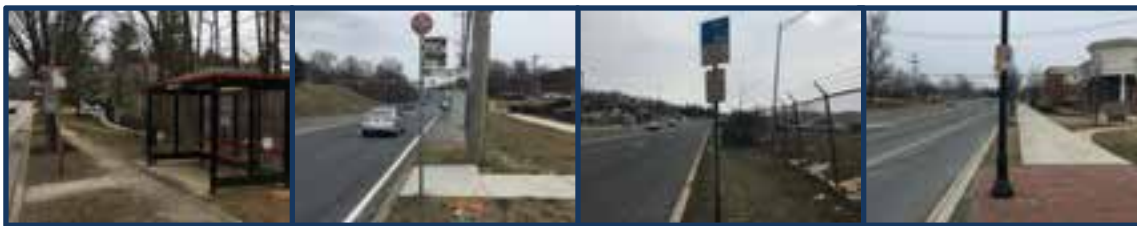
**Figure 2-6: Distinct MDOT MTA Sign Designs.** From left, Harpers Farm & Twin Rivers, Route 1 & Montevideo, MD Wholesale Food Center, and Riva & Forest

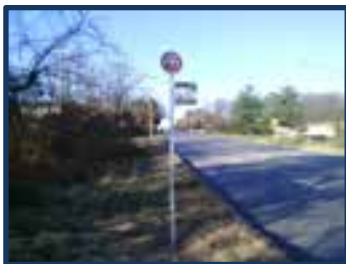
**Figure 2-7: No improvements stop at Dorsey & Candlewood.**

None of the four stops at this location are connected to a paved pathway, making transfers extremely difficult for individuals with disabilities.

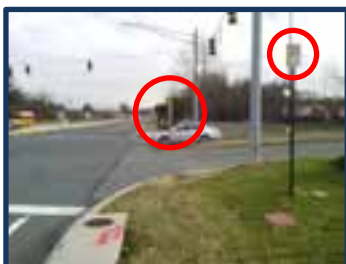
**Figure 2-8: Aberdeen Wal-Mart Stop.**

Nearside MDOT MTA stop does not have a paved connection to the farside Harford Transit stop, which is an ADA compliant shelter stop. There is not a safe crossing between these stops.

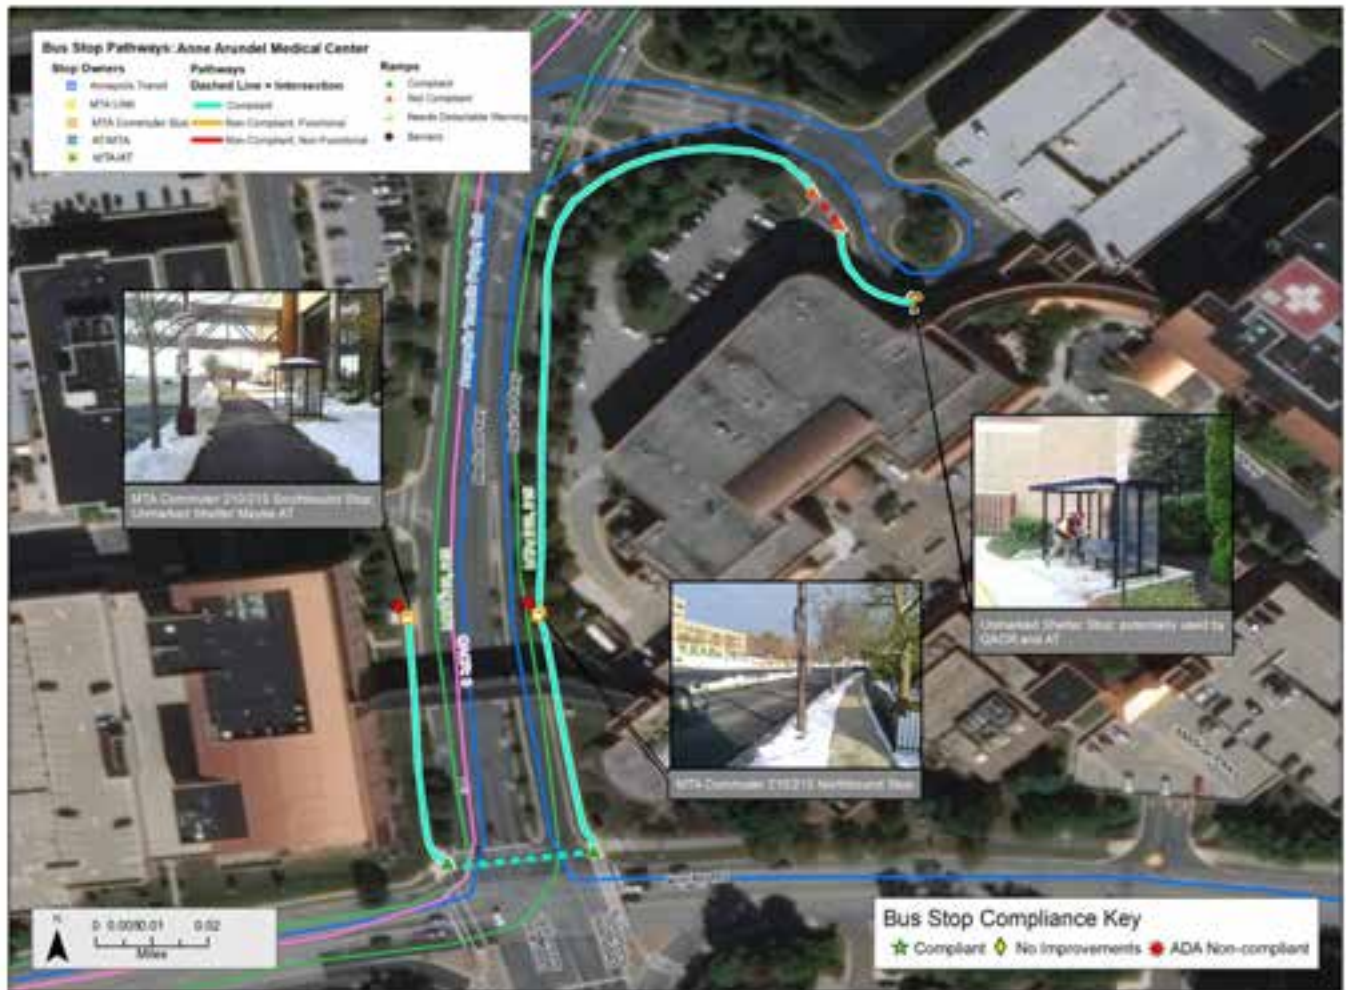
## AA Medical Center

LOTS: Anne Arundel Transit, Annapolis Transit, & Queen Anne's County Ride  
 MTA Bus Service: Commuter & LINK  
 Location Type: Medical Center  
 Number of Distinct Stops: 2

Landing Pads Needed:	2	Curb Ramps to Install:	2
Sidewalk (ft) to be installed/repaired:	0	Detectable Warnings Needed:	2
Signs with Non-Compliant Height:	0	Consolidate Signage?	
New Signs Needed:	Yes	Pedestrian Control:	Yes
Compliant Amenities:	Yes	Traffic Control:	Yes

Shelters: 1    Info Case: No  
 Shelter Foundation: Concrete    Info Case Accessible: NA  
 Shelter Damage: None    Info Case Damage: None  
 Shelter Accessible? Yes    Digital Display? No  
 Entrance Accessible? Yes    Route Schedule? No  
 Interior Accessible? Yes    System Map? No  
 Benches? 1    Route Map? No  
 Bench Location: Shelter    Trash Can? Yes  
 Bench Damage: None    Publication Boxes? 0  
 Bike Racks? No

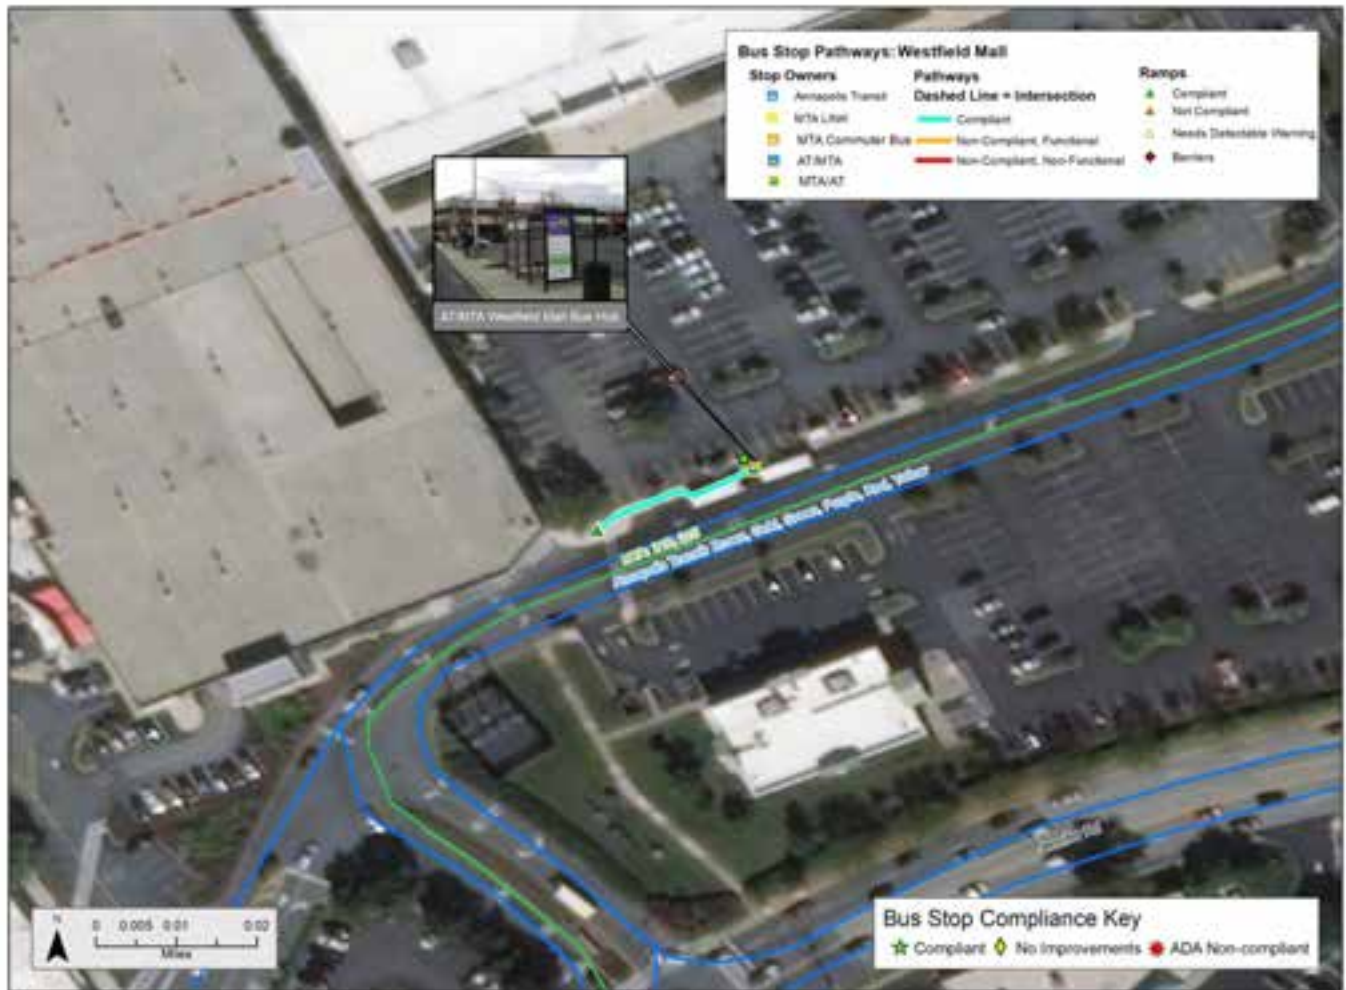
## Westfield Mall

LOTS: Anne Arundel Transit, Annapolis Transit & Queen Anne's County Ride  
 MTA Bus Service: Commuter & LINK  
 Location Type: Transit Center-Shopping Center  
 Number of Distinct Stops: 2

Landing Pads Needed:	0	Curb Ramps to Install:	0
Sidewalk (ft) to be installed/repaired:	0	Detectable Warnings Needed:	0
Signs with Non-Compliant Height:	0	Consolidate Signage?	No
New Signs Needed:	No	Pedestrian Control:	NA
Compliant Amenities:	Yes	Traffic Control:	NA

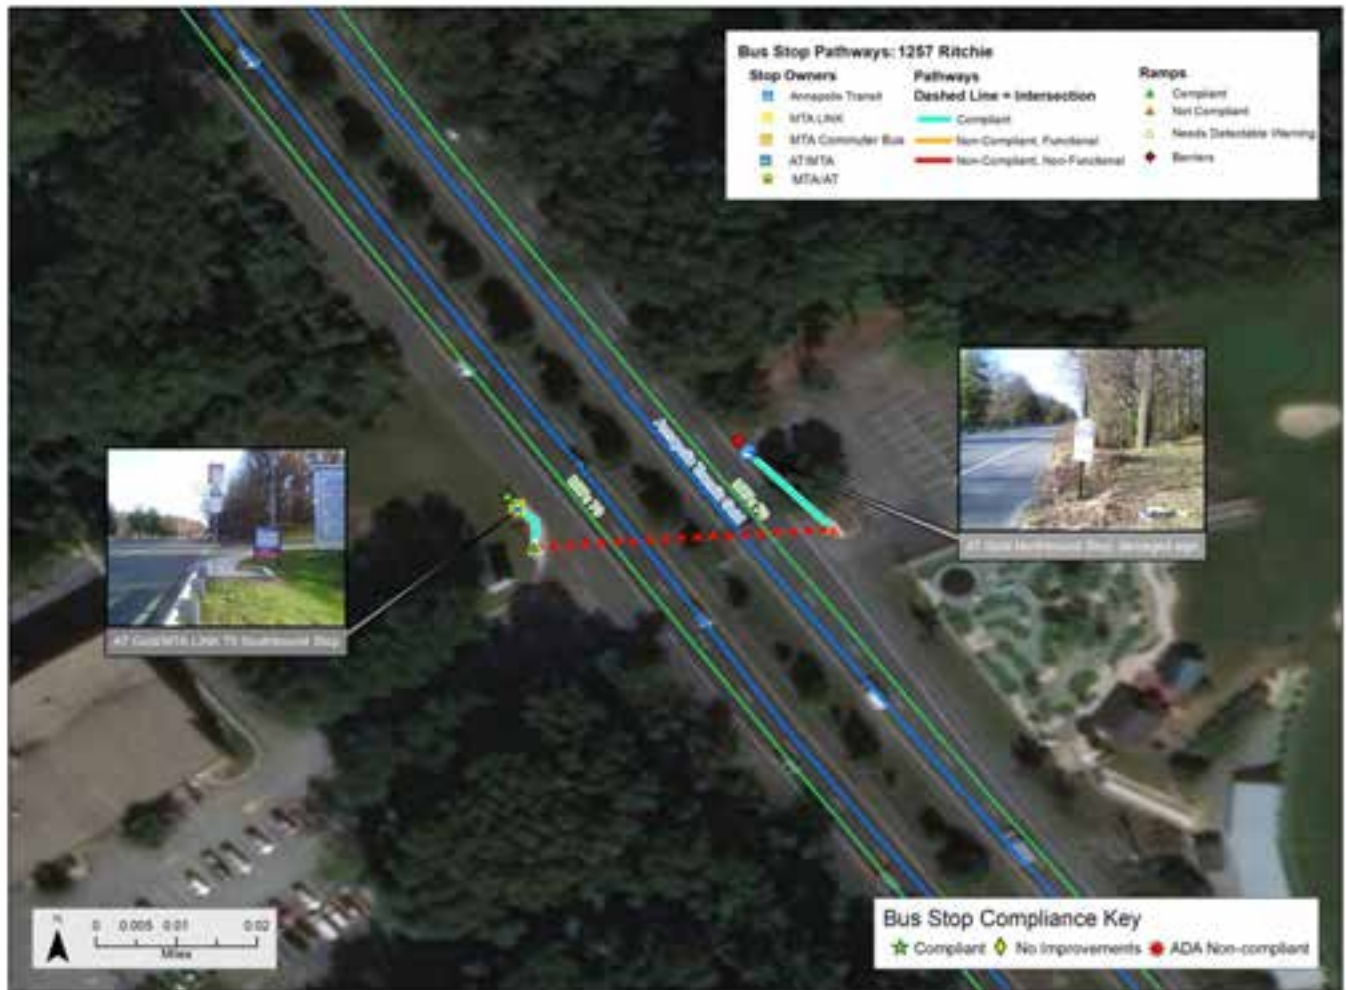
## 1257 Ritchie

LOTS: Anne Arundel Transit  
 MTA Bus Service: LINK  
 Location Type: Commercial-Office  
 Number of Distinct Stops: 2

Landing Pads Needed:	1	Curb Ramps to Install:	1
Sidewalk (ft) to be installed/repaired:	0	Detectable Warnings Needed:	1
Signs with Non-Compliant Height:	1	Consolidate Signage?	
New Signs Needed:	Yes	Pedestrian Control:	No
Compliant Amenities:	NA	Traffic Control:	No

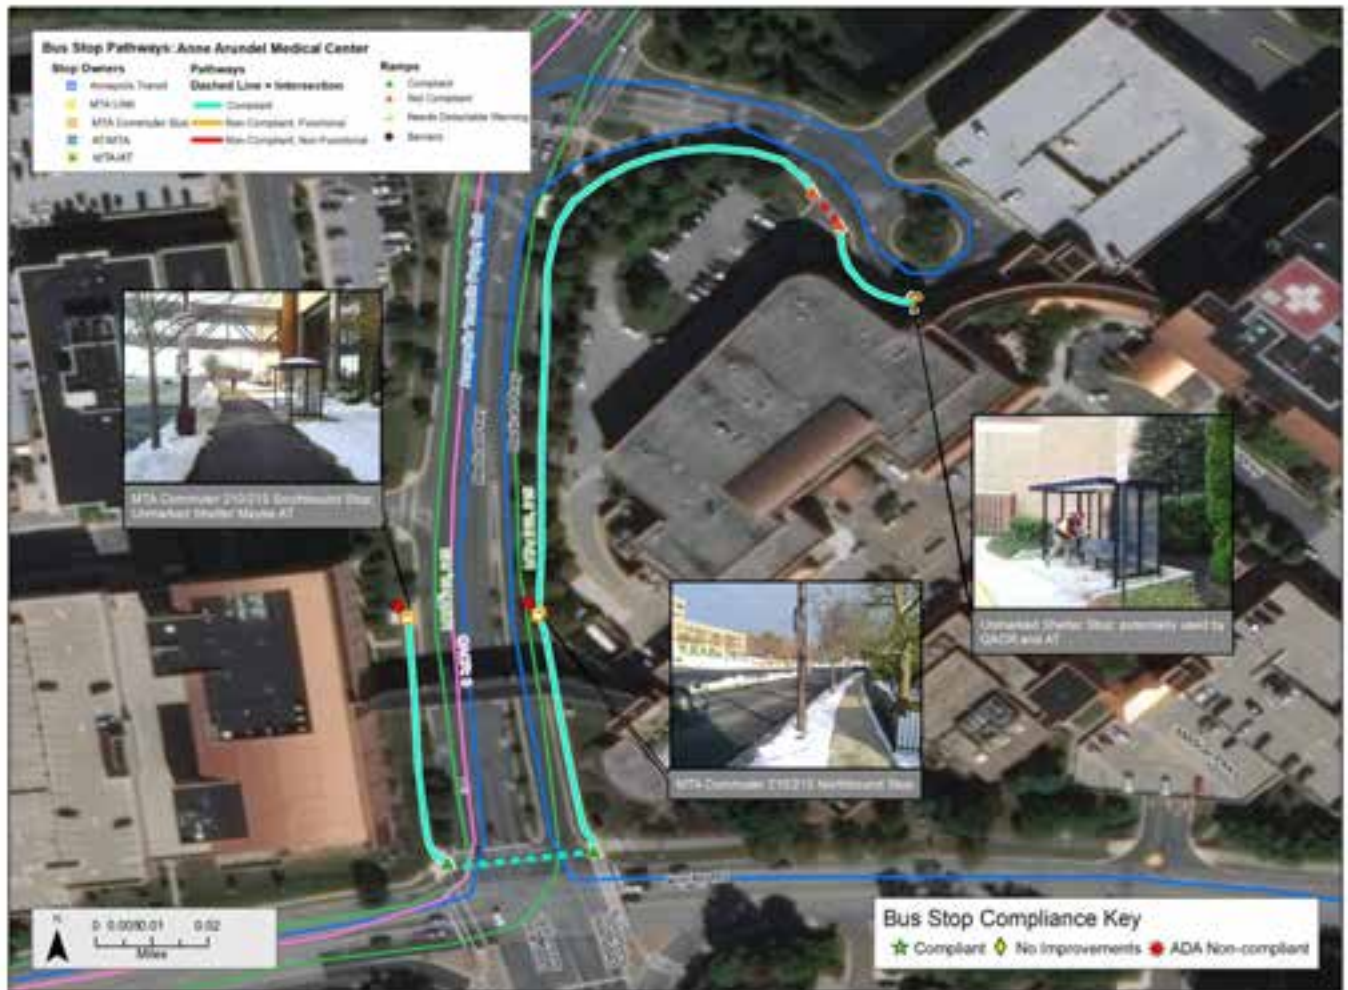
Location Type: Medical Center

Landing Pads Needed:	2	Curb Ramps to Install:	2
Sidewalk (ft) to be installed/repaired:	0	Detectable Warnings Needed:	2
Signs with Non-Compliant Height:	0	Consolidate Signage?	
New Signs Needed:	Yes	Pedestrian Control:	Yes
Compliant Amenities:	Yes	Traffic Control:	Yes

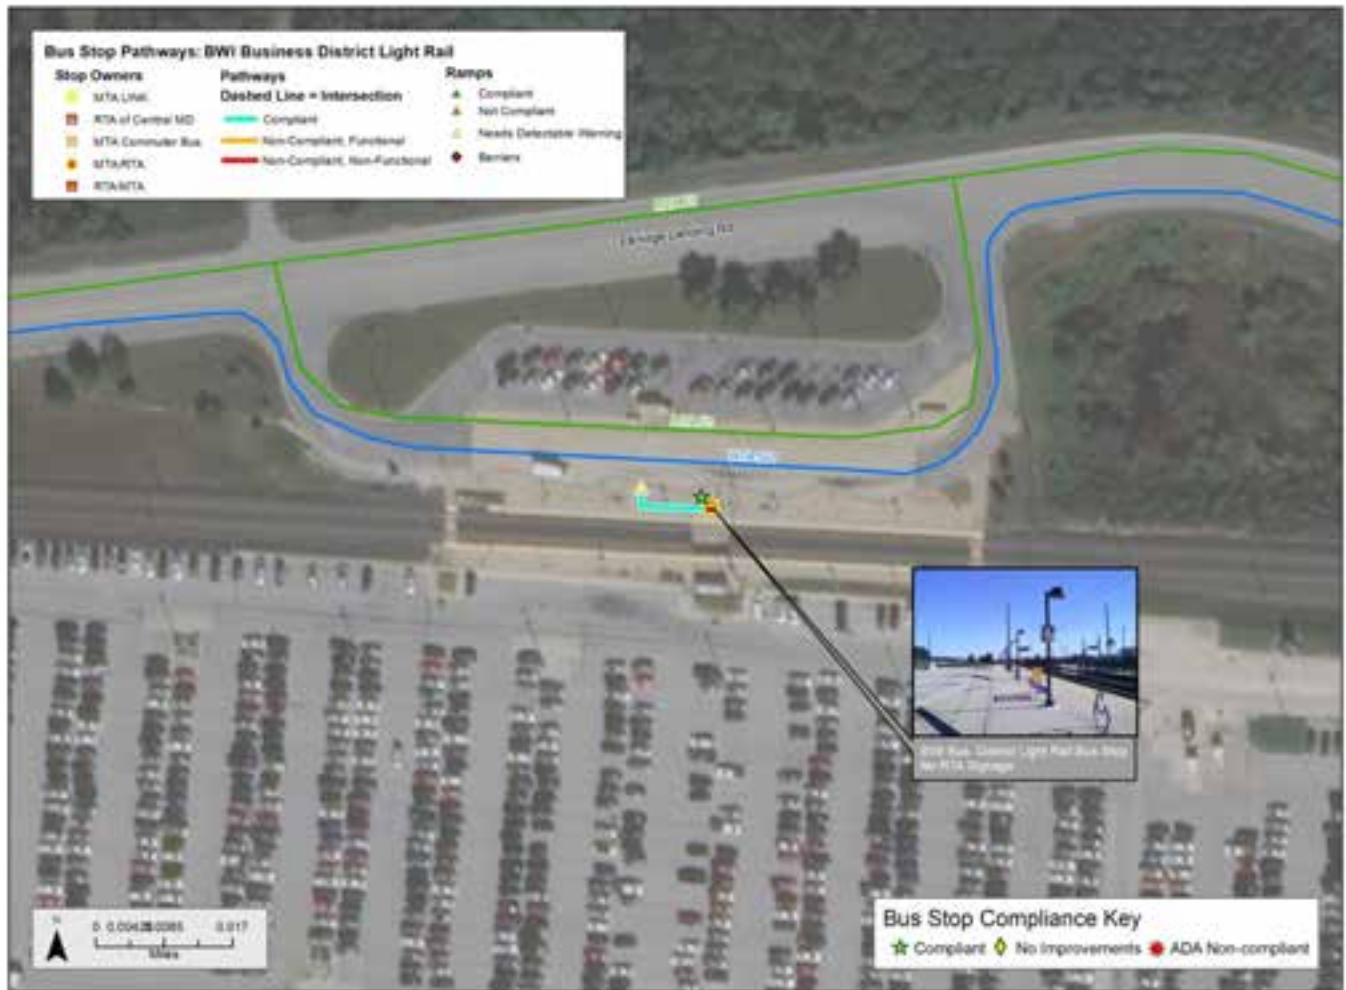
## BWI Business District Light Rail

LOTS: Anne Arundel Transit  
 MTA Bus Service: LINK  
 Location Type: Transit Center-Light Rail  
 Number of Distinct Stops: 1

Landing Pads Needed:	0	Curb Ramps to Install:	0
Sidewalk (ft) to be installed/repaired:	0	Detectable Warnings Needed:	1
Signs with Non-Compliant Height:	0	Consolidate Signage?	No
New Signs Needed:	Yes	Pedestrian Control:	No
Compliant Amenities:	NA	Traffic Control:	No

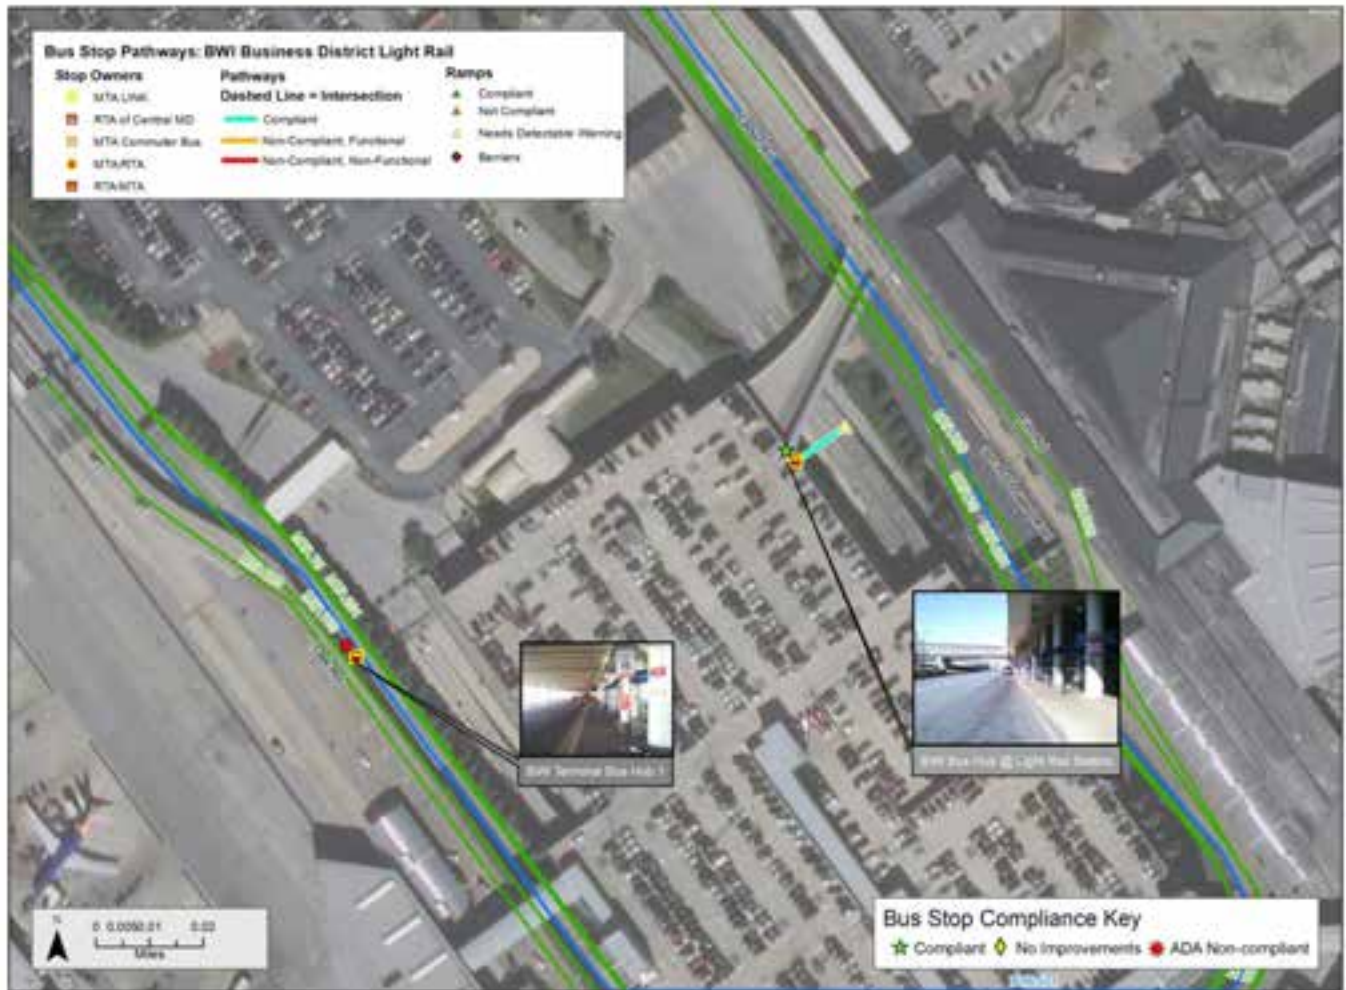
## BWI Terminal

LOTS: Anne Arundel Transit  
 MTA Bus Service: LINK  
 Location Type: Transit Center-Airport  
 Number of Distinct Stops: 2

Landing Pads Needed:	0	Curb Ramps to Install:	0
Sidewalk (ft) to be installed/repaired:	0	Detectable Warnings Needed:	1
Signs with Non-Compliant Height:	1	Consolidate Signage?	No
New Signs Needed:	Yes	Pedestrian Control:	NA
Compliant Amenities:	Yes	Traffic Control:	NA

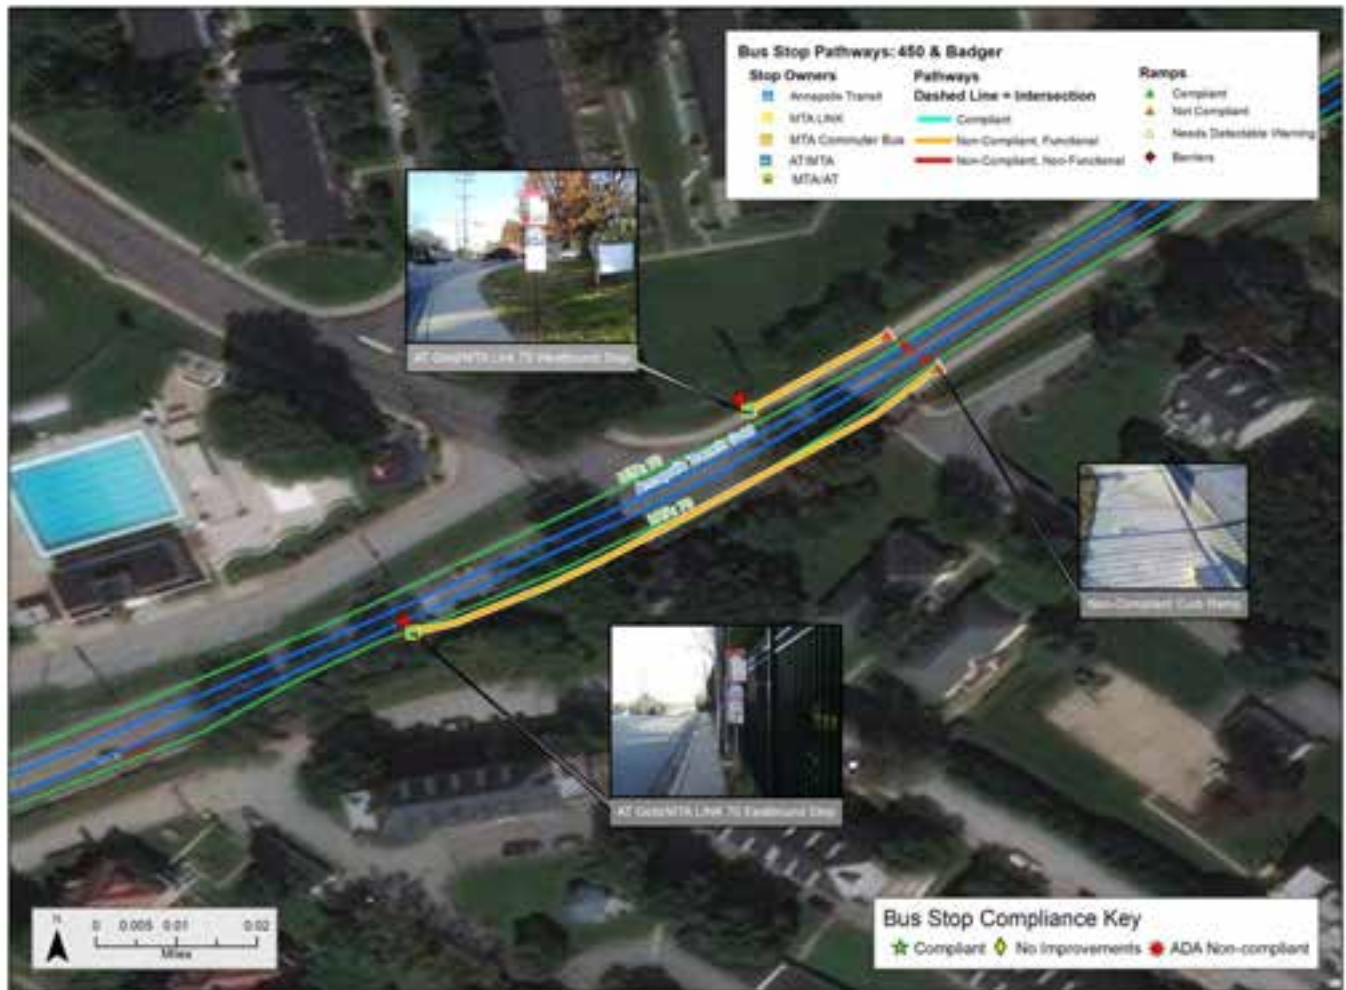
## Route 450 & Badger

LOTS: Anne Arundel Transit  
 MTA Bus Service: LINK  
 Location Type: Basic Bus Stop-Residential  
 Number of Distinct Stops: 2

Landing Pads Needed:	2	Curb Ramps to Install:	2
Sidewalk (ft) to be installed/repaired:	416	Detectable Warnings Needed:	2
Signs with Non-Compliant Height:	2	Consolidate Signage?	
New Signs Needed:	Yes	Pedestrian Control:	No
Compliant Amenities:	NA	Traffic Control:	No

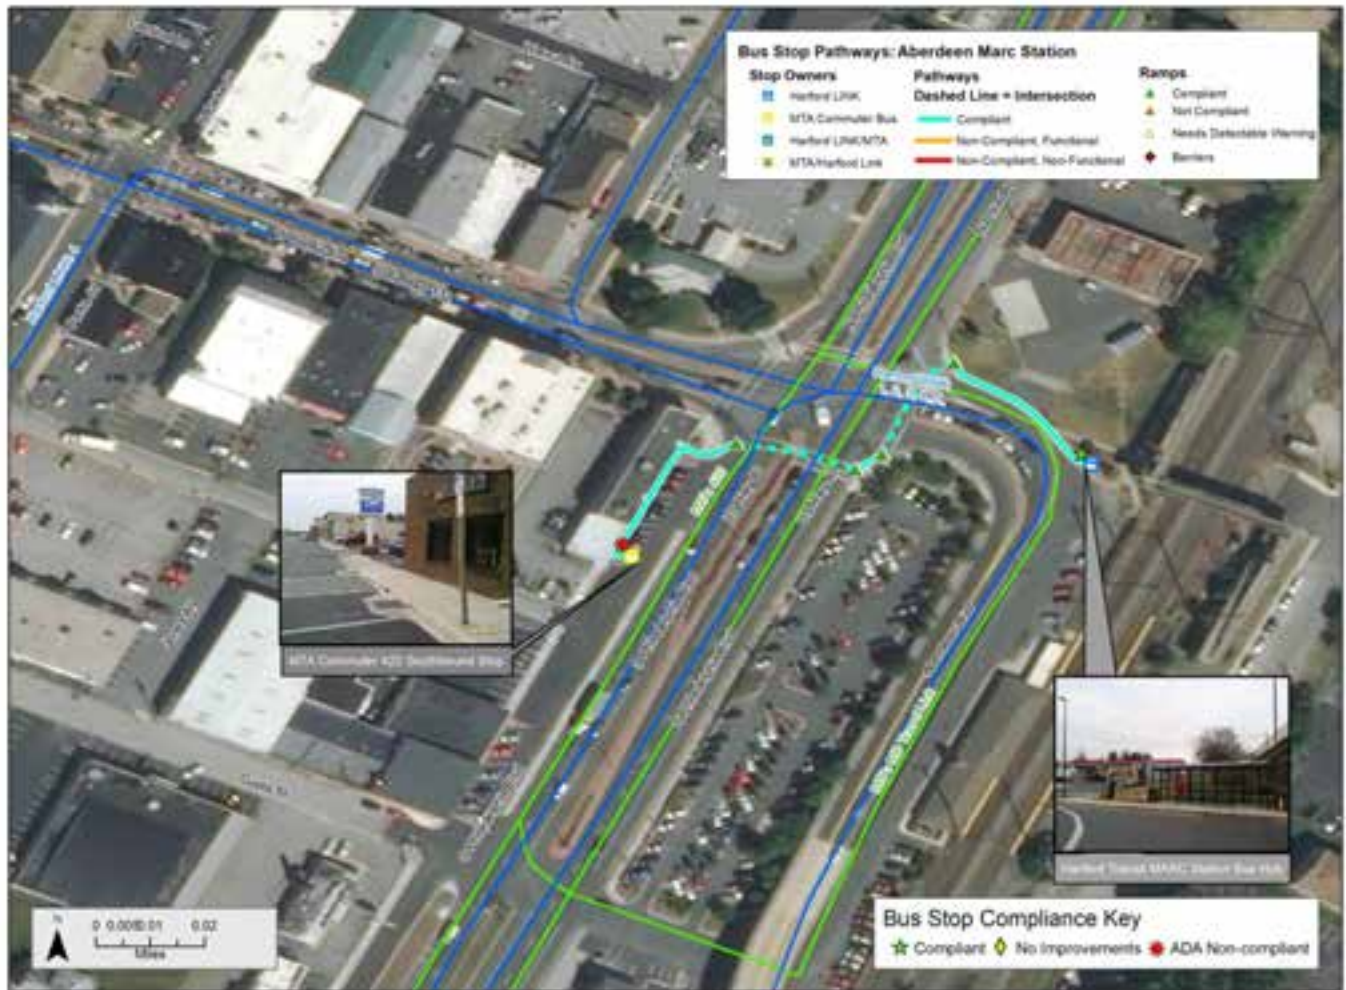
## Aberdeen MARC Station

LOTS: Harford Transit  
 MTA Bus Service: Commuter  
 Location Type: Transit Center-Shopping Center  
 Number of Distinct Stops: 2

Landing Pads Needed:	1	Curb Ramps to Install:	0
Sidewalk (ft) to be installed/repaired:	0	Detectable Warnings Needed:	0
Signs with Non-Compliant Height:	0	Consolidate Signage?	Yes
New Signs Needed:	Yes	Pedestrian Control:	Yes
Compliant Amenities:	Yes	Traffic Control:	Yes

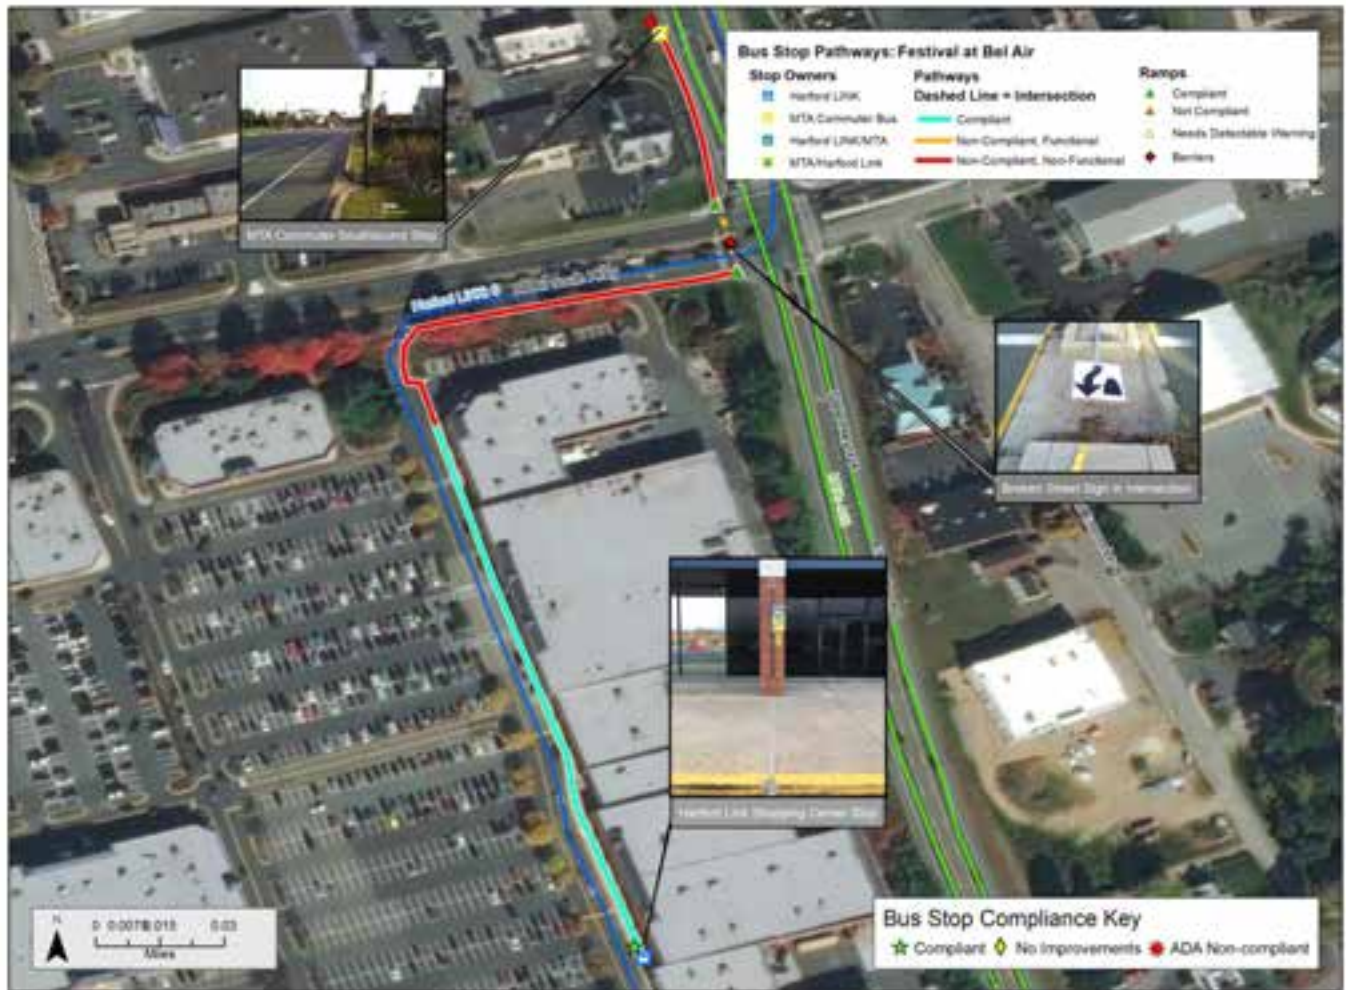
## Festival at Bel Air

LOTS: Harford Transit  
 MTA Bus Service: Commuter  
 Location Type: Commercial-Shopping  
 Number of Distinct Stops: 2

Landing Pads Needed:	1	Curb Ramps to Install:	0
Sidewalk (ft) to be installed/repaired:	670	Detectable Warnings Needed:	0
Signs with Non-Compliant Height:	0	Consolidate Signage?	Yes
New Signs Needed:	No	Pedestrian Control:	Yes
Compliant Amenities:	Yes	Traffic Control:	Yes

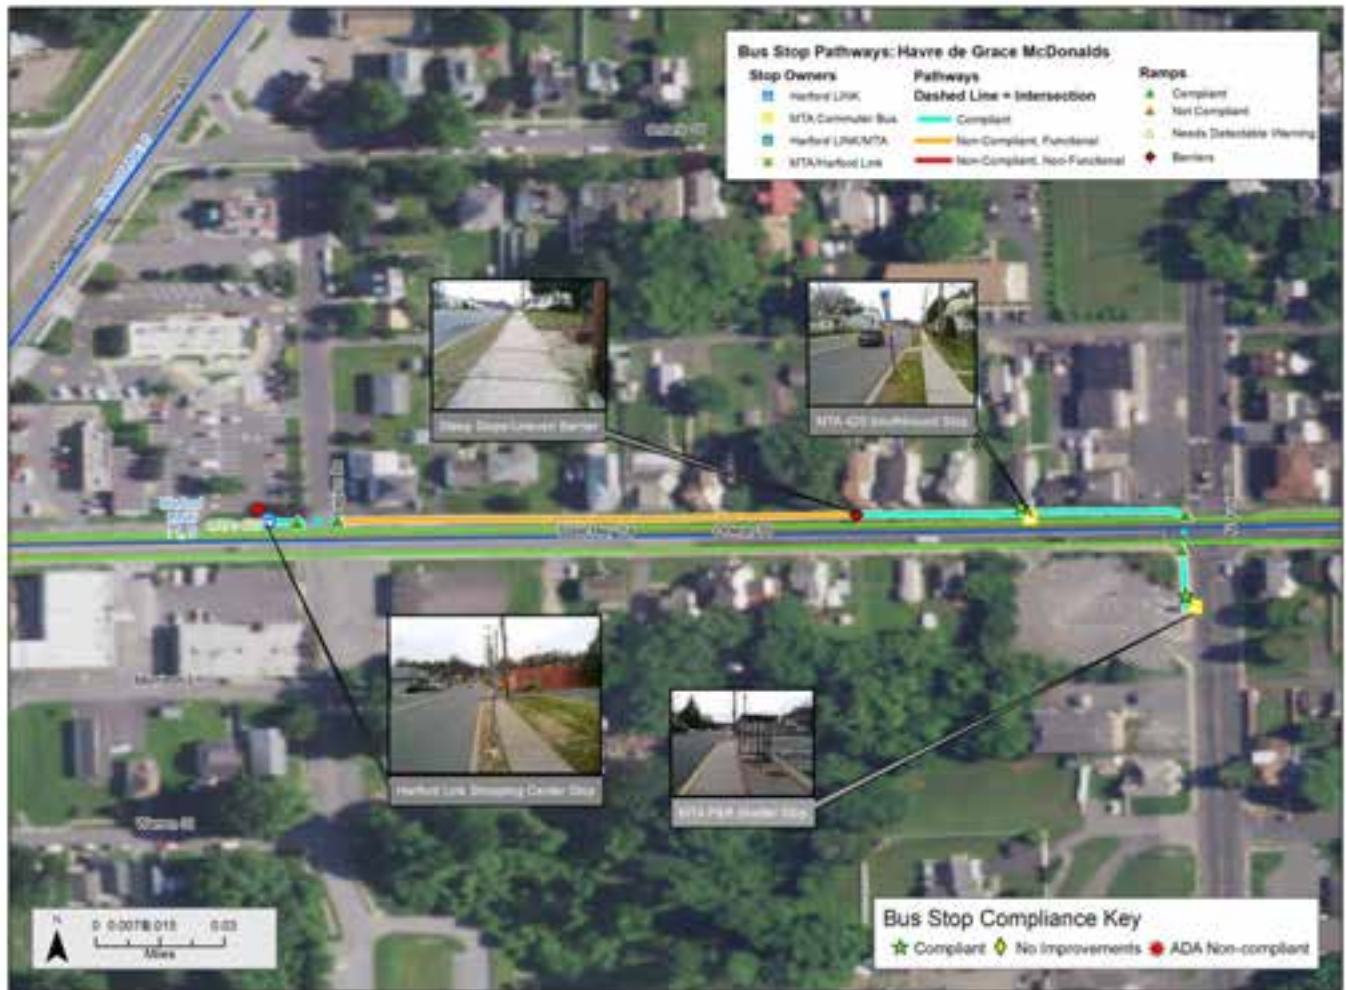
## Havre de Grace McDonalds

LOTS: Harford Transit  
 MTA Bus Service: Commuter  
 Location Type: Basic Bus Stop-Residential  
 Number of Distinct Stops: 3

Landing Pads Needed:	1	Curb Ramps to Install:	0
Sidewalk (ft) to be installed/repaired:	495	Detectable Warnings Needed:	0
Signs with Non-Compliant Height:	0	Consolidate Signage?	Yes
New Signs Needed:	Yes	Pedestrian Control:	Yes
Compliant Amenities:	No	Traffic Control:	Yes

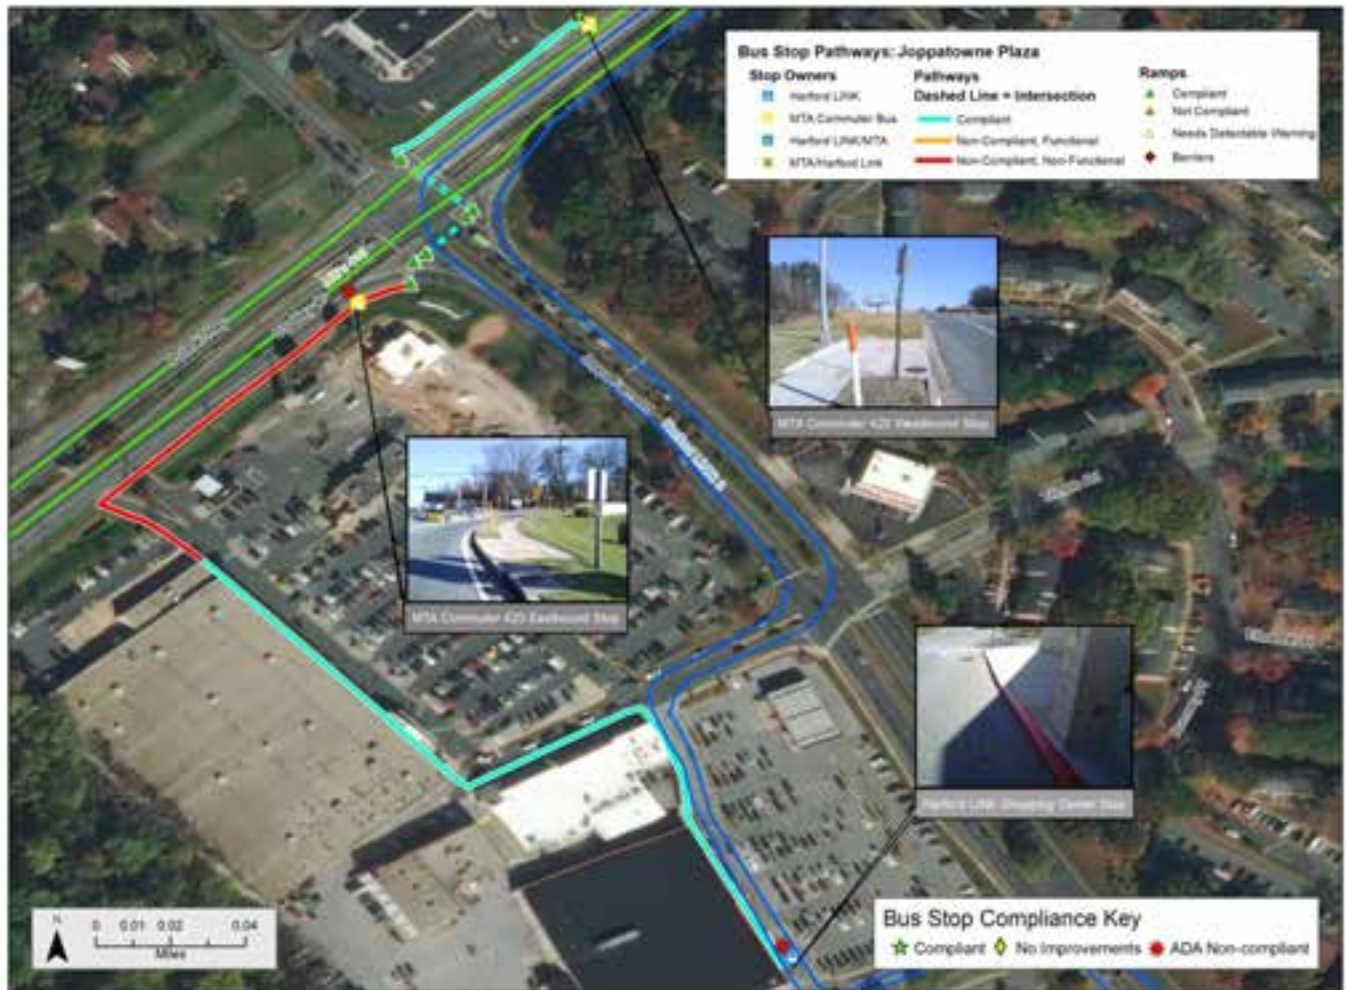
## Joppatowne Plaza

LOTS: Harford Transit  
 MTA Bus Service: Commuter  
 Location Type: Shopping Center  
 Number of Distinct Stops: 3

Landing Pads Needed:	1	Curb Ramps to Install:	0
Sidewalk (ft) to be installed/repaired:	584	Detectable Warnings Needed:	0
Signs with Non-Compliant Height:	0	Consolidate Signage?	Yes
New Signs Needed:	Yes	Pedestrian Control:	No
Compliant Amenities:	NA	Traffic Control:	No

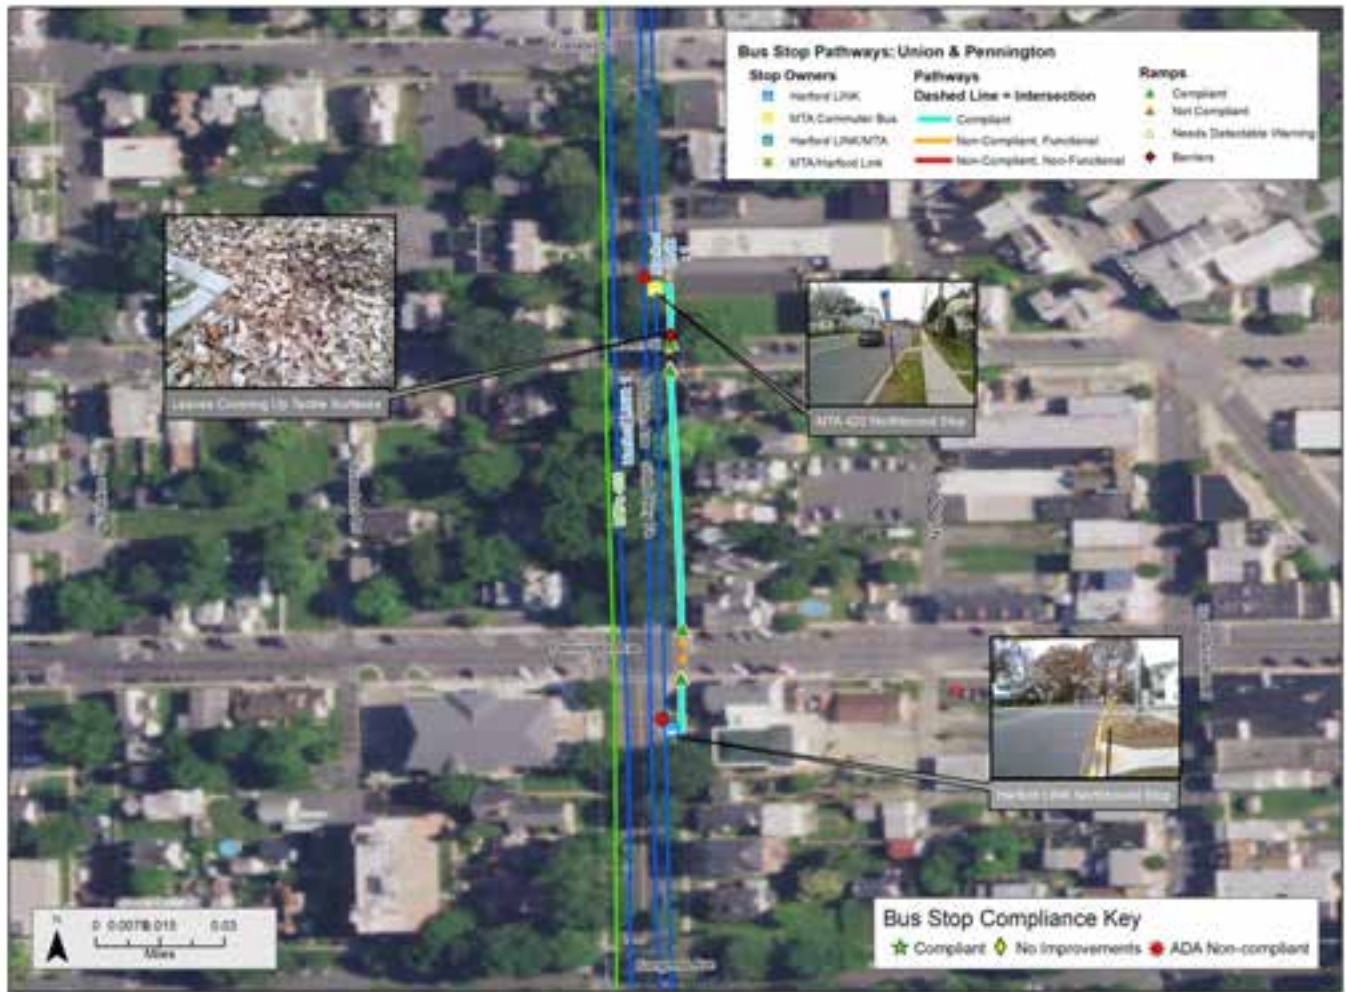
## Union & Pennington

LOTS: Harford Transit  
 MTA Bus Service: Commuter  
 Location Type: Basic Bus Stop-Residential  
 Number of Distinct Stops: 3

Landing Pads Needed:	1	Curb Ramps to Install:	0
Sidewalk (ft) to be installed/repaired:	0	Detectable Warnings Needed:	0
Signs with Non-Compliant Height:	0	Consolidate Signage?	Yes
New Signs Needed:	Yes	Pedestrian Control:	No
Compliant Amenities:	NA	Traffic Control:	Yes

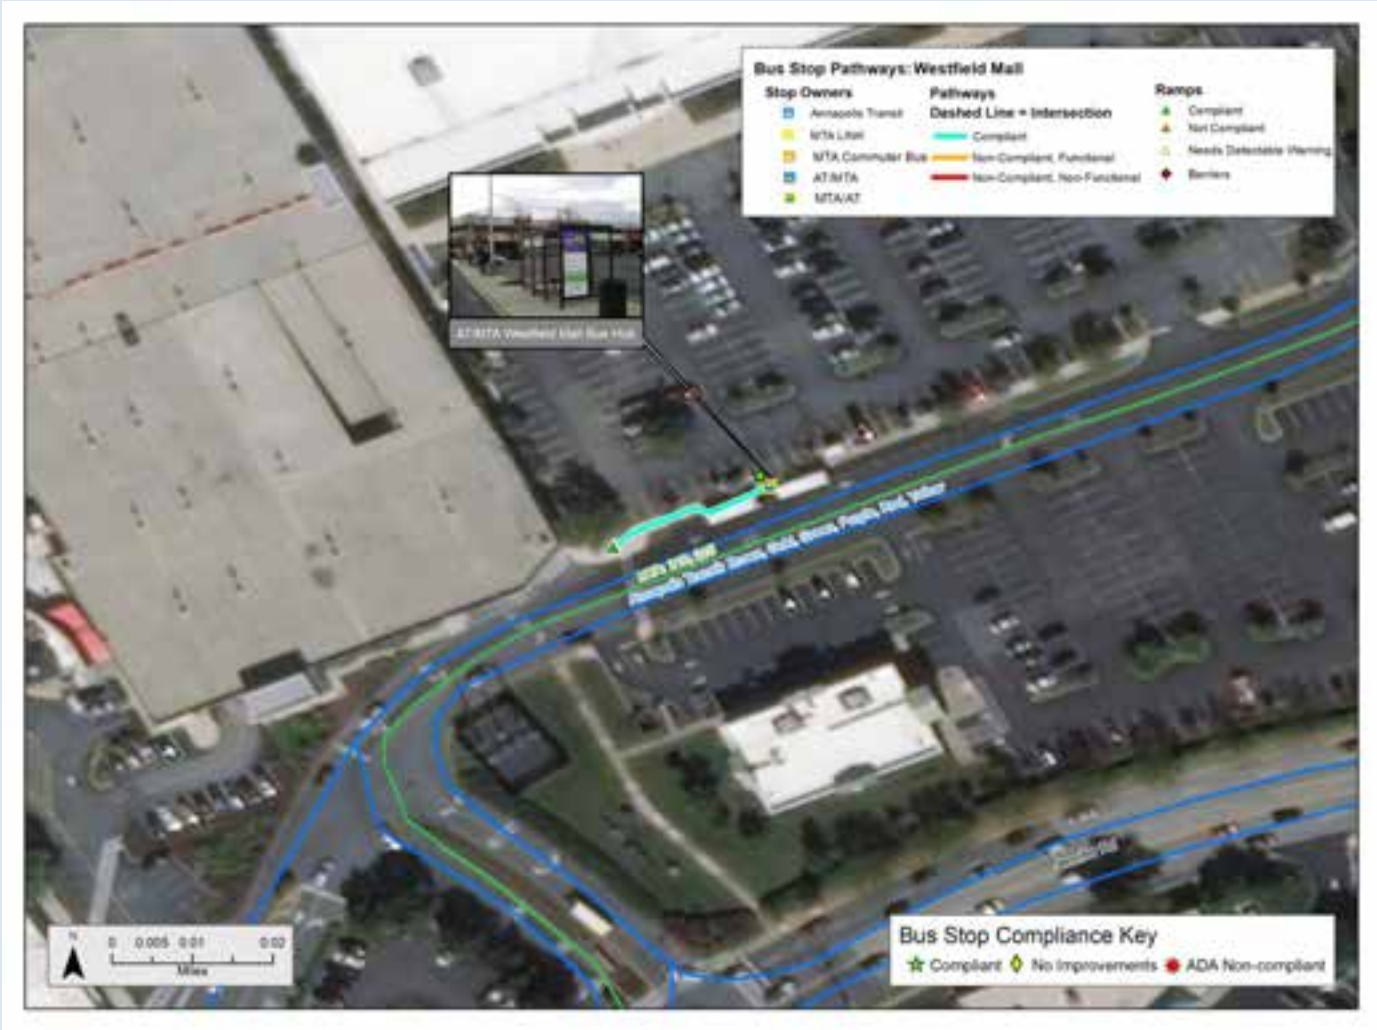
## Westfield Mall

LOTS: Anne Arundel Transit, Annapolis Transit & Queen Anne's County Ride  
 MTA Bus Service: Commuter & LINK  
 Location Type: Transit Center-Shopping Center  
 Number of Distinct Stops: 2

Landing Pads Needed:	0	Curb Ramps to Install:	0
Sidewalk (ft) to be installed/repaired:	0	Detectable Warnings Needed:	0
Signs with Non-Compliant Height:	0	Consolidate Signage?	No
New Signs Needed:	No	Pedestrian Control:	NA
Compliant Amenities:	Yes	Traffic Control:	NA

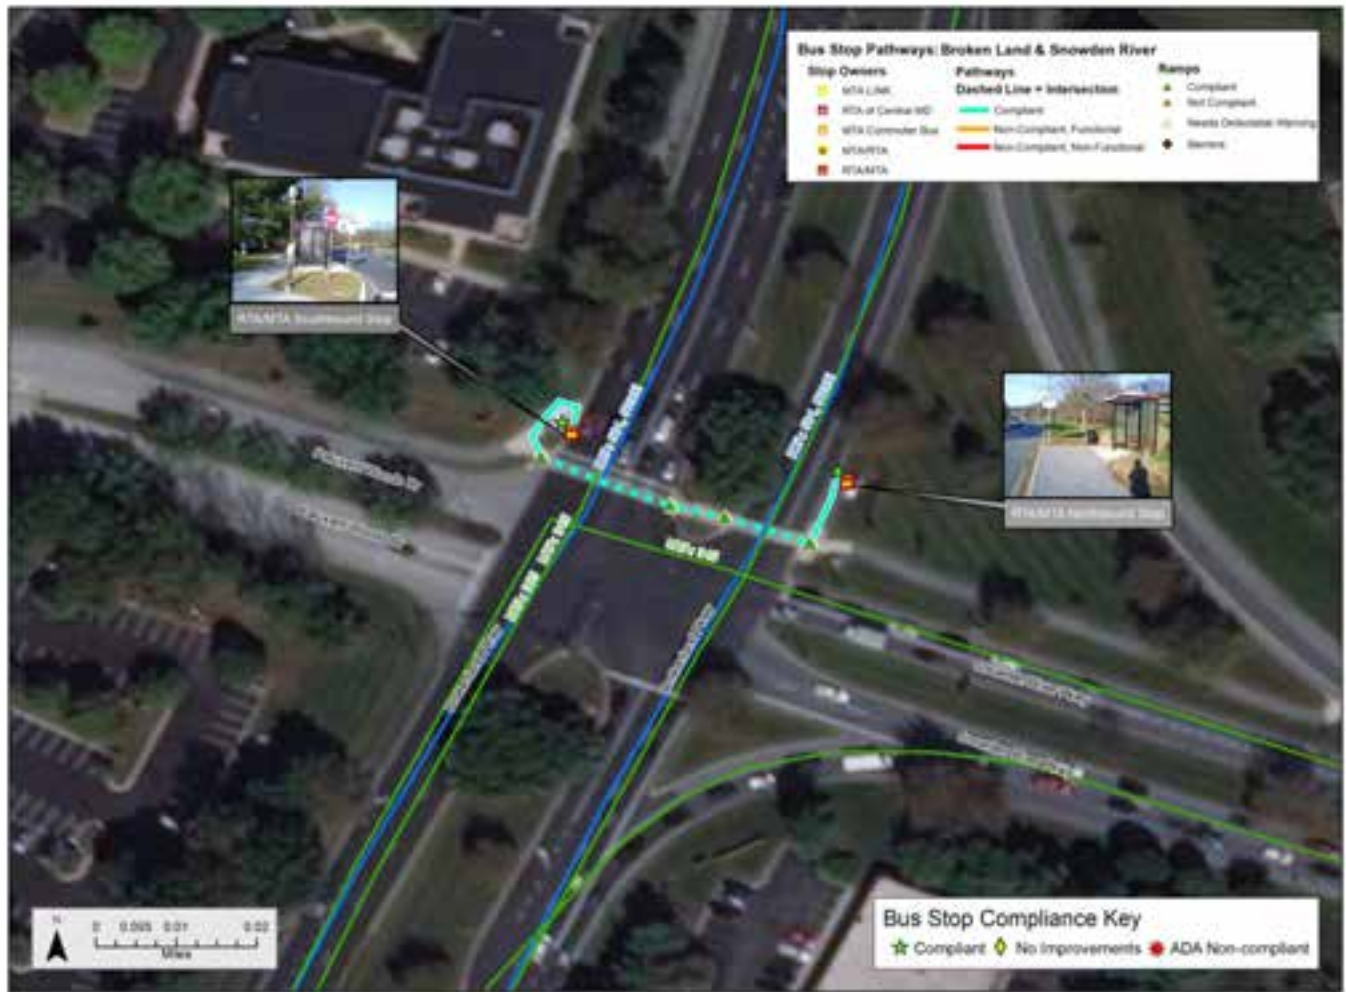
## Broken Land & Snowden River

Location Type: Basic Bus Stop

Number of Distinct Stops: 2

Landing Pads Needed:	0	Curb Ramps to Install:	0
Sidewalk (ft) to be installed/repaired:	0	Detectable Warnings Needed:	0
Signs with Non-Compliant Height:	0	Consolidate Signage?	NA
New Signs Needed:	No	Pedestrian Control:	Yes
Compliant Amenities:	Yes	Traffic Control:	Yes

<b>Broken Land &amp; Snowden River</b>		
<b>Howard County</b>		
<b>Required Improvements</b>		
New sidewalk to be installed	0	\$0.00
New curb ramps	0	\$0.00
Detectable warning	0	\$0.00
<b>Enhanced Improvements</b>		
Pedestrian Control	0	\$0.00
Crosswalk	0	\$0.00
<b>Stop 1: RTA/MTA SB Stop</b>	Primary Owner: RTA of Central MD	
New Compliant Landing Pad	0	\$0.00
New Sign	0	\$0.00
Digital Display	1	\$1,000.00
<b>Stop 2: RTA/MTA NB Stop</b>	Primary Owner: RTA of Central MD	
New Compliant Landing Pad	0	\$0.00
New Sign (Need MTA Sign)	0	\$0.00
Digital Display	1	\$1,000.00
	Location Cost:	\$0.00
	Stop 1 Cost:	\$1,000.00
	Stop 2 Cost:	\$1,000.00
	<b>Total Cost</b>	<b>\$2,000.00</b>
