# Baltimore Metropolitan Council Regional MTA/LOTS Transfer Points Study Final - August 2019

This report serves as the final, comprehensive document for the Regional MDOT MTA/LOTS (Locally Operated Transit Systems) Transfer Study, commissioned by BMC and completed by KFH Group, Inc. This report has re-organized and refined the prior project technical memorandums into the following three chapters. Included within this report are appendices that contain improvement profiles, line-item cost estimates, and LOTS/MDOT MTA transfer tables for each transfer location.

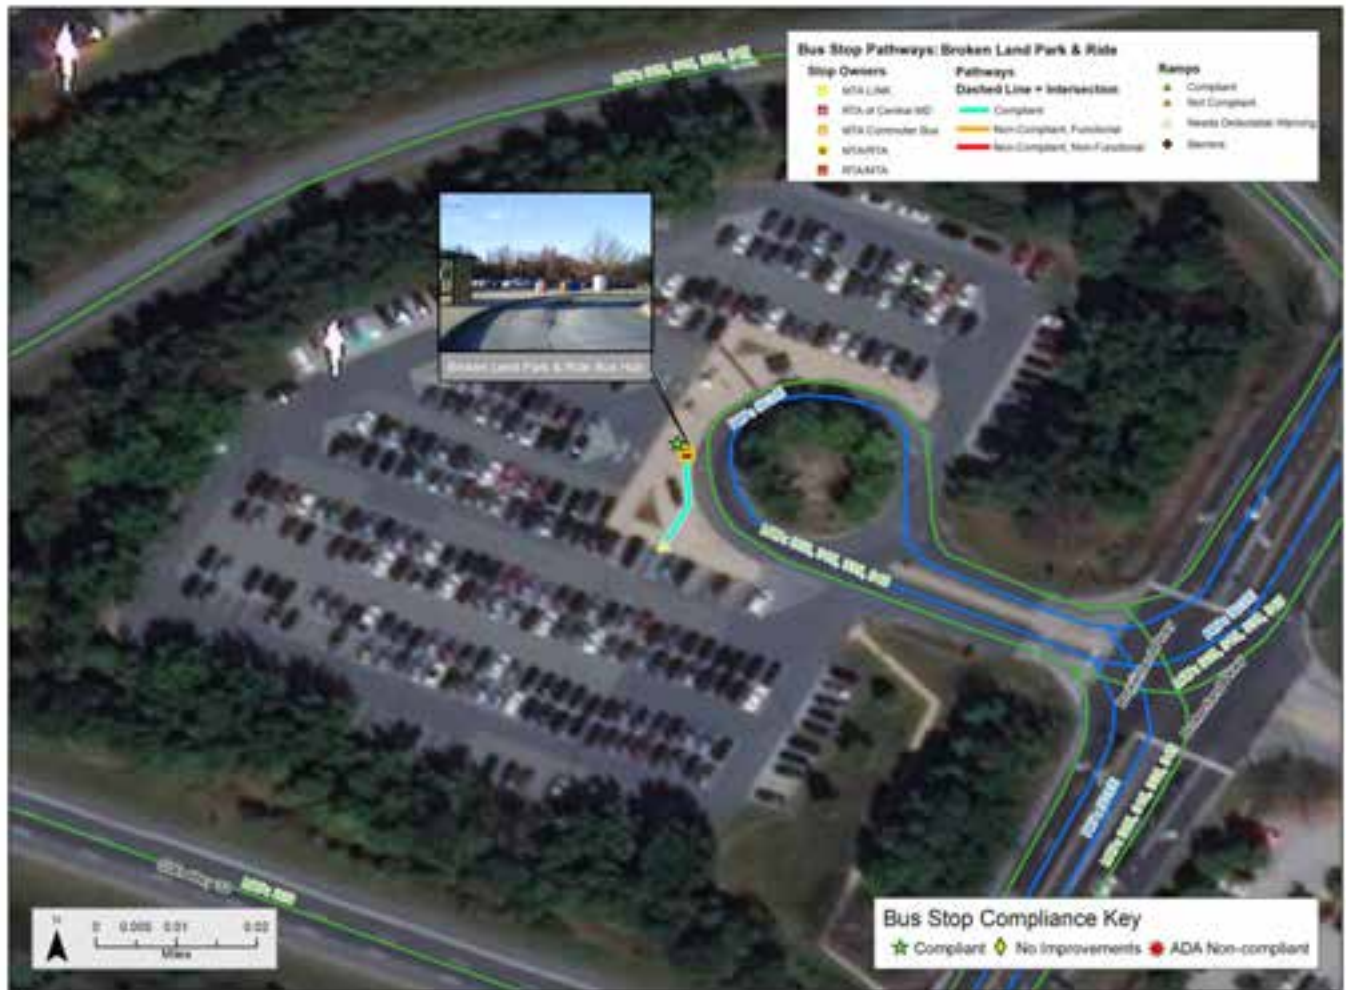
## Broken Land Park & Ride

LOTS: RTA of Central MD  
 MTA Bus Service: Commuter  
 Location Type: Transit Center-Park & Ride  
 Number of Distinct Stops: 1

Landing Pads Needed:	0	Curb Ramps to Install:	0
Sidewalk (ft) to be installed/repaired:	0	Detectable Warnings Needed:	1
Signs with Non-Compliant Height:	0	Consolidate Signage?	NA
New Signs Needed:	No	Pedestrian Control:	NA
Compliant Amenities:	Yes	Traffic Control:	NA

<b>Broken Land Park &amp; Ride</b>		
<b>Howard County</b>		
<b>Required Improvements</b>		
New sidewalk to be installed	0	\$0.00
New curb ramps	0	\$0.00
Detectable warning	1	\$75.00
<b>Enhanced Improvements</b>		
Pedestrian Control	0	\$0.00
Crosswalk	0	\$0.00
<b>Stop 1: RTA/MTA P&amp;R Stop</b>	Primary Owner: MTA Commuter Bus	
New Compliant Landing Pad	0	\$0.00
New Sign	0	\$0.00
New Shelter	1	\$15,000.00
Digital Display	1	\$1,000.00
	Location Cost:	\$75.00
	Stop 1 Cost:	\$16,000.00
	<b>Total Cost</b>	<b>\$16,075.00</b>

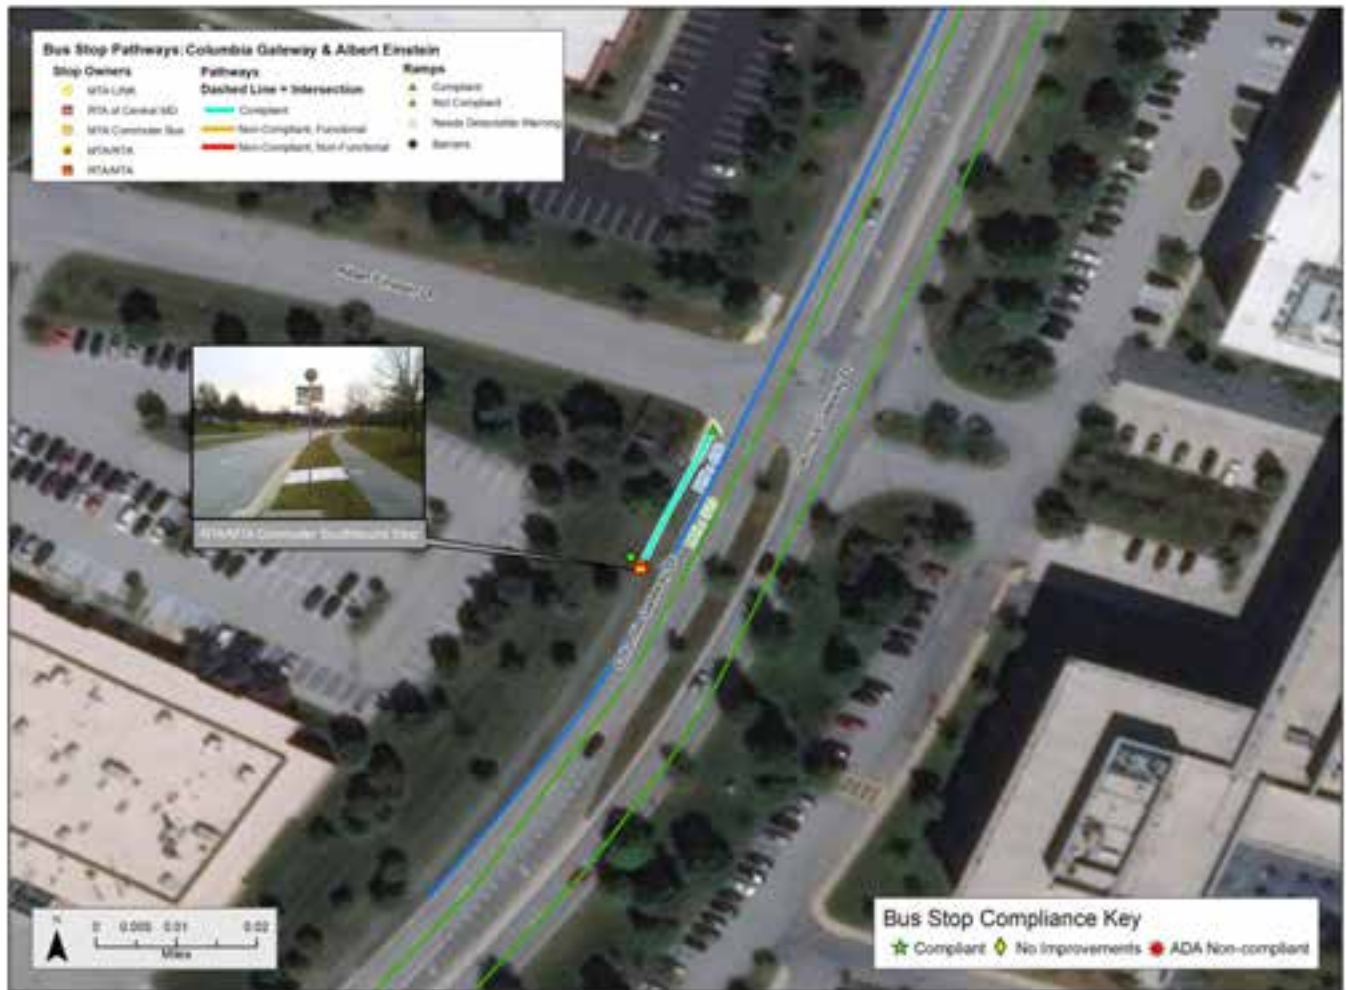
Location Type: Commercial-Office

Number of Distinct Stops: 1

Landing Pads Needed:	0	Curb Ramps to Install:	0
Sidewalk (ft) to be installed/repaired:	0	Detectable Warnings Needed:	0
Signs with Non-Compliant Height:	0	Consolidate Signage?	NA
New Signs Needed:	No	Pedestrian Control:	No
Compliant Amenities:	NA	Traffic Control:	No

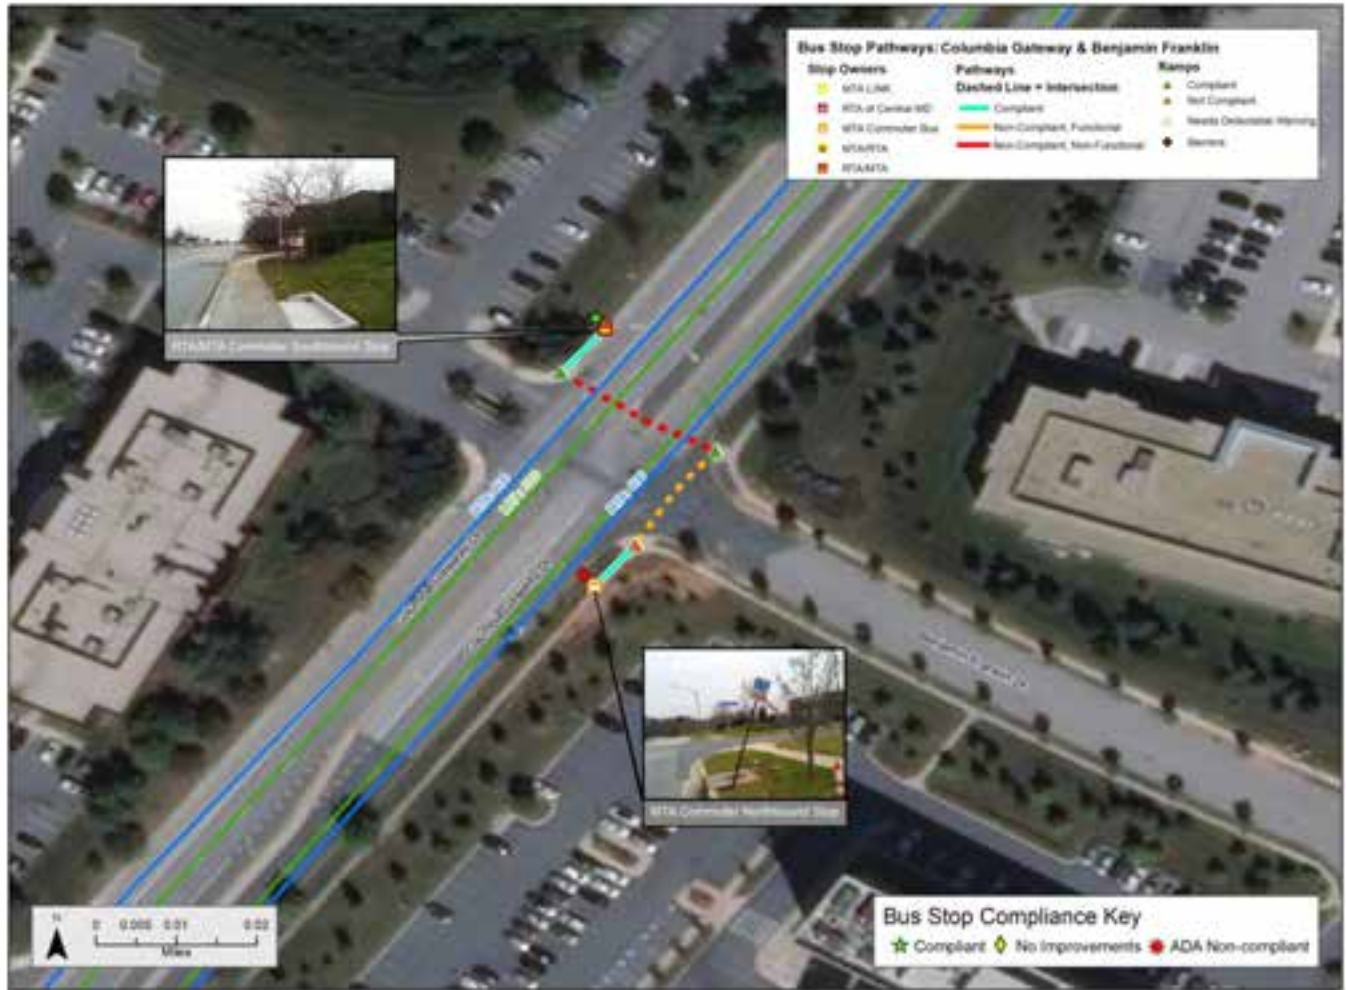
Location Type: Commercial-Office

Number of Distinct Stops: 2

Landing Pads Needed:	1	Curb Ramps to Install:	1
Sidewalk (ft) to be installed/repaired:	0	Detectable Warnings Needed:	1
Signs with Non-Compliant Height:	0	Consolidate Signage?	No
New Signs Needed:	No	Pedestrian Control:	No
Compliant Amenities:	NA	Traffic Control:	No

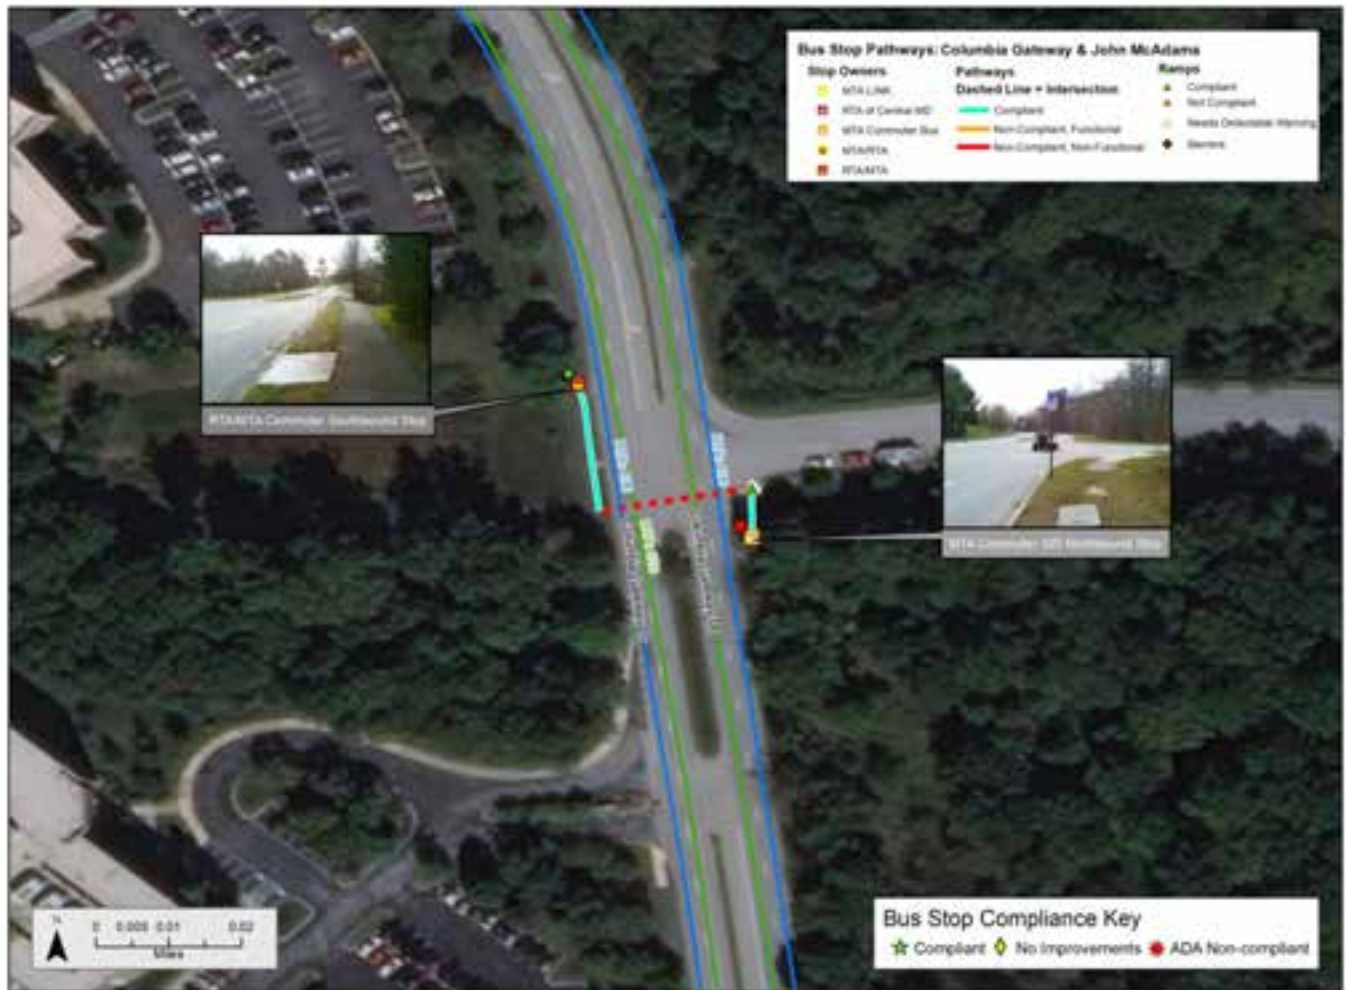
Location Type: Commercial-Office

Number of Distinct Stops: 2

Landing Pads Needed:	1	Curb Ramps to Install:	1
Sidewalk (ft) to be installed/repaired:	8	Detectable Warnings Needed:	1
Signs with Non-Compliant Height:	0	Consolidate Signage?	No
New Signs Needed:	Yes	Pedestrian Control:	No
Compliant Amenities:	NA	Traffic Control:	No

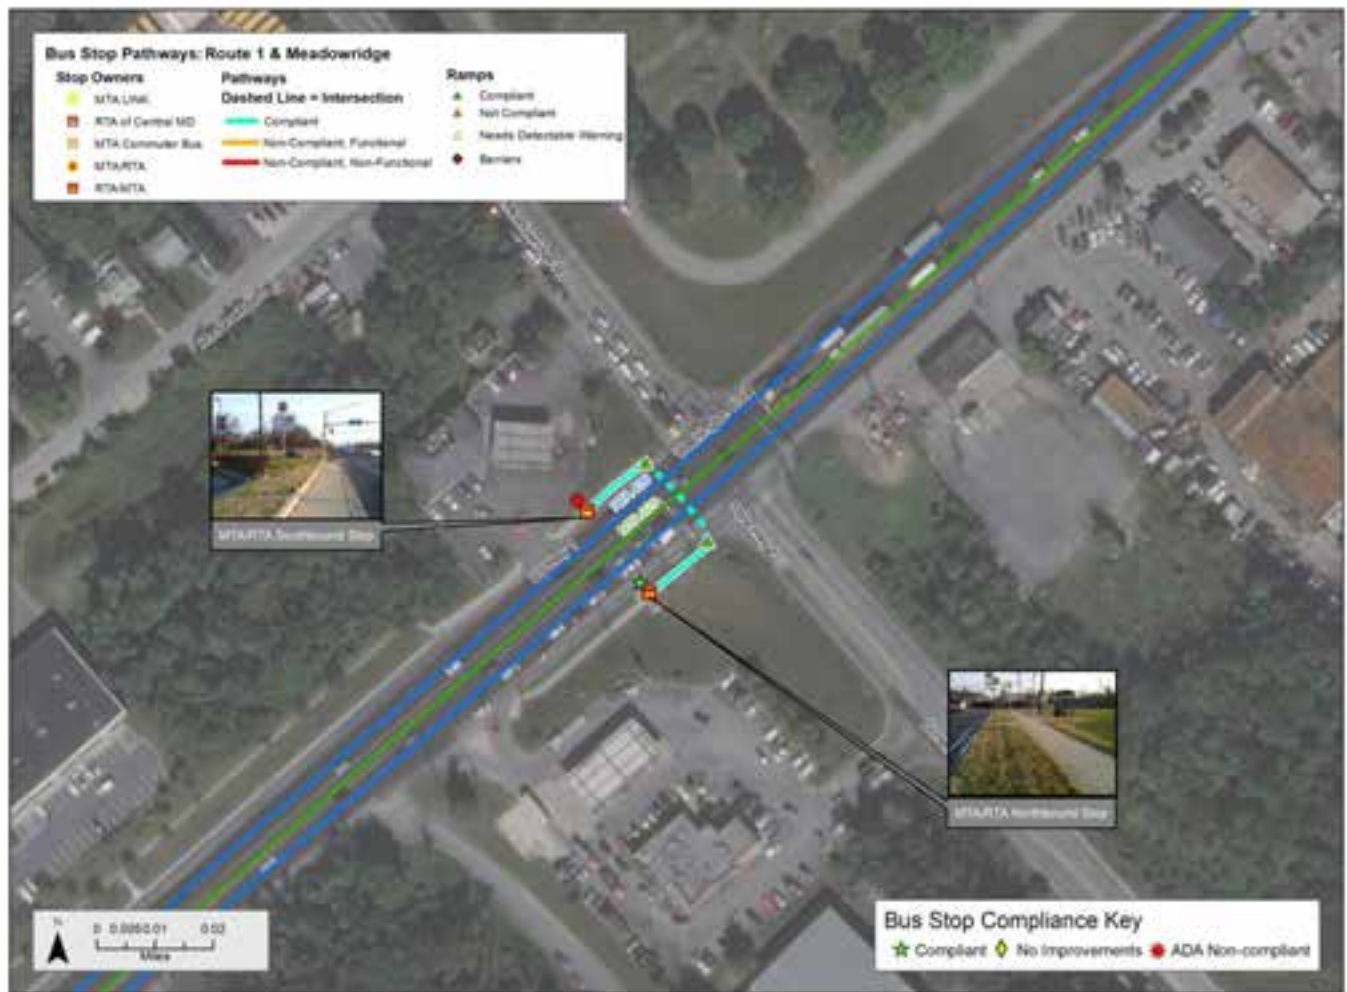
Location Type: Basic Bus Stop-Commercial

Number of Distinct Stops: 2

Landing Pads Needed:	1	Curb Ramps to Install:	0
Sidewalk (ft) to be installed/repaired:	0	Detectable Warnings Needed:	0
Signs with Non-Compliant Height:	0	Consolidate Signage?	No
New Signs Needed:	No	Pedestrian Control:	No
Compliant Amenities:	Yes	Traffic Control:	Yes

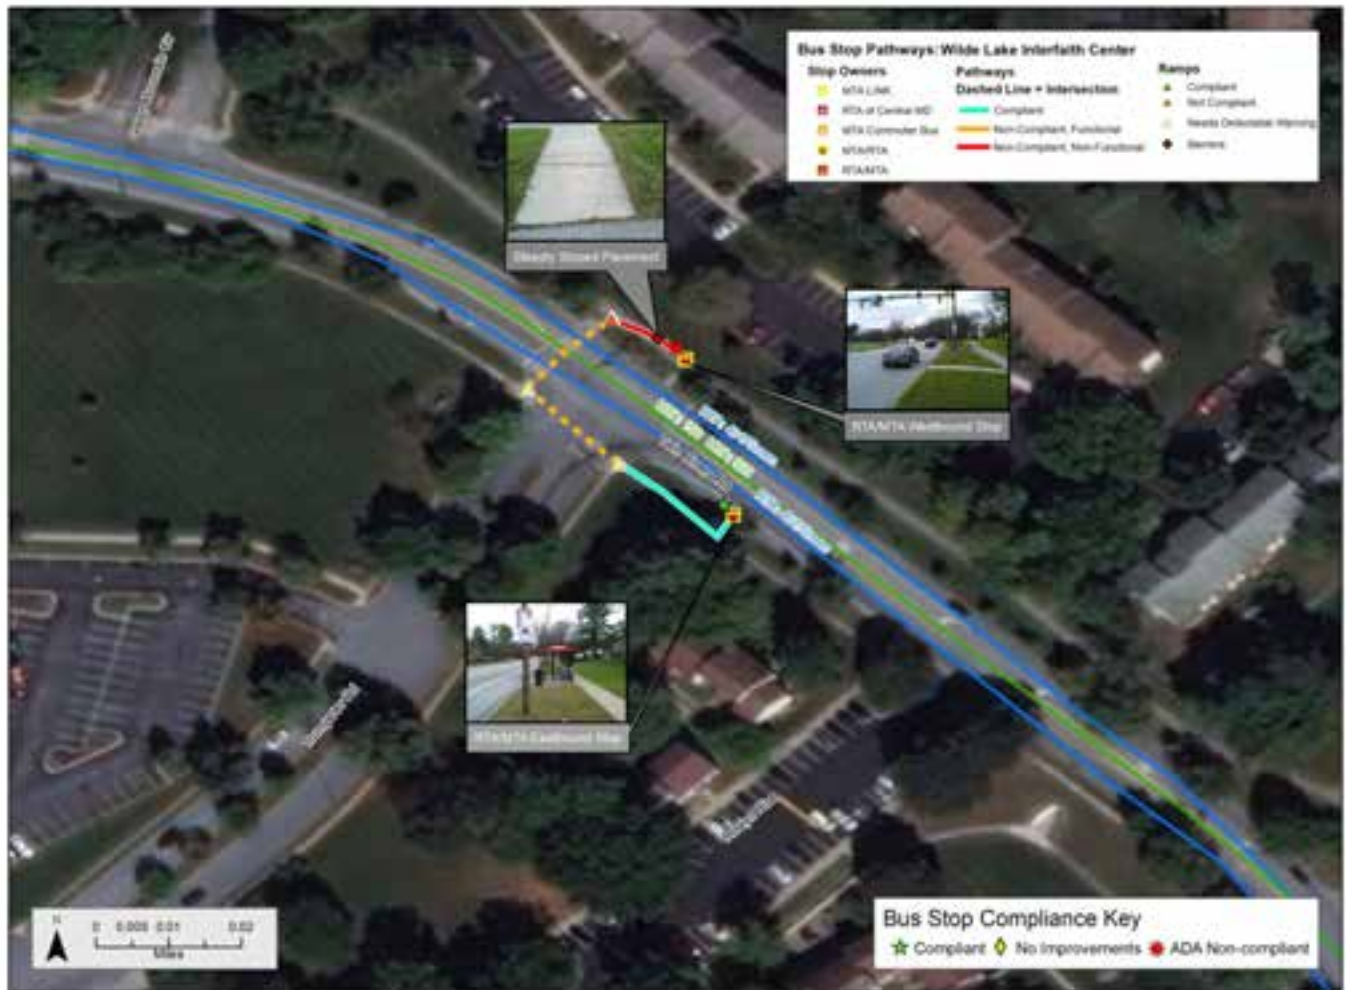
## Wilde Lake Interfaith Center

LOTS: RTA of Central MD  
 MTA Bus Service: Commuter  
 Location Type: Basic Bus Stop-Residential  
 Number of Distinct Stops: 3

Landing Pads Needed:	1	Curb Ramps to Install:	1
Sidewalk (ft) to be installed/repaired:	50	Detectable Warnings Needed:	3
Signs with Non-Compliant Height:	0	Consolidate Signage?	No
New Signs Needed:	No	Pedestrian Control:	Yes
Compliant Amenities:	Yes	Traffic Control:	Yes
