Existing Conditions

Station: Mount Washington

Recommended Improvements

Station: Mount Washington
Rail Line: Light Rail

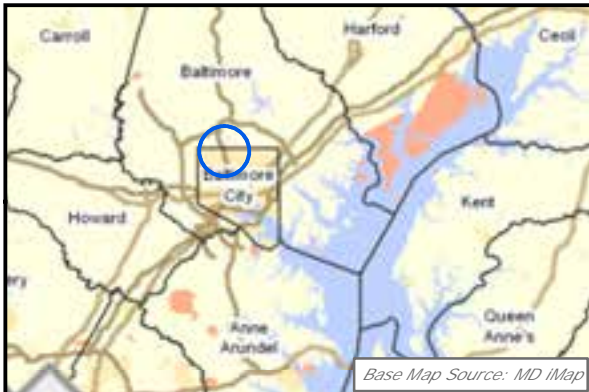
Rail Line: Light Rail

This area has adequate sidewalk coverage. However, as typical in older communities, some sidewalks are narrow and obstructed by utility poles in places. General sidewalk maintenance is needed. Crosswalks at intersections could be improved for better pedestrian safety.

Mount Washington LRT		Baltimore City	Smith Ave @ Newberry Street			Roadway Jurisdiction	Recommended Improvement	Distance (Mi)
Facility Type	Recommendation Type	Roadway Intersection	Roadway Name	From	To			
	SIDEWALK SEGMENT MISSING		KELLY AVE.	NEWBERRY ST.	NEWBERRY ST.	CITY	INSTALL 200'X5' OF SIDEWALK ON SOUTH SIDE	
	SIDEWALK SEGMENT MISSING		SULGRAVE AVE.	KENFORD ROAD	MOUNT WASHINGTON ELEMENTRY SCHOLL 250' EAST	CITY	INSTALL 1800'X5' OF SIDEWALK	
	SIDEWALK DAMAGED		KELLY AVE.	LOCHLEA ROAD		CITY	REMOVE THE TREES, REPLACE 250'X4' OF SIDEWALK	
	SIDEWALK DAMAGED		KELLY AVE.	SULGRAVE AVE.	NEWBURY ST.	CITY	RELOCATE THREE UTILITY POLES,ROW REQUIRED	
	SIDEWALK DAMAGED		SMITH AVE.	GREELY ROAD	REGENT ROAD	CITY	RELOCATE TWO UTILITY POLES FROM THE SIDEWALK	
	SIDEWALK DAMAGED		SMITH AVE.		SMITH AVE.	CITY	WIDEN 310'X4' OF SW,ADD 310' OF C/G:15' LANES	
	SIDEWALK DAMAGED		SMITH AVE.	SMITH AVE.	OLIVER STREET	CITY	RELOCATE ONE UTILITY POLE FROM THE CURB RAMP

PEDESTRIAN CROSSING SIGNS MISSING	KELLY AVE AND S ROAD ON S ROAD				CITY	INSTALL 2- PED. XROSSING SIGNS, 2-ADV. PED CROSSING SIGNS	
	LIGHTING AT BUS STOP	KELLY AVE. AND LOCHLEA ROAD	KELLY AVE.			CITY	INSTALL LIGHTING AT BUS STOP	
	DIRECTIONAL SIGNING MISSING		SMITH AVE.			CITY	INSTALL LIGHT RAIL SIGN ON SMITH AVE. TO DIRECT THE TRAFFIC TO MOUNT WASHINGTON LIGHT RAIL STATION	
	DESIRED LINE PRESENT		SULGRAVE AVE.	SULGRAVE AVE.	PLATFORM	CITY	INSTALL A RAMP TO ACCESS THE PLATFORM FROM THIS POINT	
	CURB RAMP MISSING	FALLS RD AND SMITH AVE				CITY	INSTALL 2- CURB RAMPS AT THIS INTERSECTION	
	CURB RAMP MISSING	LOCHLEA RD AND KELLY AVE				CITY	INSTALL 4- CURB RAMPS FOR BOTH CROSSENGS AT THIS INTERSECTION	
PEDESTRIAN	CURB RAMP MISSING	MOUNT WASHINGTON STATION				STATE	INSTALL 1-CURB RAMP AT HANDICAP PARKING TO ACCESS THE PLATFORM	
	CURB RAMP MISSING	SMITH AVE AND COTTONWORTH AVE				CITY	INSTALL 4- CURB RAMPS FOR BOTH CROSSENGS AT THIS INTERSECTION

CURB RAMP MISSING	SULGRAVE AVE AND LOCHLEA RD				CITY	INSTALL 2- CURB RAMPS ON THE WEST LEG OF THE INTERSECTION	
	CROSSWALK MISSING	KELLY AVE. AND SULGRAVE AVE.				CITY	INSTALL 190' XWALK, 2-PED SIGNS	
	CROSSWALK MISSING	NEWBERRY AND KELLY ST.	KELLY STREET			CITY	INSTALL 200' XWALK	
	CROSSWALK MISSING	NEWBURY ST AND SULGRAVE AVE				CITY	INSTALL 450' XWALK ON N.ANDS. LEG	
	CROSSWALK MISSING	SMITH AVE AND GREELY RD				CITY	INSTALL 120' XWALK AND 2 PED SIGNALS	
	CROSSWALK FADED	KELLY AVE. AND FALLS ROAD				STATE	REPAINT CROSSWALKSON ALL THREE LEGS-TOTAL OF 400' OF P.M.	
	CROSSWALK FADED	KELLY AVE. AND GREELY ROAD/SULGRAVE AVE.				CITY	REPAINT CROSSWALK ON S LEG OS INTERSECTION-TOTAL OF 370' OF P.M.	
	CROSSWALK FADED	KELLY AVE. AND LOCHLEA ROAD				CITY	REPAINT AND REALIGN CROSSWALKS ON N AND E LEG OF THE INTERSECTION-TOTAL OF 550' OF P.M.	
	CROSSWALK FADED	KELLY AVE. AND SOUTH ROAD				CITY	REPAINT CROSSWALK-TOTAL OF 300' OF P.M.

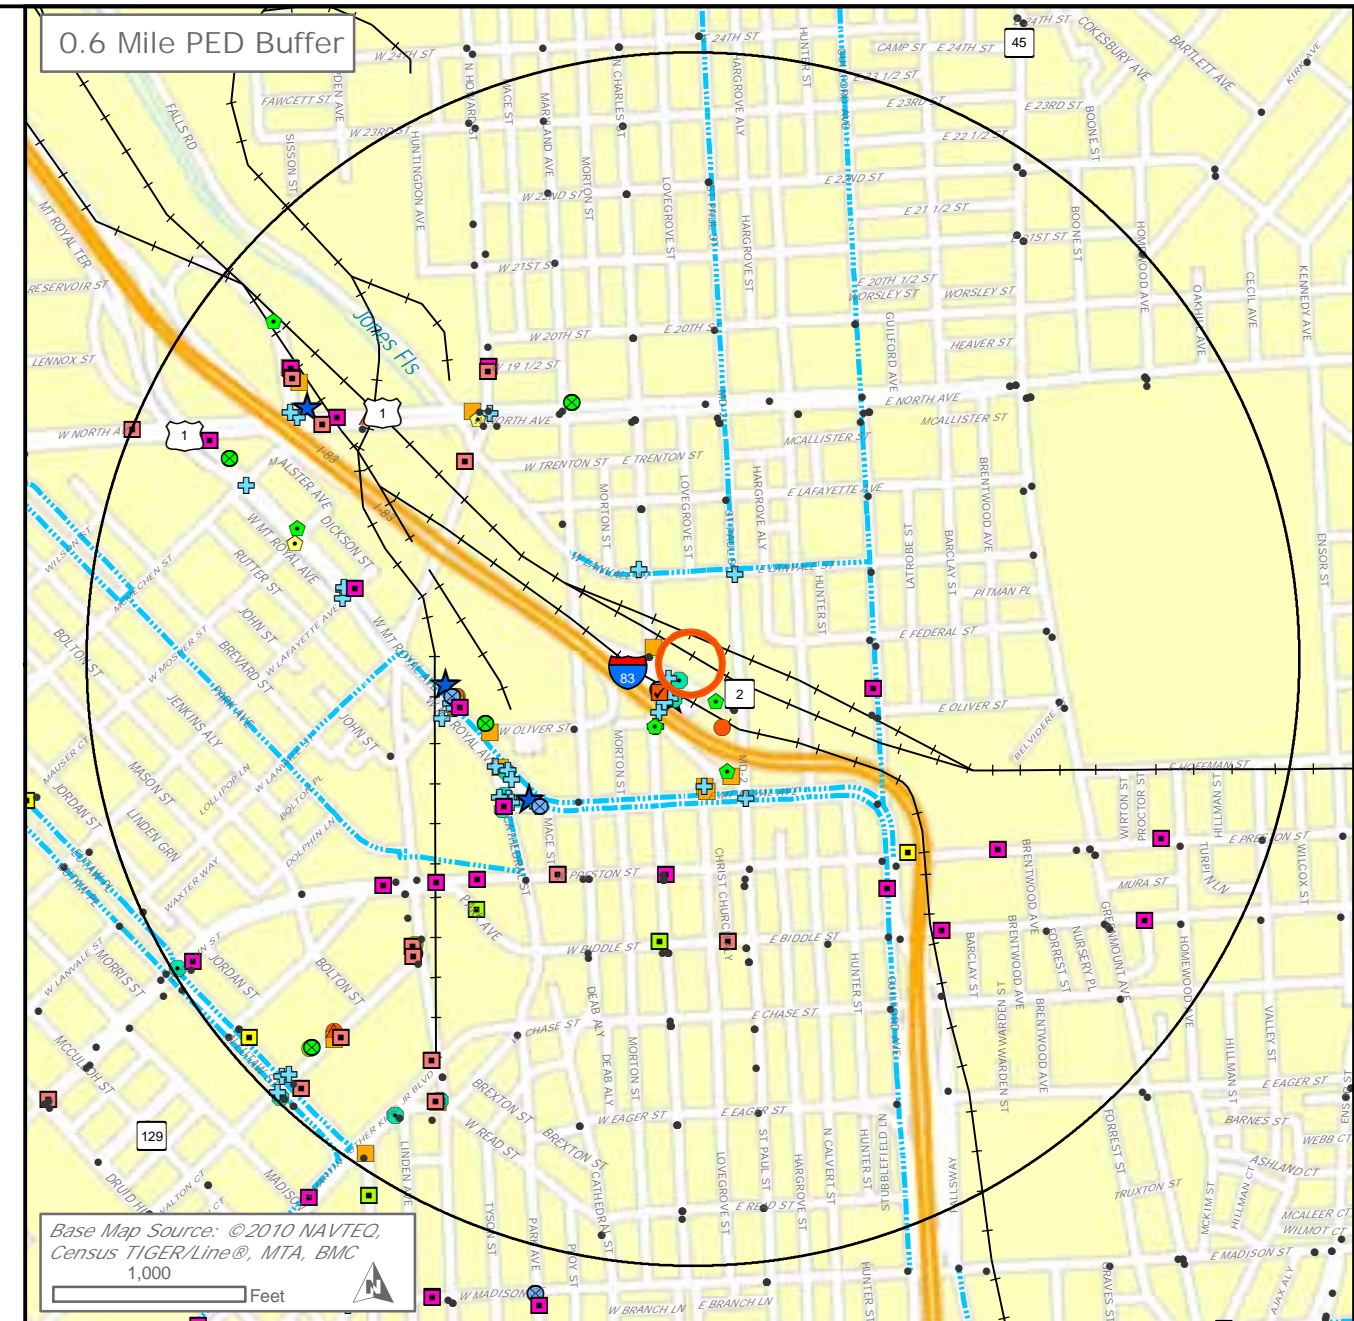
Existing Conditions
 Station: Penn Station
 Rail Line: Light Rail

- It was assumed that a missing section of sidewalk observed on Charles Street near the station would be replaced when construction is completed.
- A segment of missing sidewalk was documented on West Mt Royal Ave and should be installed.
- Crosswalks are faded or missing in the following locations and should be provided: at the station entrance; within the station in the 3 minute loading /unloading area; at St Paul @ East Mt Royal Ave; N. Charles @ Lanvale; N.Charles @ Academic Center; I-83 off ramp to W. Mt Royal.

- For the shared use lane on Falls Road – Share the Road Sign and marking is recommended between Chestnut Ave and Charles Street.

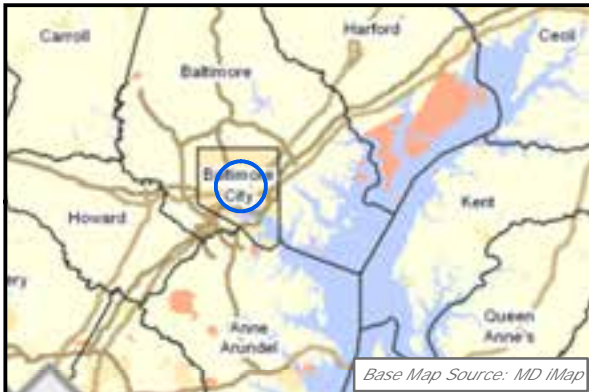
All the streets in the area have sidewalks, usually on both sides. Sidewalks in the area are generally in good condition. The sidewalk on the east side of North Charles Street between E Mt. Royal Avenue and the station entrance was temporarily closed due to construction.

Station wayfinding signage is recommended on N Charles Street for the Light Rail Station and MARC stations. Additional bicycle storage racks may be needed.

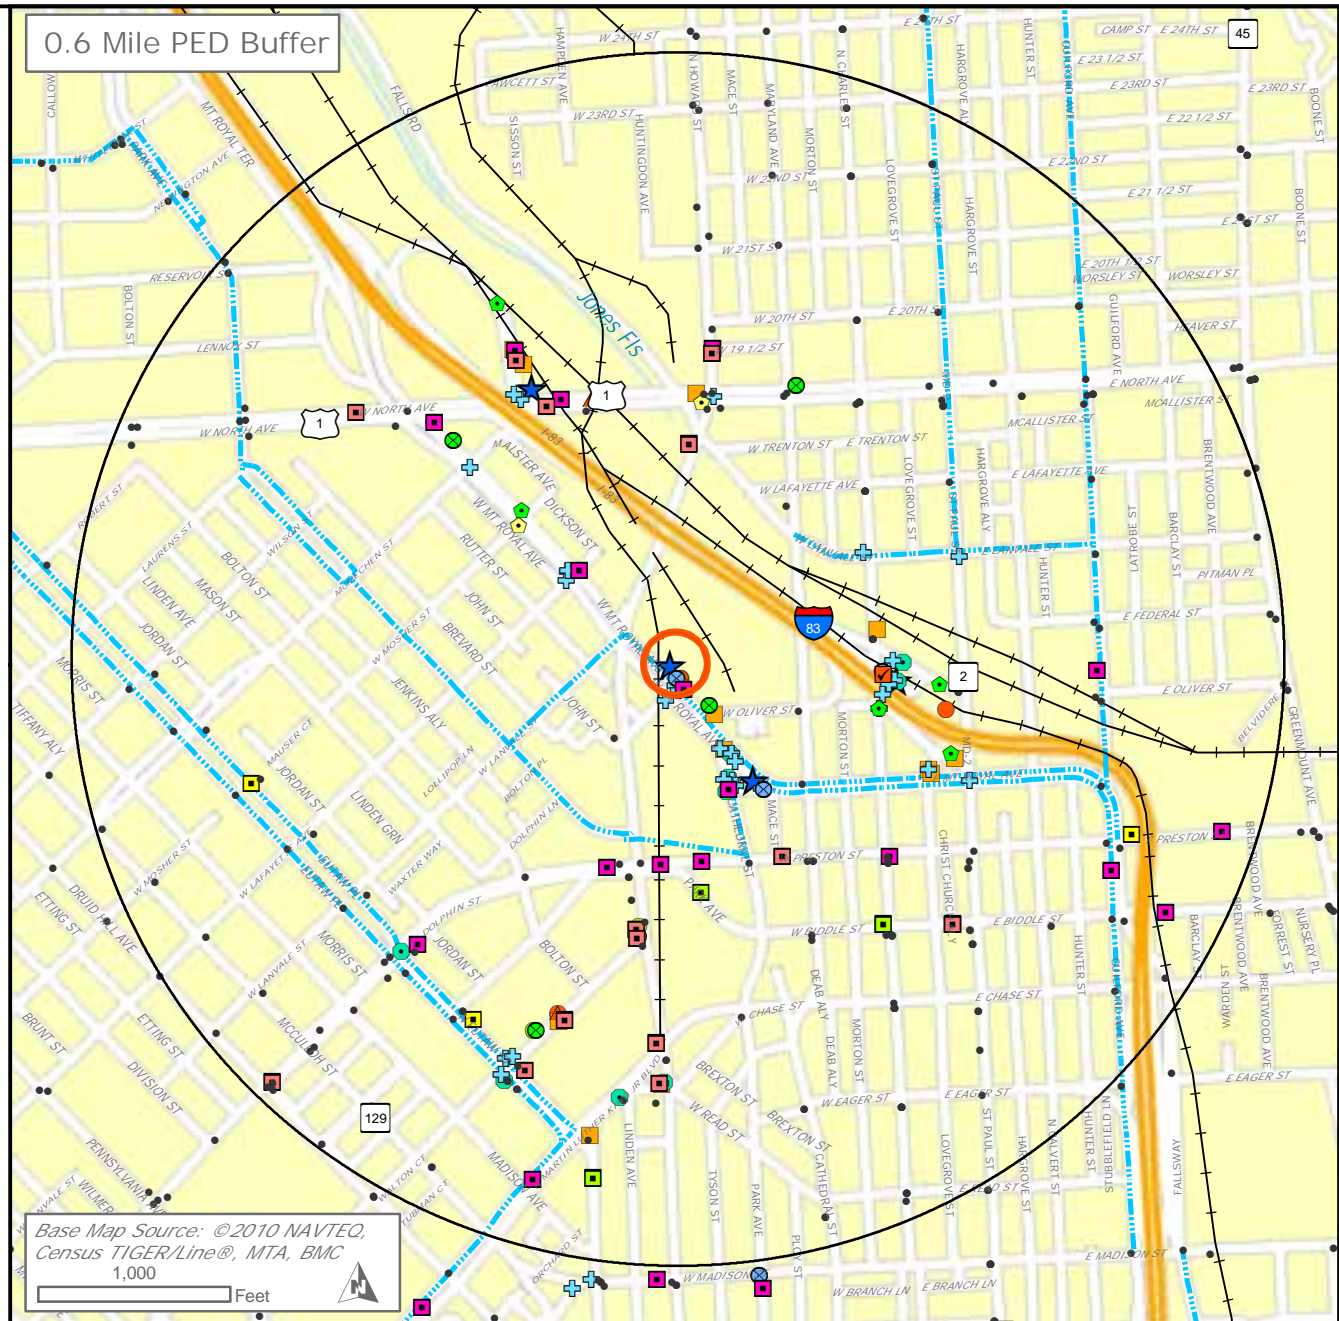
Existing Conditions

- There are segments of missing and damaged sidewalk on North Avenue and West Mt Royal that should be replaced.
- Faded or missing crosswalks should be replaced at the following locations: West Mt Royal at the rail crossing @ Dolphin Street; Mt Royal @ Cathedral; Mt Royal @ Lafayette. Pedestrian crossing signs and advanced crossing signs are also recommended at these locations.
- Curb ramps are needed at Mt Royal and Cathedral Streets.
- Station wayfinding signage is recommended on Mt Royal Ave.

- For the shared use lane on Cathedral Street, from West Mt Royal to Preston Street share the road signage and marking is recommended.
