## Existing Conditions

Station: Hunt Valley  
Rail Line: Light Rail

**Recommended Improvements**

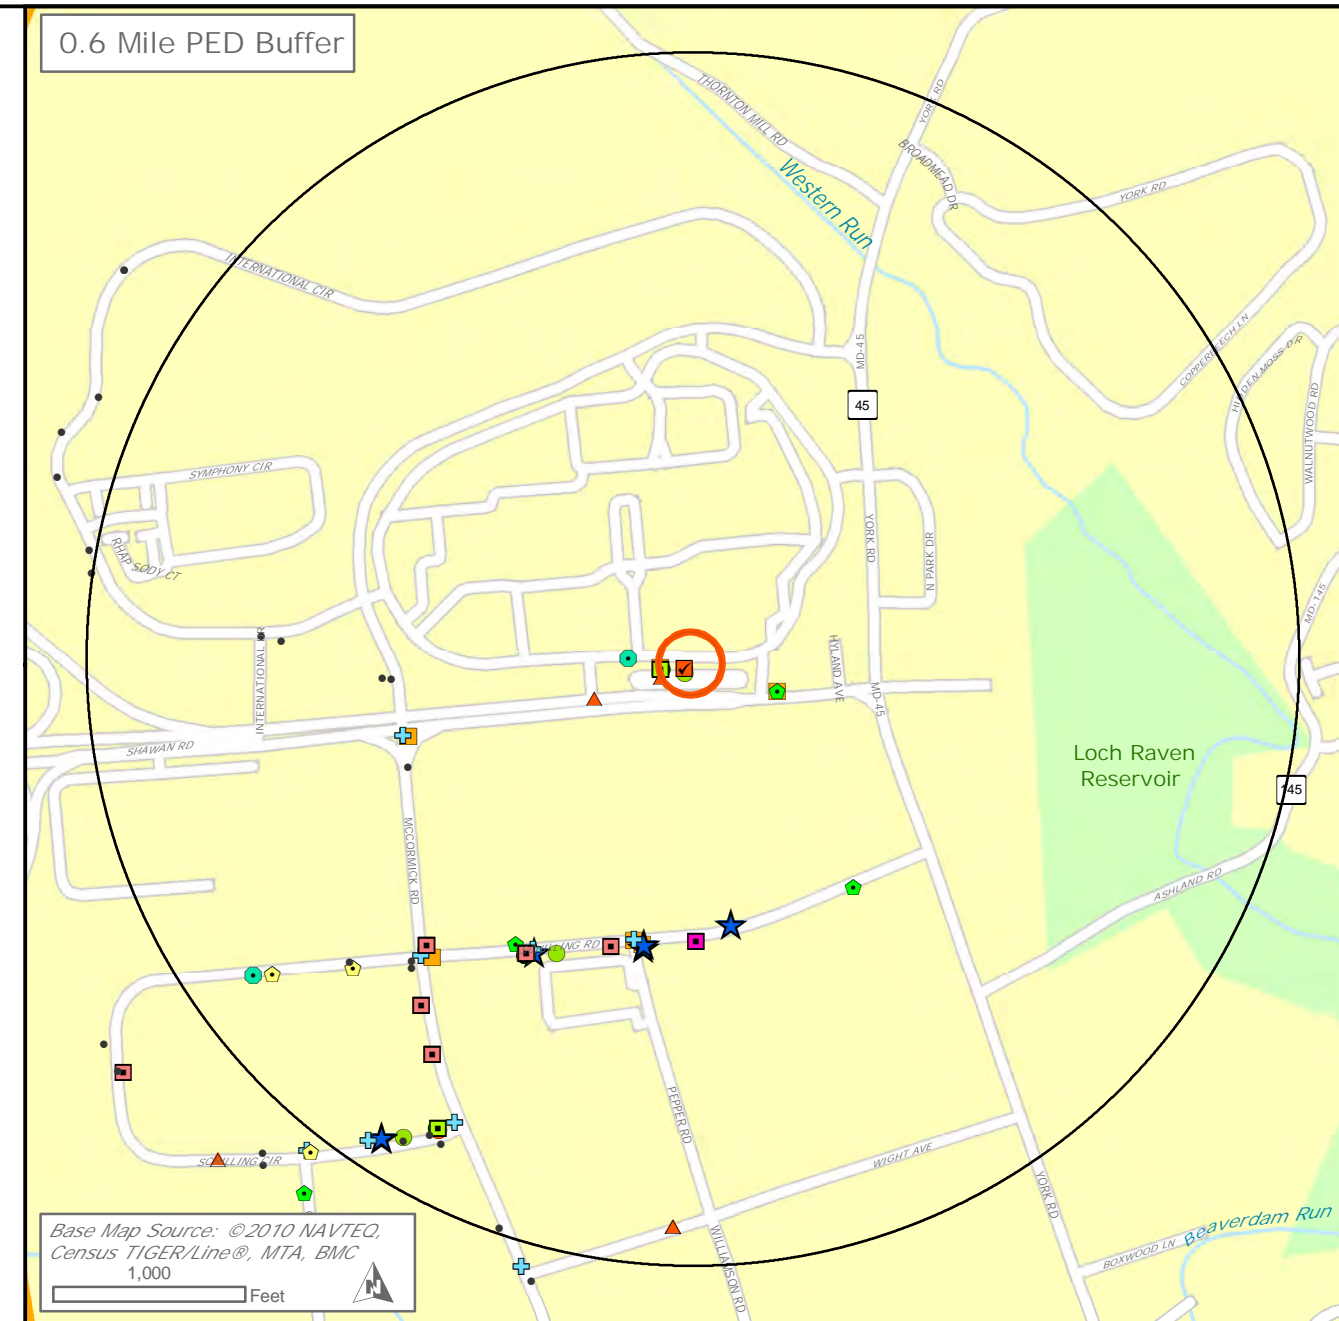
The majority of the streets within 0.6 miles radius of the station have sidewalks at least on one side of the road. Sidewalks are generally in good condition. Several sidewalk gaps were found on the Shawan Road which is the main access to the station. Businesses outside the mall along the Shawan Road and the York Road are not well connected. Signalized pedestrian crossings were present at the intersection of Shawan and McCormick Road and at the entrance to the mall.

There are no bicycle racks or lockers present in the station area. The roads are generally wide enough to accommodate bicycles, however no marked bike lanes are provided. A very popular off-road hiker-bike trail nearby is the Northern Central Railroad (NCR) trail. However, the trail is not easily accessible at this time from the light rail station. Websites for regional trails are listed in the Appendix.

3 Mile Bike Buffer

0.6 Mile PED Buffer

- Sidewalks are missing along Shawan Road between York Road and the station and should be provided.
- Pedestrian Crossing signs should be posted designating a walkway between the station parking and the platform.
- Street lighting is recommended on Shawan at the station entrance and on Paper Mill Road at the pedestrian crossing.

- Share the Road signs and marking are recommended for a wide outside lane on Shawan from Weil Mandel to York Road.

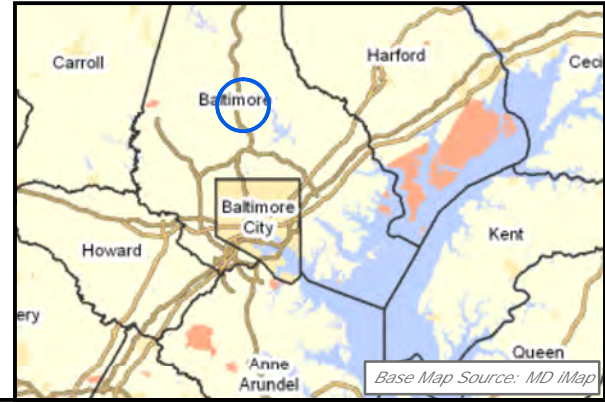
Station: Hunt Valley  
 Rail Line: Light Rail

- There are segments of missing and damaged sidewalk along McCormick Road and Schilling Road that should be replaced.
- A mid-block crossing is recommended along Schilling Road.
- The intersection of McCormick Road and Schilling is recommended for pedestrian crossing and advanced pedestrian warning signs.

- Signage and drainage improvements are recommended on MD 145 between York Road and the NCR Trail to improve access between the trail and the station.
- To provide a shared use lane on Schilling it is recommended that signage, marking and bicycle safe drainage improvements be made.

Facility Type	Recommendation Type	Roadway Intersection	Roadway Name	From	To	Roadway Jurisdiction	Recommended Improvement	Distance (Mi)
PEDESTRIAN	SIDEWALK SEGMENT MISSING		SHAWAN ROAD	YORK ROAD	TRAIN STATION	COUNTY	INSTALL 600'X5' OF SIDEWALK	
	PEDESTRIAN CROSSING SIGNS MISSING		AT HUNT VALLEY STATION			STATE	INSTALL 120' OF XWALK, 2-PED CROSSING SIGN FROM PARKING TO THE PLATFORM AREA	
	LIGHTING AT INTERSECTION	AT HUNT VALLEY STATION				STATE	INSTALL 1LIGHT POLE AT SHAWAN AND MALL ENTRANCE	
	LIGHTING ALONG ROADWAY	PAPER MILL RD. AND TORREY C. BROWN RAIL TRAIL	PAPER MILL ROAD			STATE	INSTALL 1-LIGHT POLE ON SOUTH SIDE OF THE ROAD AT PED/BIKE CROSSING	
	CURB RAMP MISSING	WEST RAMP TO HUNT VALLEY'S MALL				COUNTY	INSTALL 2-CURB RAMPS AND CROSSWALK-260' OF P.M.	
BIKE	WIDE LANE		SHAWAN ROAD	WEIL MANDEL WAY	YORK ROAD	COUNTY	ROUTE, SIGNING, MARKING	1.25

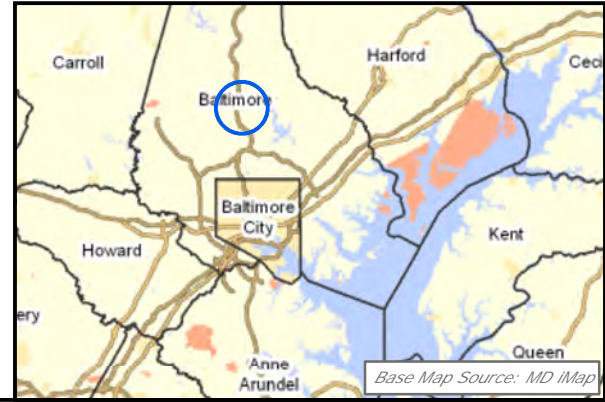
Station: Pepper Road  
Rail Line: Light Rail

- There are segments of missing and damaged sidewalk on Schilling Road that should be replaced.
- There are faded and missing crosswalks at McCormick and Wight and on Schilling Circle.
- There are curb ramps missing on Schilling Circle.
- Street Lighting is recommended for the intersections of Schilling @ Gilroy and Pepper @ Wight.

- Bicycle Route signing, marking and some compatible drainage is recommended along McCormick Road from Shawan to Beaver Dam to support a shared use lane.

Facility Type	Recommendation Type	Roadway Intersection	Roadway Name	From	To	Roadway Jurisdiction	Recommended Improvement	Distance (Mi)
PEDESTRIAN	SIDEWALK SEGMENT MISSING		SCHILLING ROAD	MCCORMICK ROAD	TRAIN STATION	COUNTY	INSTALL 1700'X5' OF SIDEWALK	
	SIDEWALK SEGMENT MISSING		SCHILLING ROAD	TRAIN STATION	YORK ROAD	COUNTY	INSTALL 1100'X5' OF SIDEWALK	
	SIDEWALK DAMAGED		SCILLING CIR.	340' WEST OF MCCORMICK ROAD		COUNTY	REPLACE 10'X4' OF SIDEWALK	
	SIDEWALK DAMAGED		SCILLING CIR.	780' WEST OF MCCORMICK ROAD		COUNTY	REPLACE 10'X4' OF SIDEWALK	
	PEDESTRIAN CROSSING SIGNS MISSING	MCCORMICK ROAD AND SCHILLING ROAD				COUNTY	INSTALL 160' XWALK, 2-RAMPS, 2-PED SIGNALS	
	PEDESTRIAN CROSSING SIGNS MISSING	MCCORMICK ROAD AND SHAWAN ROAD				COUNTY	INSTALL 2-PED CROSSING ON SHAWAN ROAD CHANNELIZED RIGHT TURN, 1-ADV. PED CROSSING SIGN	
	PEDESTRIAN CROSSING SIGNS MISSING						INSTALL 2-PED CROSSING SIGNS ON NB MCCORMICK CHANNELIZED RIGHT, 1-ADV. PED CROSSING

DESIRED LINE PRESENT		SCHILLING ROAD	AT ATLANTIC FINANCIAL FEDERAL CREDIT UNION		STATE	INSTALL MIDBLOCK CROSSING, 2-PED CROSSING SIGNS, 2 STOP BARS, 2-CURB RAMPS	
	DESIRED LINE PRESENT		SCHILLING ROAD	MCCORMICK ROAD	PEPPER ROAD	COUNTY	INSTALL MIDBLOCK CROSSWALKS, STOP BARS ON EACH SIDES, PED CROSSING SIGNS, RAMP ON EACH SIDE	
	DESIRED LINE PRESENT	PEPPER RD AND SCHILLING RD	PEPPER ROAD			COUNTY	INSTALL MIDBLOCK CROSSING, STOP BARS ON EACH SIDE, PED CROSSING SIGNS,AND CURB RAMPS ON BOTH SIDES	
CROSSWALK MISSING	MCCORMICK ROAD AND SCHILLING ROAD				COUNTY	INSTALL 50' S.B. ON THE W LEG		
CROSSWALK MISSING	PEPPER RD AND SCHILLING RD				COUNTY	INSTALL 320' CROSSWALK,25' S.B.,2-PED SIGNSON EB		
BIKE	WIDE LANE		SCHILLING ROAD	MCCORMICK ROAD	YORK ROAD	COUNTY	ROUTE, SIGNING, MARKING, DRAINAGE	0.128788
	WIDE LANE		SCHILLING ROAD				SIGNING, MARKING	0.128788
	WIDE LANE		SCHILLING ROAD				SIGNING, MARKING, DRAINAGE	0.128788

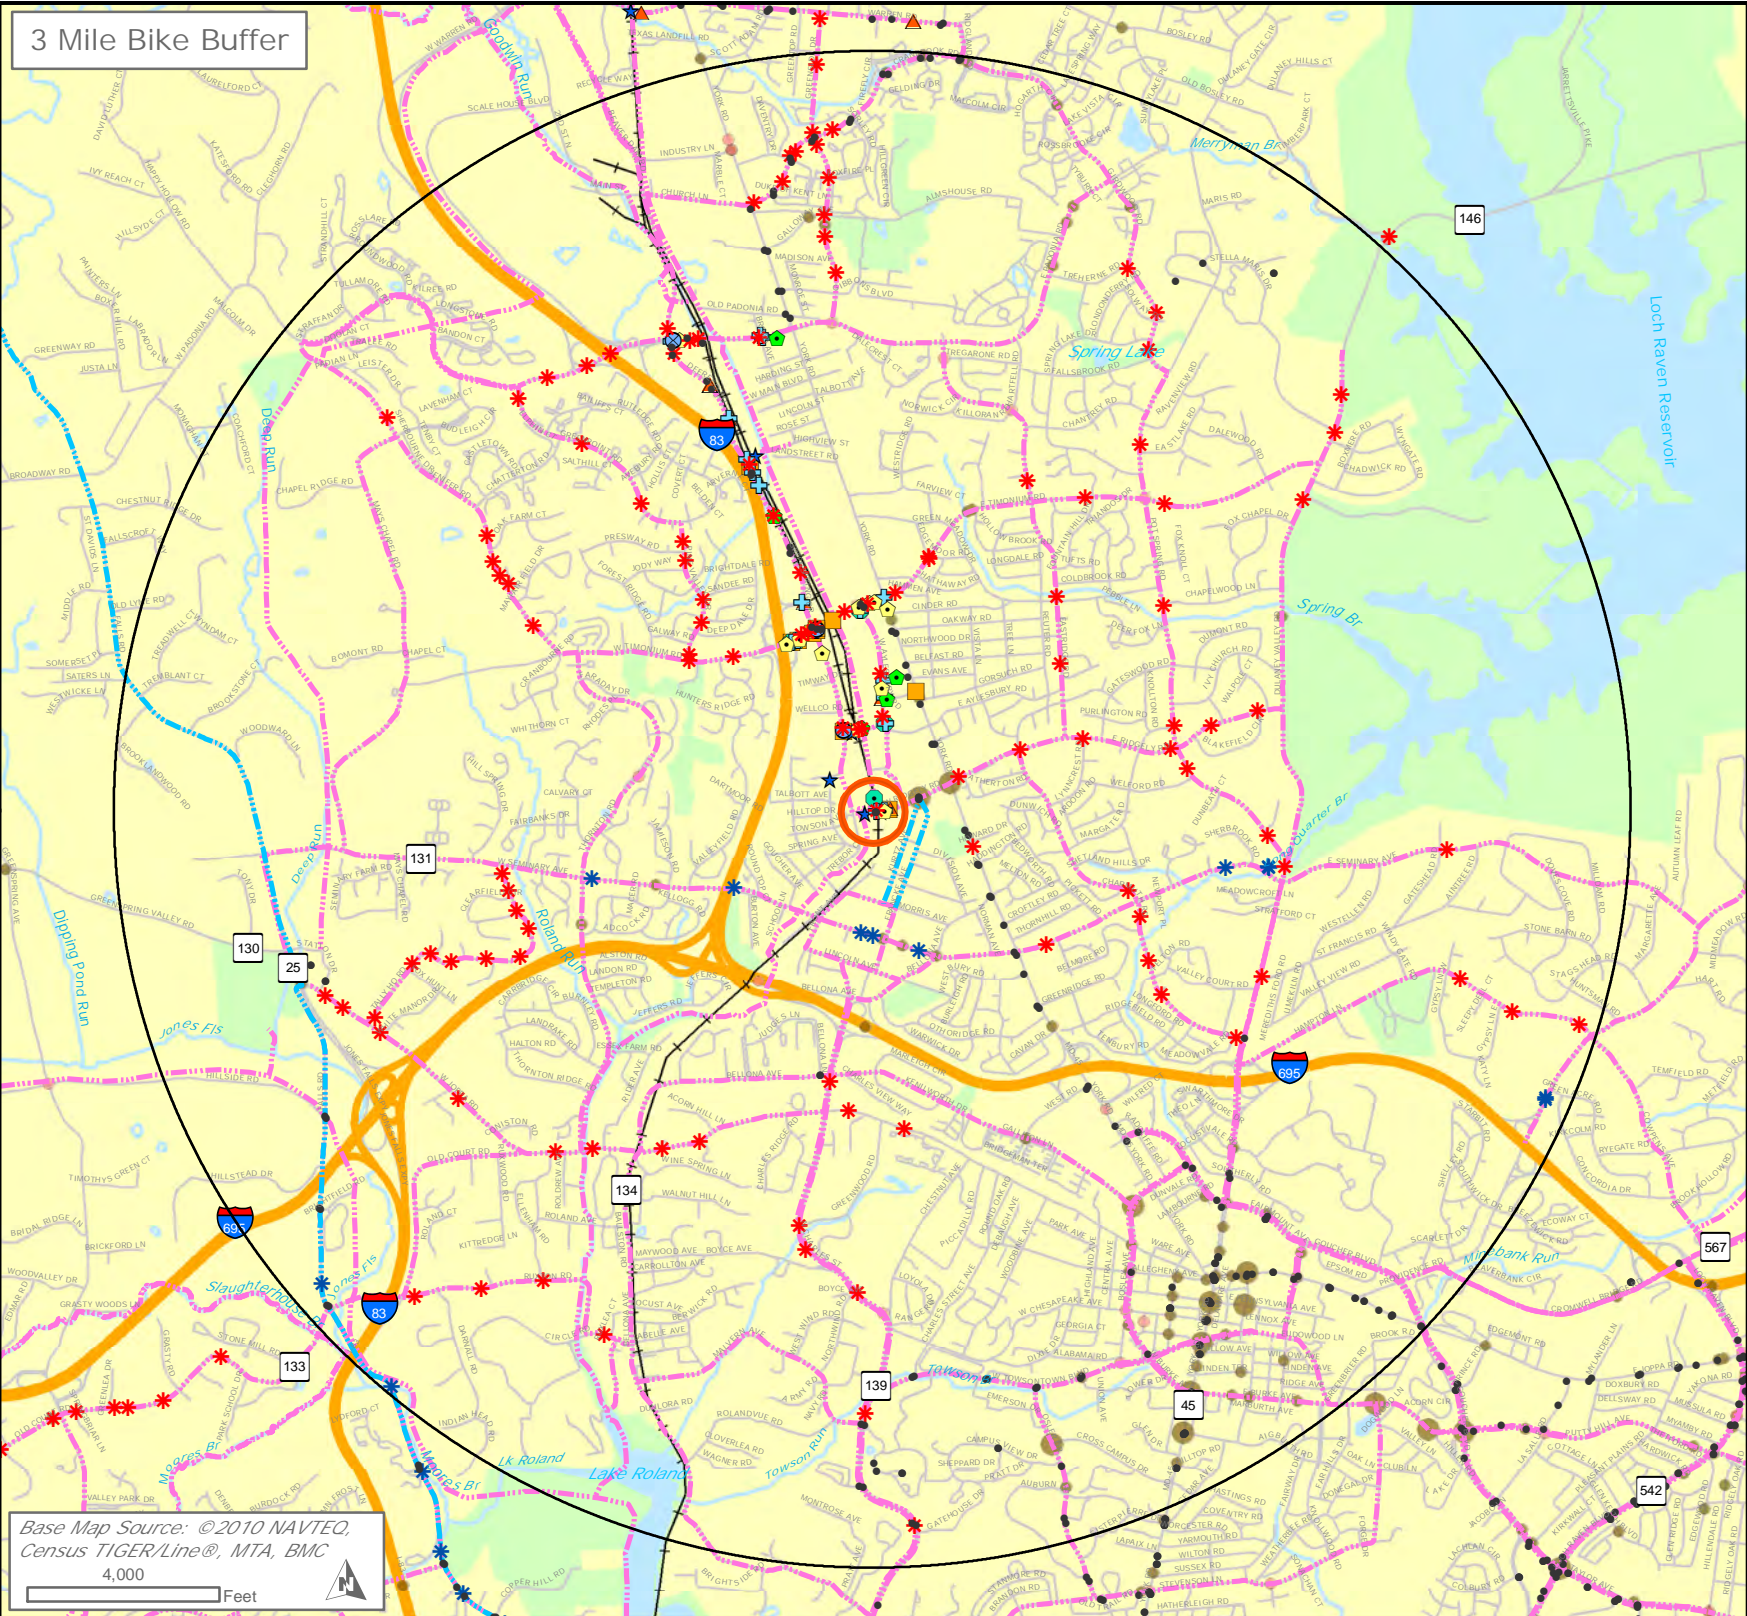
**Recommended Improvements**

Station: Lutherville  
Rail Line: Light Rail
