## APPENDIX A: CONCEPTUAL CORRIDOR PROFILES

This section of the Plan presents 20 preliminary studies, 13 bicycle corridor studies and 7 pedestrian improvement zones. These profiles are designed to be short term projects that can be implemented relatively easily and help illustrate different types of low cost solutions to improve bicycle and pedestrian conditions. Each bicycle corridor study includes a description of the corridor, existing roadway conditions and the proposed improvements. A table showing the before and after Bicycle Level of Service score for each corridor is also included for each. The majority of the proposed bicycle improvements can be implemented in the short term and primarily involve restriping and resurfacing of the roadways to provide more space for bicyclists. These improvements should include the appropriate signs and pavement markings as illustrated in the Engineering Solutions chapter of this report. The pedestrian improvement zone studies identify problem areas within each zone and present possible improvements to address the problems. While the data on the region's pedestrian environment was not comparable to the information available to evaluate on-r

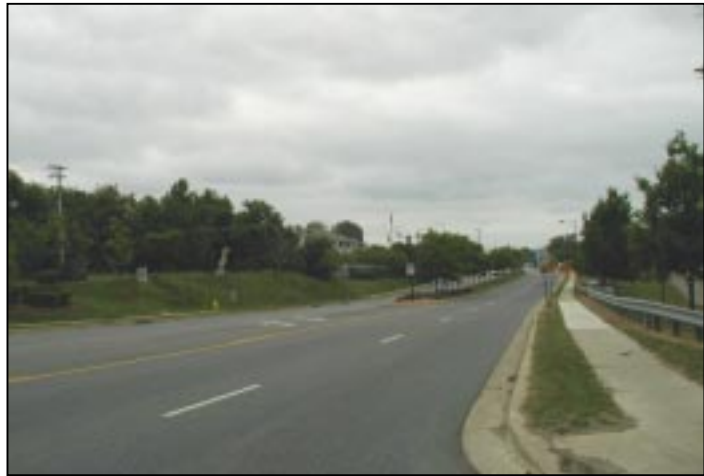
Currently, there are no bicycle facilities along Bestgate Road. Bicycle conditions are poor with a Bicycle LOS “E”. Bestgate Road is a 4-lane, divided arterial road with curb and gutter along the entire segment. The proposed improvement to Bestgate Road is the addition of a 4-foot bike lane. The resulting road cross-section would be four 10-foot travel lanes and two 4-foot bike lanes. Additional traffic calming measures should be considered to reduce the speed limit from 35 mph to 25 mph. These changes will greatly enhance the bicycling environment and achieve a Bicycle LOS “C”, a 30% improvement over existing roadway conditions.

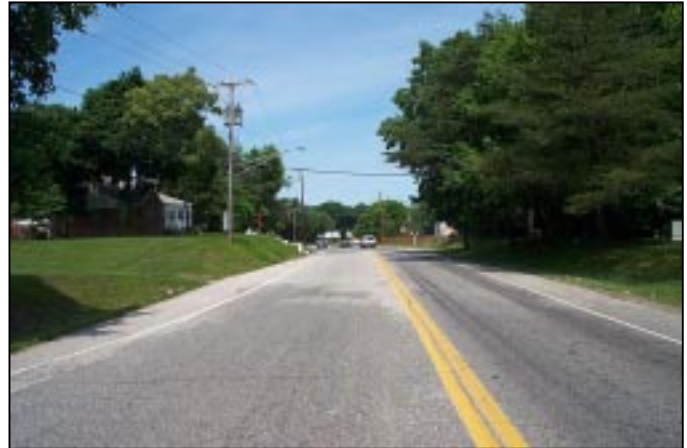
Current bicycling conditions are poor along this corridor; the Bicycle Level of Service is rated a “D” as shown in the table below. The road cross-sections vary within the corridor from an open section with shoulders to sections with curb and gutter in residential areas. The recommended improvements are to repave the existing shoulders in areas where they have deteriorated, and strip the shoulders as bicycle lanes, at least 4 feet wide in areas with curb and gutter, leaving two 10-foot travel lanes for motor vehicles. These improvements should raise the Bicycle LOS to a “C”.

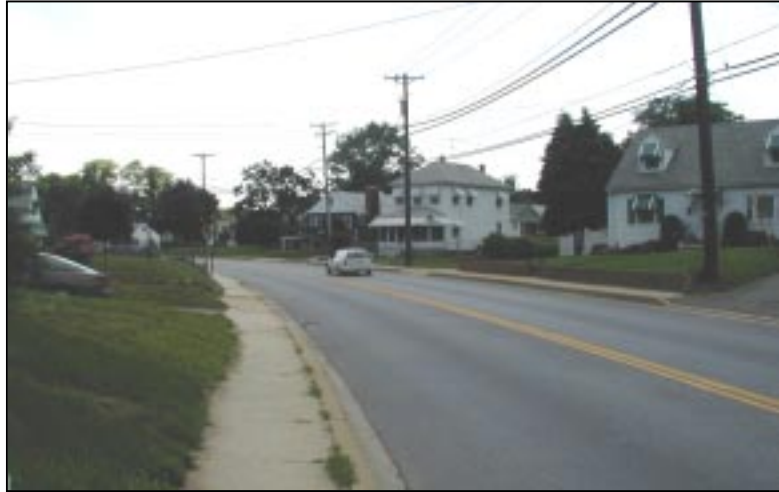
Current bicycling conditions are poor along this corridor; the Bicycle Level of Service is rated a “D” as shown in the table below. The cross-section on this 2-lane undivided roadway is curb and gutter in residential areas and 15-foot travel lanes. The recommended improvement for Spa Road includes re-striping the existing pavement with 5-foot bicycle lanes, leaving 10-foot travel lanes for motor vehicles. These improvements will raise the Bicycle LOS to a “C”.

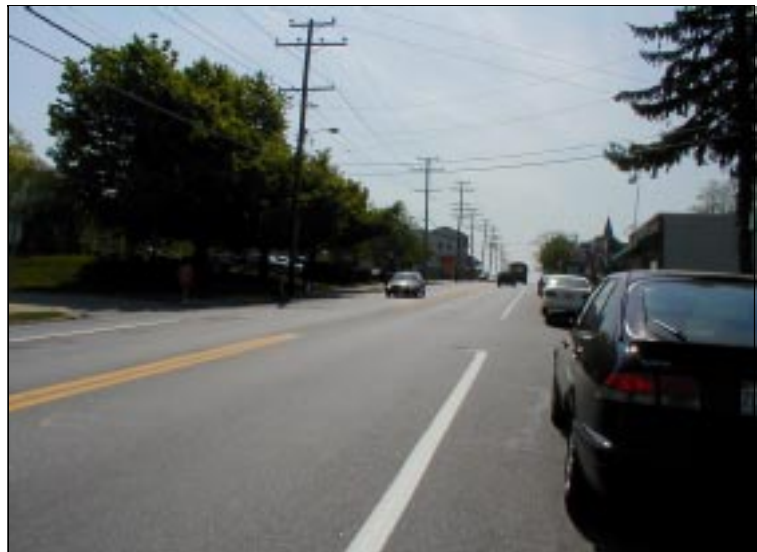
The bicycling conditions along this corridor are poor with a Bicycle Level of Service of “E”. Frederick Road is currently a four-lane undivided arterial road with curb and gutter and on street parking on both sides. The total width of Frederick Road is 44 feet; each travel lane is 12 feet wide and the parking lanes have a width of 10 feet. Based upon the potential for increased bicycle activity along this segment, improvements are recommended. Changes along this section of Frederick Road include resurfacing and restriping the road to include two 10-foot travel lanes, two, 7-foot parking lanes and the creation of two 5-foot wide bicycle lanes. These improvements will enhance conditions considerably for bicycling, from a Bicycle LOS “E” to “D”.

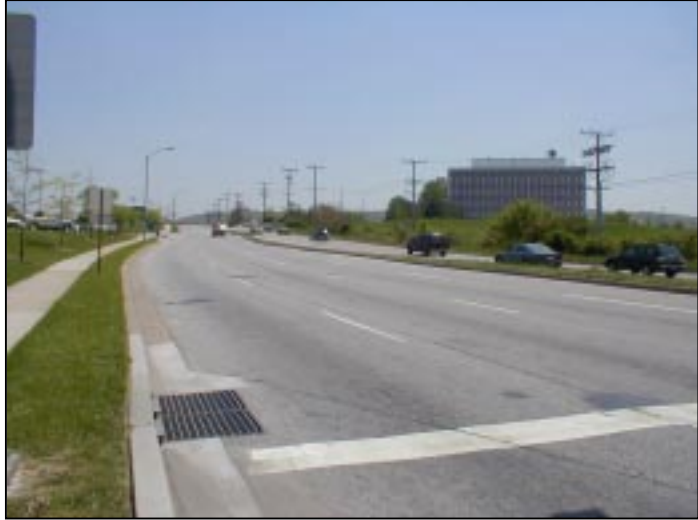
Shawan Road is a six lane arterial road with right and left turn lanes at most intersections. Traffic volumes, 14,900 VPD, are high, particularly during peak hours. Current conditions for bicycling and walking are poor, with a Bicycle LOS “F”, and limited accommodation of pedestrians. Sidewalks are missing on the south side of the road and the few existing crosswalks require pedestrians to cross multiple lanes of high-speed traffic without refuge areas. There is currently a fair amount of pedestrian activity between the offices located on the south side of the road and the retail and restaurants in and around the Hunt Valley Mall on the north.

Recommended pedestrian improvements are to complete the sidewalk network on the south side of the road, from York Road to International Drive. The sidewalk should be at least five feet wide and **preferably** ten feet wide to also accommodate bicycle travel. Pedestrian signal heads should be added at all signalized intersections where none are in place today. Additionally, a pedestrian phase activated by a push button should be included at all signals. Pedestrian refuge islands should be installed in Shawan Road at the intersections of with McCormick Road and the Entrance to the Light Rail Station. Installation of a traffic signal should be considered at the Hyland Road intersection. The signal should include pedestrian signal heads and phases, and refuge islands should be installed in Shawan Road.

The existing conditions on Shawan Road are not conducive to bicycling, with a Bicycle LOS rating of “F”. Multiple lanes, and high speeds and volumes or traffic combine to create an uncomfortable environment for cycling. It would be very difficult to make changes to the roadway cross-section that would result in significant improvements to the Bicycle LOS. However, the land use and access patterns along this section of Shawan Road are conducive to the installation of a shared use path adjacent to the road.

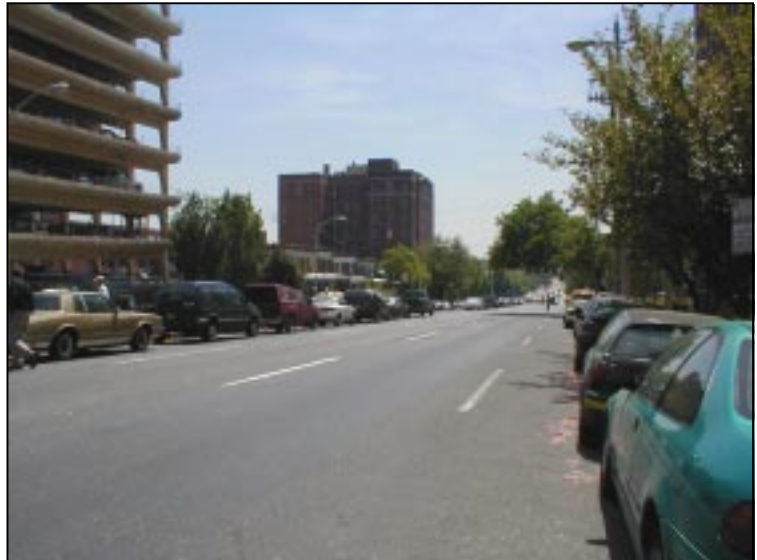
Current bicycling conditions in the corridor are poor with Bicycle LOS scores of “E” between University Parkway and North Avenue and “D” from University Parkway to Charles Street. The road cross-section varies throughout the corridor, from a 54-foot wide street with two-way traffic from Charles Street to University Parkway to a one-way street southbound from University Parkway to North Avenue, with parking on both sides of the street and widths of 40 or 44 feet. St. Paul Street is the southbound segment of a one-way pair system, with Charles Street, that serves north-south traffic through north central Baltimore. Parking is prohibited during the morning peak hours, 7:00-9:30 AM, to allow an additional travel lane. Because of the different traffic patterns during the day two alternatives are proposed for St. Paul Street. The first is to stripe a parking lane and bike lane adjacent to the left side curb to accommodate bicycles at all hours. The resulting cross-section would be a 7-foot parking lane, a 5-foot bike lane, and three 10 foot travel lanes, raising the Bicycle LOS to “C”. A second alternative is to stripe a wide curb lane on the right side of the road. The resulting cross-section would be a 13-14 foot lane adjacent to the right curb, two 10-11 foot travel lanes and a 7-foot parking lane on the left side. The wide curb lane would improve conditions during the morning peak hours and also allow for parking during the rest of the day. This cross-section would improve the Bicycle LOS to a “D”. In some segments the configuration of bike lanes will need to be carefully studied, to reduce potential conflicts between bicycles and parked cars. However, accommodating bicycle travel along St. Paul Street is an important step in meeting the high demand for bicycling in the corridor.

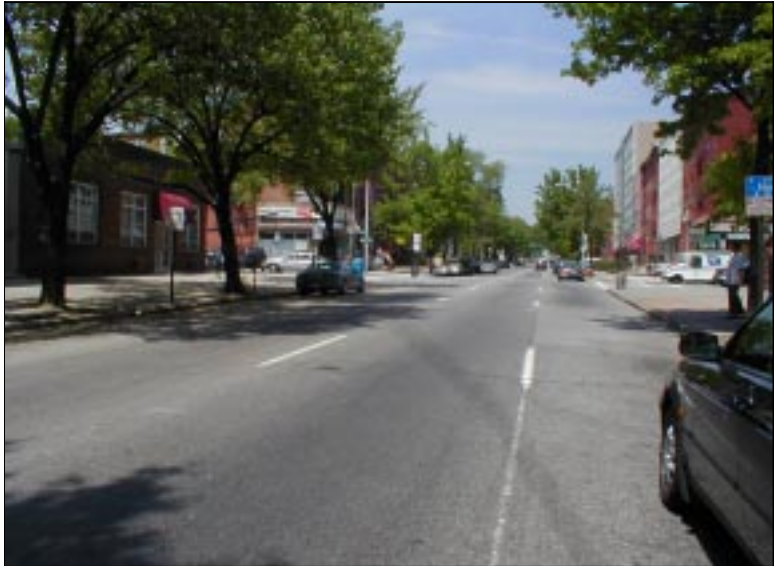
Current bicycling conditions in the corridor are poor with Bicycle LOS scores of “D” and “E” for segments in the corridor. The road cross-section varies throughout the corridor, but is generally a one-way street north bound, with parking on one or both sides of the street and has a contra-flow vehicle lane for southbound traffic during the morning peak hour adjacent to Johns Hopkins University. Charles Street is the northbound segment of a one-way pair system, with St. Paul Street, that serves north-south traffic through north central Baltimore. The street width varies from 40 to 60 feet. Parking is prohibited during the afternoon peak hours, 4:00-6:30 PM, to allow an additional travel lane. Because of the different traffic patterns during the day two alternatives are proposed for Charles Street. The first is to stripe a parking lane and bike lane adjacent to the left side curb to accommodate bicycles during all hours. The resulting cross-section would be a 7-foot parking lane, a 5-foot bike lane and three 10 foot travel lanes, raising the Bicycle LOS to “C”. A second alternative is to stripe a wide curb lane on the right side of the road. The resulting cross-section would be a 13-14 foot lane adjacent to the right curb, two 10-11 foot travel lanes and a 7-foot parking lane on the left side. The wide curb lane would improve conditions during the morning peak hours and also allow for parking during the rest of the day. This cross-section would improve the Bicycle LOS to a “D”. In some segments the configuration of bike lanes will need to be carefully studied, particularly in front of Johns Hopkins University, between 29<sup>th</sup> street and University Parkway where a contra-flow vehicular lane is in place during the AM peak hour. However, accommodating bicycle travel along Charles Street is an important step in meeting the high demand for bicycling in the corridor.

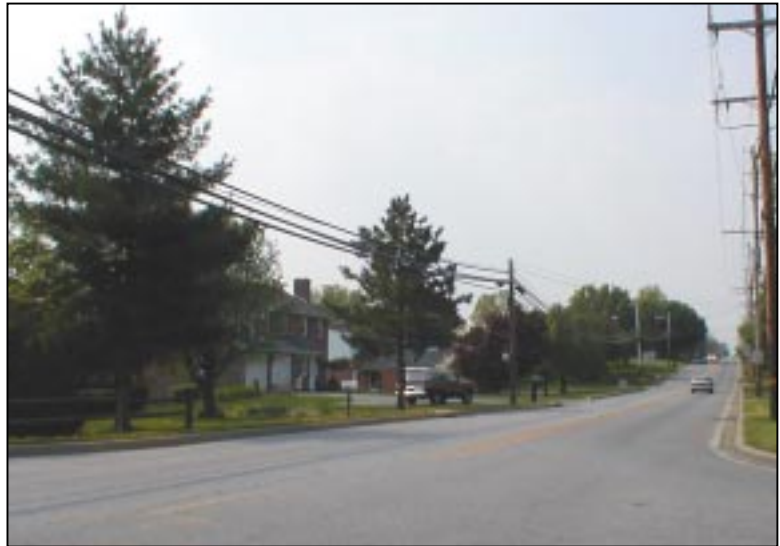
MD 32 is a 2-lane undivided roadway with no bicycle or pedestrian facilities. Current bicycling conditions are poor with a Bicycle LOS “F”. Considering the potential for bicycling activity, improvements on this road are recommended. Based on the existing pavement width, the road would be restriped with two 10-foot travel lanes and two 4-foot bicycle lanes. In addition, construction of five-foot wide sidewalk on both sides of the roadway is recommended. The recommended changes, coupled with a reduction of the posted speed limit to 35 mph will greatly improve the Bicycle LOS to a “D”. During the next resurfacing project a few feet of pavement should be added to enable the installation of curb and gutter where it does not exist closer to Main Street and allow for an additional foot to be added to the bicycle travel lanes. These additional steps would achieve a Bicycle LOS “C” for this section of MD 32.

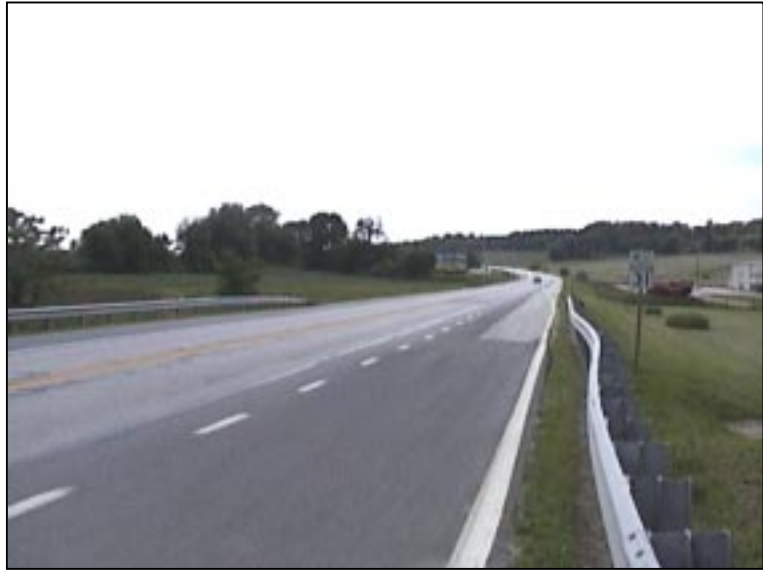
This 2-lane undivided road has 10-foot shoulders, 12-foot travel lanes and no curb and gutter. Conditions for bicycling along this section of MD 31 are average but could be enhanced from a Bicycle LOS “C” to “A” by restriping the existing shoulders as bicycle lanes and installing proper bicycle lane signage to raise motorist awareness. These changes are a good example of how inexpensive improvements to the bicycling environment can encourage bicycling.

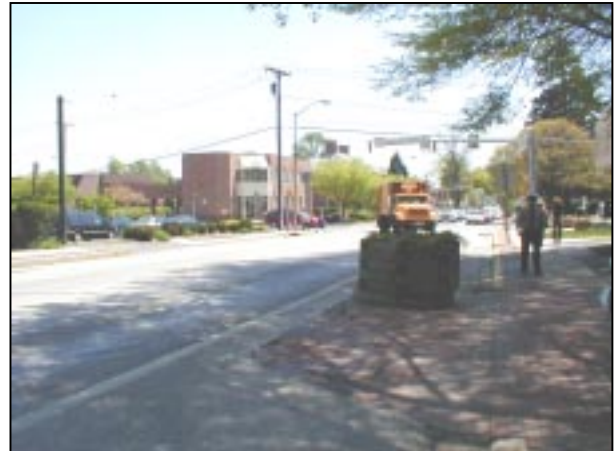
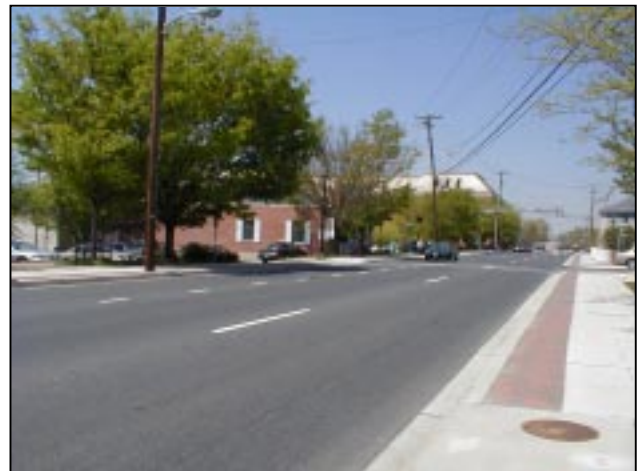
Conditions for bicycling on Bond and Main Streets are currently poor with Bicycle LOS grades of “D” for both Streets. Main Street is currently configured with two 11-foot travel lanes and a 9-foot parking lane on both sides of the street. Tree islands, extending 7 feet beyond the face of curb are installed intermittently on both sides of the street. Bond Street has two lanes with parking on the west side from Main Street to Lee Street, and then three lanes with no parking to Fulford Avenue. All travel lanes on Bond Street are 12-feet wide. The recommended improvement for Main and Bond Streets is to add bike lanes to both streets. On both streets bike lanes could be created by restriping the road. The resulting cross-section for Main Street would be two 10-foot travel lanes, two 7-foot parking lanes and a 6-foot bike lane. The cross-section on Bond Street would be three 10-foot travel lanes and a 5-foot bike lane. Consideration should be given to striping the bike lane on the left side of Bond Street, because most of the large number of retail and restaurant uses on the east side of the street and on Main Street.

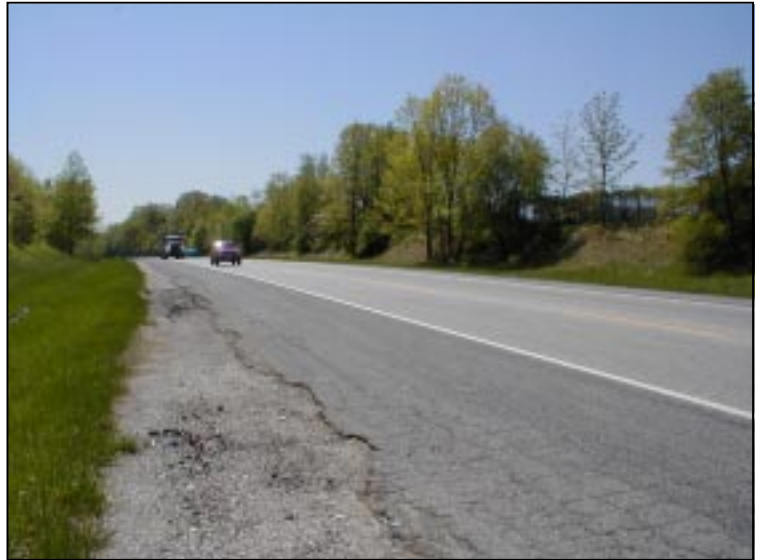
Current conditions along this two-lane undivided roadway are average, Bicycle LOS “C”. Considering the potential for increased activity along this corridor, improvements are recommended. The shoulders along this road are in disrepair. Resurfacing the shoulders, marking them as bicycle lanes and installing bicycle route signs on Trimble Road directing cyclists to the MARC Station and Aberdeen Proving Ground, will provide an improved bicycling environment along this segment. As shown on the second row of the table below, a Bicycle LOS “B” would be achieved with these improvements.

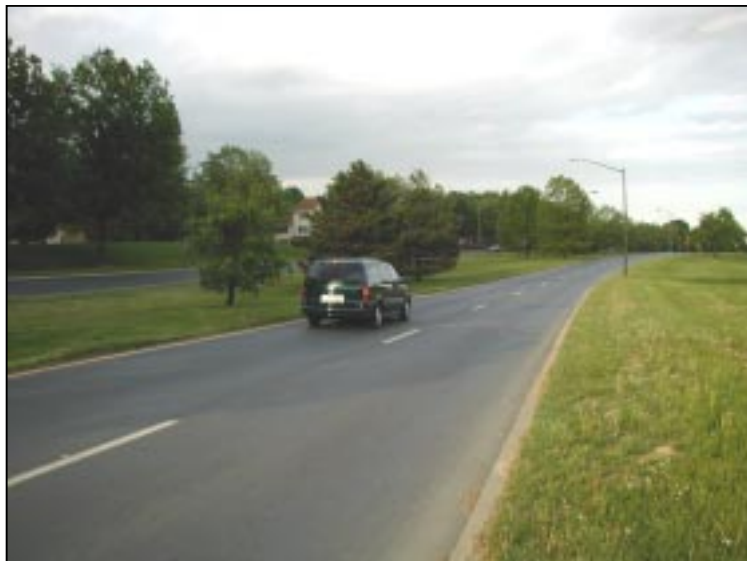
Current bicycling conditions on Little Patuxent Parkway are poor with Bicycle LOS scores of “E” and “F” between Cedar Lane and Governor Warfield Parkway. The roadway cross section varies considerably along the corridor: from a 4-lane two-way street with no center turn lane around the “loop”, to a 4-lane two-way street with a wide grassed center median between end of the loop and Broken Land Parkway, to a 6-lane two way street with a center parkway through Town Center. Along each cross section, however, there are opportunities to accommodate bicycles relatively easily, in some cases without adding additional pavement.

The proposed improvement for Little Patuxent Parkway is to install bike lanes for the entire length of the corridor. It is recommended that the 6-lane section of Little Patuxent Parkway between Broken Land Parkway and Governor Warfield Parkway (north of mall) be reduced to a 4-lane roadway. This section exceeds the amount of roadway width normally needed to carry current traffic volumes. It carries 23,000 vehicles per day and operates at a motor vehicle LOS of “A” – the reduction to a 4-lane road will not degrade motor vehicle LOS below an “A.” The additional space may be used for bike lanes on each side (as well as additional sidewalk space). The resulting improvement in bicycling conditions would be dramatic – going from an “F” to a “B” (see below).

Along the 4-lane section between Cedar Lane and Broken Land Parkway, the existing 12’ lanes could be narrowed to 10’ wide (which may also have the benefit of reducing excessive motor vehicle speed on this road), leaving 4’ of space on the sides for bike lanes. Another option would be to add a few feet of pavement on the inside, non-curbed portion of the road (alongside the center median) and shift the travel lanes over in order to have room for bike lanes on the outside edge.

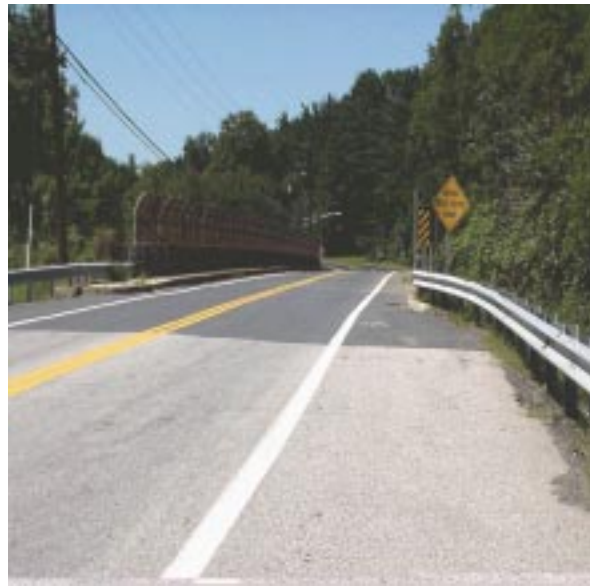
Current bicycling and walking conditions are poor to barely adequate. West of Landing Road, the Bicycle Level of Service is rated as “E”; east of Landing Road it is “D”. Sidewalks are almost non-existent. Cross section west of Landing road narrows and shoulders are often one foot to two feet wide (reflecting limited right-of-way). East of Landing Road (I-95) to US 1, shoulders vary but are adequate in some segments. However, motor vehicle traffic volumes are higher in this segment as well. The impending second connection of Marshalee Drive to Montgomery Road near I-95 will divert traffic from part of Montgomery Road improving the “E” Bicycle Level of service road segment. The recommended direction of improvements is to widen and demarcate shoulders especially on uphill grades in the direction of traffic and to provide protected pedestrian crossings at key intersections. Constrained right-of-way may require that centerline striping be shifted to maximize lateral clearance on the side where needed more critically. Shoulder design, signing and construction should accommodate both pedestrians and cyclists where possible.

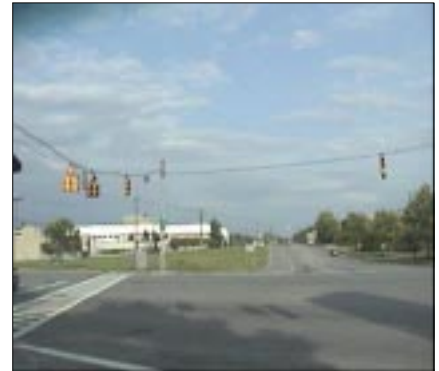
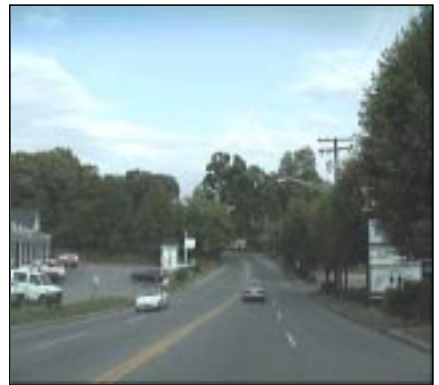
**Concern:** A continuous system of sidewalks is not provided at this location between commercial and residential areas. In addition, in the residential area, there are horizontal and vertical curves that create limited sight distance for pedestrians.

**Short Term:** Provide visible crosswalks and pedestrian signage at the intersections of Forest Drive with Riva Road, Solomons Island Road and Chinquapin Round Road, as well as the entrances to the shopping areas. Investigate sight distances in the proximity of vertical and horizontal curvatures throughout residential areas with specific attention to transit stops generating midblock crossings.

**Long Term:** Complete the missing sidewalks on the north side of Forest Drive between Riva Road and Solomons Island, as well as the south side of Forest Drive from Riva Town Center Road to Solomons Island Road, as well as the entrances to the shopping areas with some physical separation from the motor vehicle traffic where permitted. Investigate the feasibility of a system of sidewalks through the residential area. Install pedestrian crossing signals at all major intersections including Riva Road, Solomons Island Road, and Chinquapin Round Road, as well as at the shopping mall entrances.

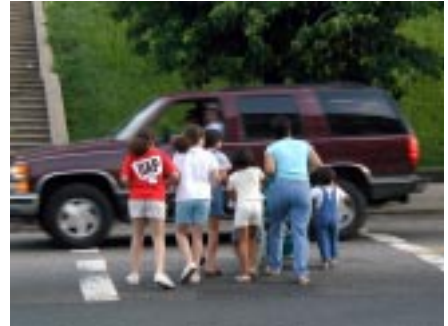
*(Above) Motorists are failing to yield to pedestrians in marked crosswalks. Pedestrian signals and systems fail to reward pedestrians who come to these crossings. There are insufficient marked crossings for pedestrians in this compact village area.*

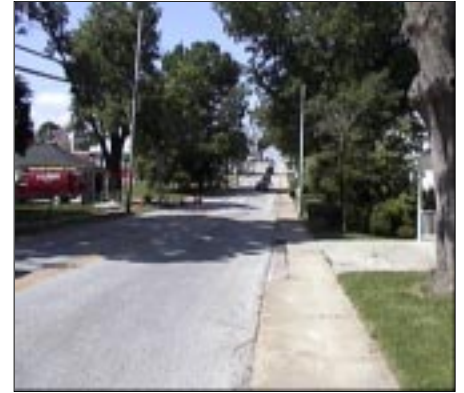
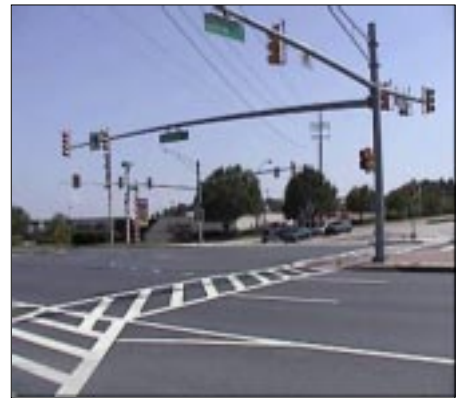
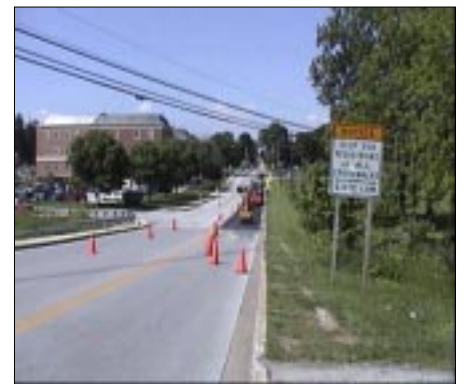
**Walking Conditions:** Existing pedestrian conditions include sidewalk gaps on the west side of Center Street in the vicinity of the Carroll County Offices. Generally, sidewalk conditions are poor.

**Concern:** This is a key travel corridor for residents, downtown employees and visitors to access the commercial zone located on MD 140. Crossings are poorly marked and traffic volumes are low to moderate along Center Street. In addition, the crossing at MD 140 is difficult due to the multiple lane configuration of the roadway, which results in long crossing distances.

**Short Term** Provide crosswalks and pedestrian signage at the intersections of Center Street with Main Street, and MD 140, as well as in front of the Carroll County Offices. Investigate signal timing at MD 140 to provide adequate crossing time. Provide crosswalks on north and west sides of the MD 140 intersection.

**Long Term:** Complete sidewalk on west side of Center Street in front of Carroll County Offices. Investigate geometric layout of MD 140 intersection to reduce vehicle turning speeds at pedestrian crossing areas. Install pedestrian signals at all approaches to MD 140 intersection. Provide curb cuts and pedestrian signal heads in new design. Signals and recall buttons are needed in median islands. Provide median noses to protect pedestrians in the center of their crossing.

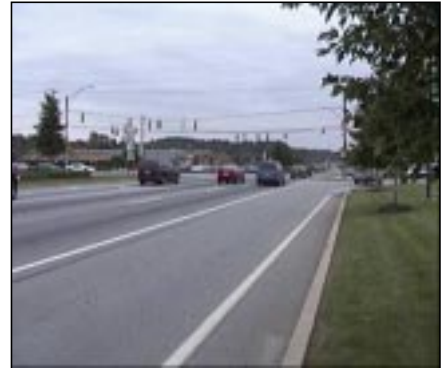
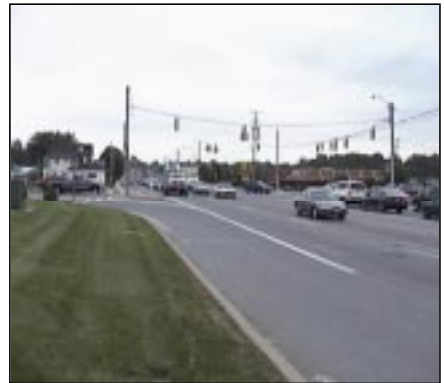
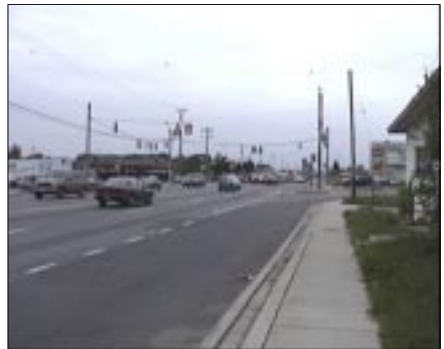
**Walking Conditions:** Land use at this intersection is predominantly commercial including Harford Mall, Tollgate Plaza, Bel Air Plaza, and Bel Air Town Center. From a land use perspective, high numbers of pedestrians can be expected at this intersection.

**Concern:** There are a number of impediments at this intersection including: high traffic volumes, excessive speed, the absence of sidewalks on the MD 24 approaches, push button actuation systems missing to cross MD 24, large crossing distances, and free flowing right turns. In addition, the parking lots for these commercial sites include little treatment for pedestrian circulation. Pedestrian accessibility is a major concern for this corridor that is so densely populated by retail destinations.

Provide crossing treatments, including pedestrian crossing signage, at the four free flowing right turn ramps. Investigate appropriate time required on pedestrian crossing signals to allow five lanes of traffic to be crossed on Business US 1 and six lanes to be crossed on MD 24. During the field visit, actuation of the push button resulted in approximately 2 seconds of walk time, and approximately 5 seconds blink-do not walk time.

Provide a complete system of sidewalks, with additional buffering where possible, at the MD 24 approaches to the intersection. Investigate a safe alternative to managing pedestrians crossing Business US 1 with opposing dual lefts on MD 24.

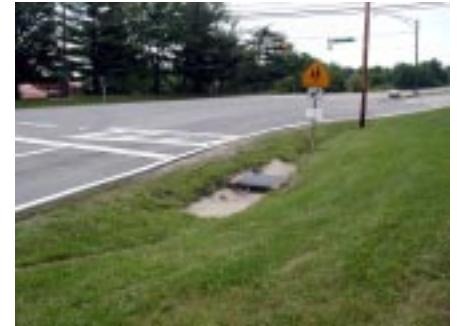
**Walking Conditions:** The existing conditions at the Intersection of Waterloo Road/MD 108 and Old Montgomery Road include: no sidewalks, poorly defined crossing, and no pedestrian signal heads. A pedestrian and bike trail connection is provided to the Columbia area homes.

**Concern:** There is a need to provide a safe pedestrian environment with the limit of the elementary school. Speeds are excessive, and sight distances on Old Montgomery Road approaches are questionable.

*(Above) Sidewalks are missing on all approaches to the school. Traffic speeds are high, and turning movements are complex. Children cannot see the signals, and pedestrian signals are missing. This intersection may model well for a roundabout. Sidewalks are needed to area housing and other destinations.*

**Long Term:** Provide added support for walking and bicycling through long term improvements to this intersection and area roadways. Within 1200 feet of the school sidewalks should be 8 foot width. At greater distances sidewalks can be 5 foot width. Study this intersection for a roundabout, which would reduce speeds at the school to the 15-20 mph range 24 hours daily.
